Rear Axles...What Fails and Why (PART 1)

R-R Silver Dawn, Silver Wraith. BENTLEY MKVI, R type.

N.W.Geeson ver 1. 2006

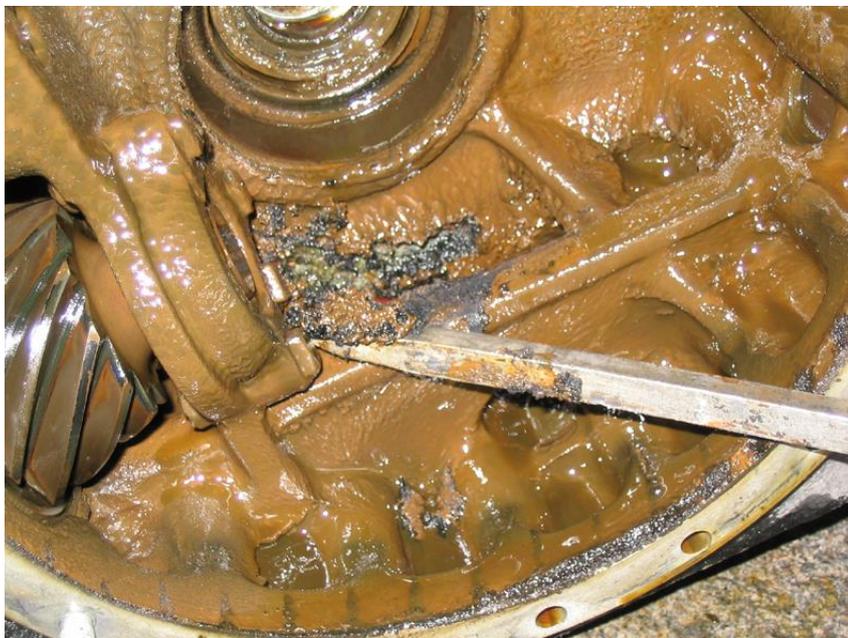
Fig 2. The extent of the sludge depth is shown clearly on this R-R Silver Dawn axle.

Fig 2 shows sludge and additive build up in a R-R Silver Dawn axle; there is no better medium for blocking oil ways than this material. The consequences are just as bad as if it was rust!

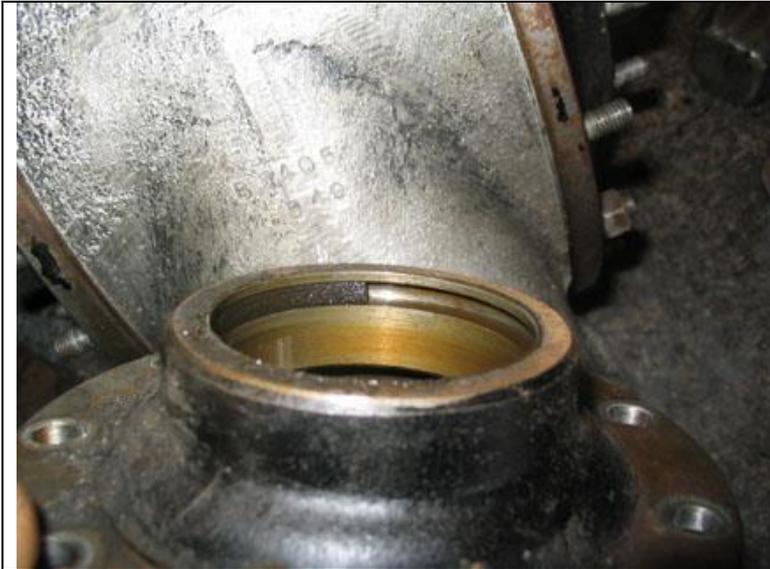
Fig 3. About 66% of the old felt oil seal is missing from this seal carrier, this is quite normal!

Fig 3 illustrates what the owner normal sees when the seal carrier is removed, over half the seal is missing! The best fix on earlier axles is to fit a modern oil seal of 55mm x 45mm by machining from the inside face of the seal carrier and turning the drive flange rubbing area down to 45.25 mm diameter. On all the Silver Cloud and Bentley S series axles an oil seal of 55mm x 60 mm will perform the same duty. If you own a Phantom V / VI it is your lucky day as these cars were fitted as standard with a leather oil seal to the pinion housing, now you know why the Queen never stepped in axle oil!

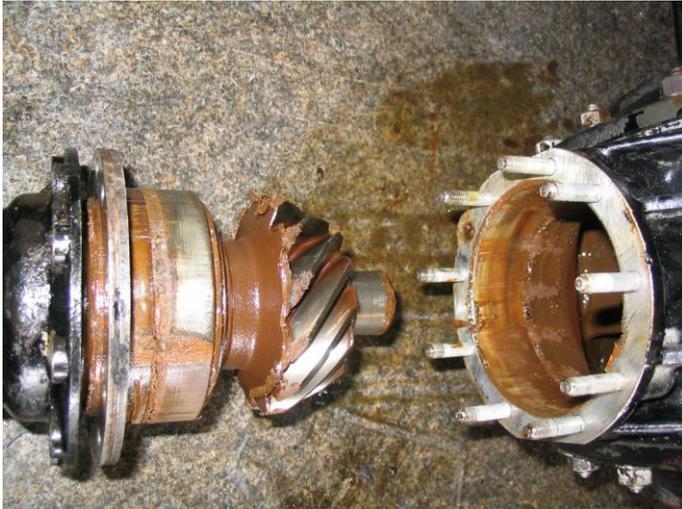
Fig 4. Clearly shown on this Bentley SI Continental axle is how sludge has filled the bearing housing oil groove.

The amount of sludge that can accumulate can be seen from the pinion assembly in Fig 4, which has just been removed from a Bentley S1 Continental axle. Incidentally this axle has only completed some 87,000 miles from new! Fig 5 shows how it should look, note the difference in the absence of dirt around the belted bearing oil feed groove.

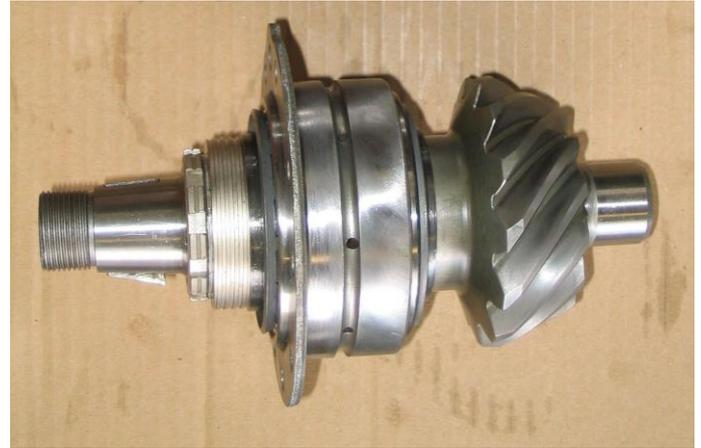
Fig 5. The pinion bearings on this axle will now receive oil again, compare it with the last image.

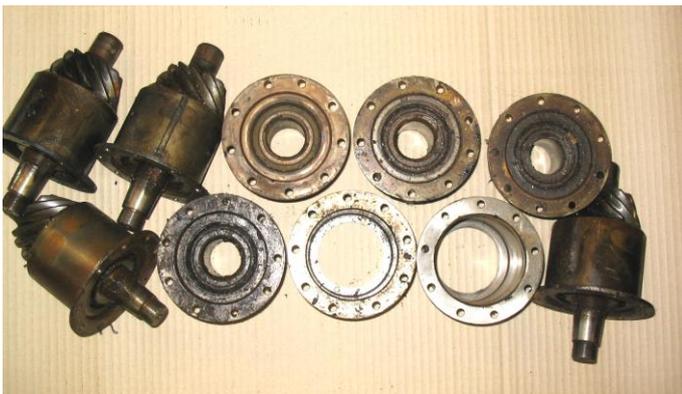
Fig 6. A collection of Bentley MKVI pinions, bearings and housings, all have or had the triple pinion bearing arrangement.

All the pinion assemblies illustrated in Fig 6 are out of Bentley MKVI. The observant readers will note that they are all of the triple bearing type that tells a story in itself! The later taper bearings are much more reliable, but as shown in Fig 7 they do like more oil than dirt, or this happens. In this instance a blown bearing on a Bentley S2 showing what happens when the bearing rollers try to obtain a divorce from the track at high speed. Fig 8 shows the usual greeting facing any owner who is wise enough to withdraw the pinion on his early axle, complete blockage of the two oil feed holes.

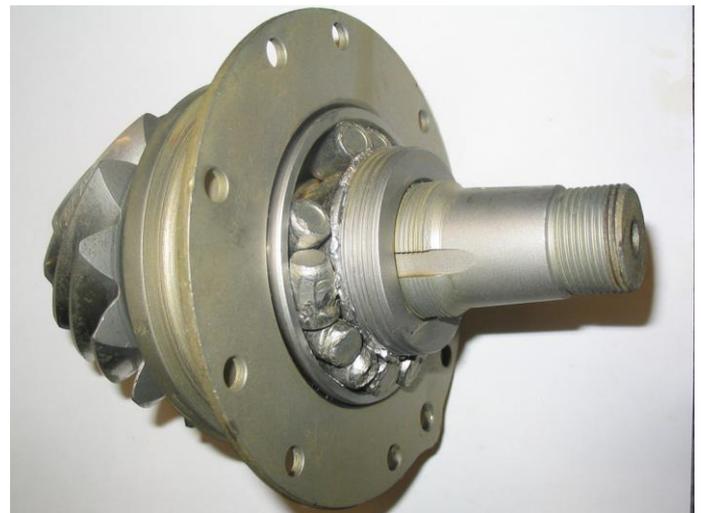
Fig 7. Even taper rollers on Bentley S2 axles depart from their nested tracks if they do not receive oil; this assembly is shown after having been cleaned. If this happens to your S2 axle you can only wish you have not tied the dog to the grab handles, because this car is going to stop.....and quick!

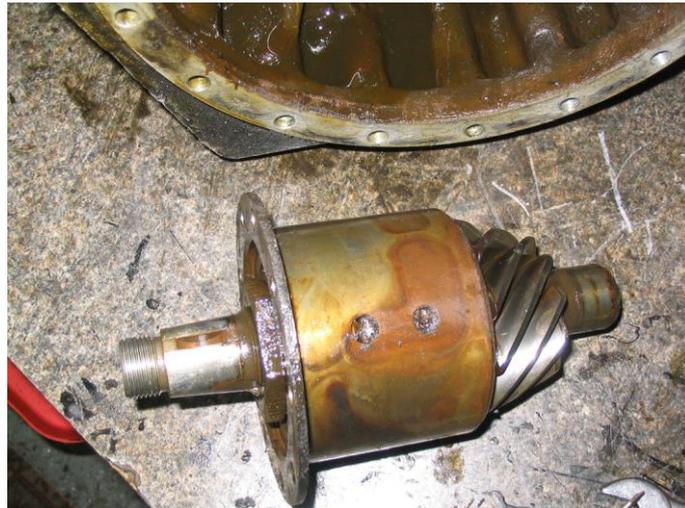
Fig 8. The two oil feed holes on the triple bearing pinion of an early Silver Wraith are well and truly blocked.

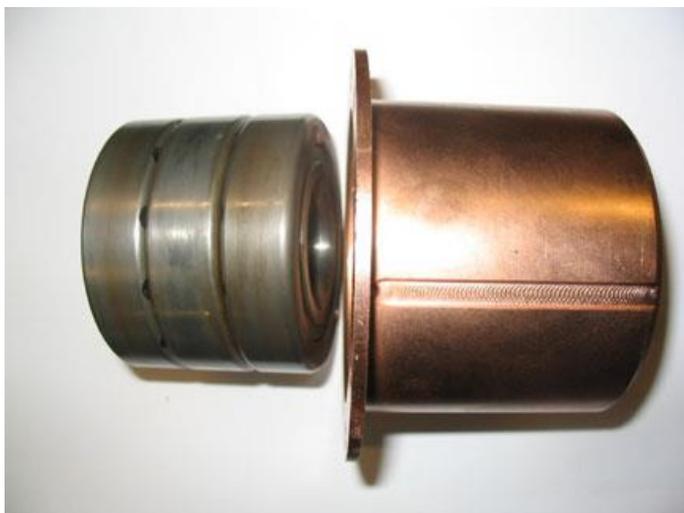
Fig 9. Triple pinion bearing and the matching bearing housing.

These images illustrate one of the major failing and weakness of this early triple bearing assembly. Fig 9 shows the early bearing and bearing housing. In this instance the housing has been copper plated to prevent rust, this housing is used for demonstration purposes only and the copper should be ignored. FIG 10 shows how easily the first section of the bearing can be inserted into the housing, this also applies to the last section of the bearing. The reason for this is that only the centre segment of these bearing is designed to contact the bearing housing. This design lacks stability at the main bearing end of the pinion and places great reliance upon the integrity of the small pinion nose bearing. Luckily for owners of the later models R-R realised the error of their ways and utilised taper bearings.

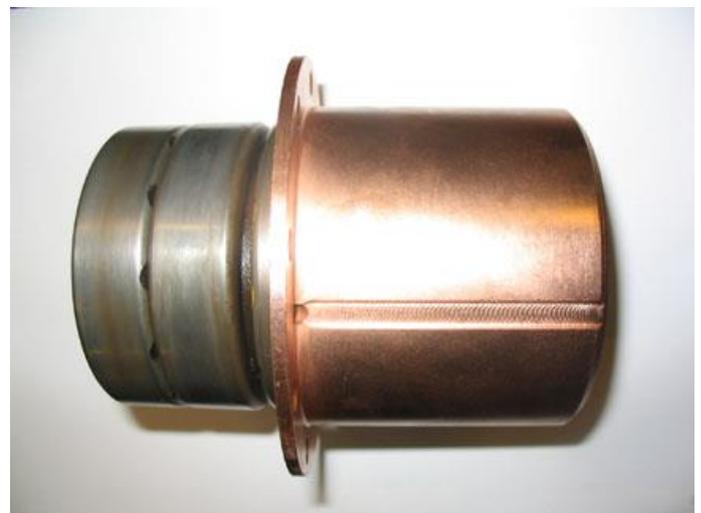
Fig 10. Only the centre section of this type of bearing contacts the bearing housing. It might be said it was dreamed up on a bad day, R-R made some costly mistakes in their time!

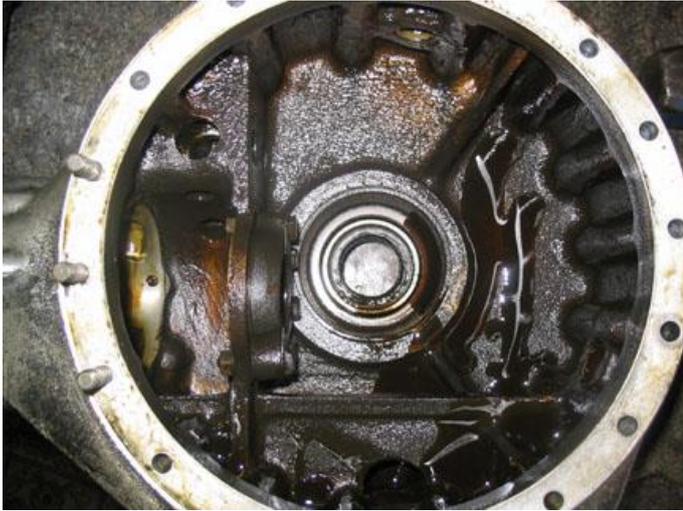
Fig 11. The light brown colour is caused by oil additive; otherwise this case can be classed as “clean”.

Continuing with the theme of sludging problems, the following few images are offered for the owners delight. Firstly Fig 11 is shown to illustrate just about the cleanest Bentley MKVI axle I have stripped in the last few years, the moral here is that your axle is likely to be in the mould of the axles shown from Fig 12 onwards where the captions explain all!

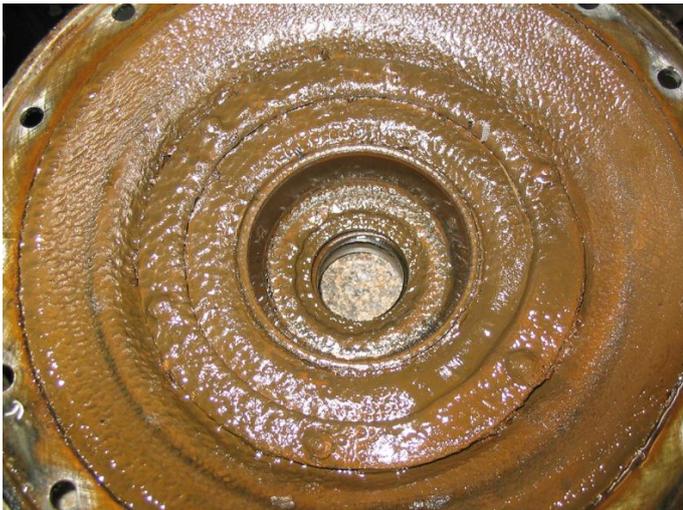
Fig 12. Ready for a good clean, the left hand side plate off a Bentley R type. Not much chance of the bearing surviving for long in this sludge.

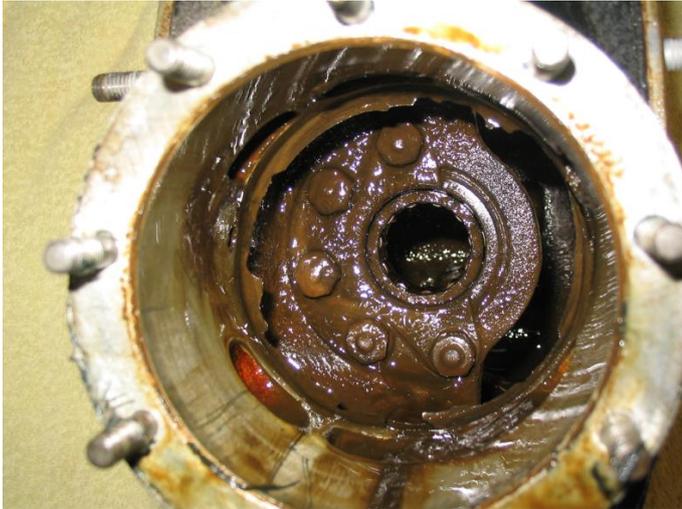
Fig 14. The normal view one faces after removing the pinion assembly on a Bentley MKVI. Owners are encouraged to remove the pinion assembly to assess the sludging on their axles.

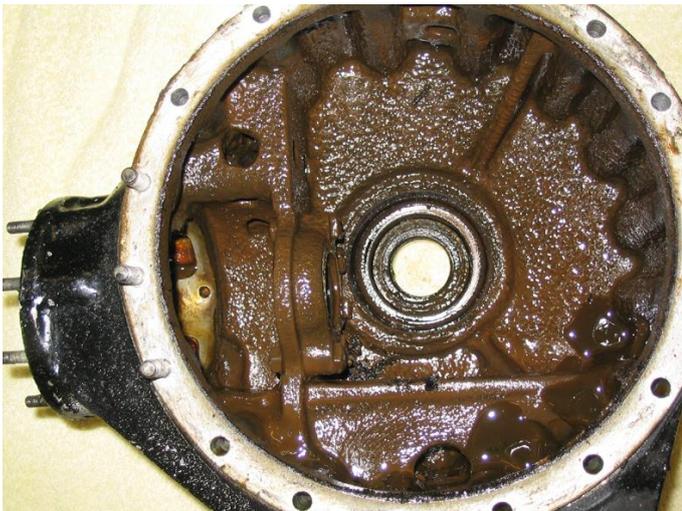
Fig 16. Just about the view you should expect after taking off the left side plate and removing the crown wheel assembly. Notice the labyrinth of holes at the 10 o'clock position which makes hard work of cleaning this Bentley R type case.

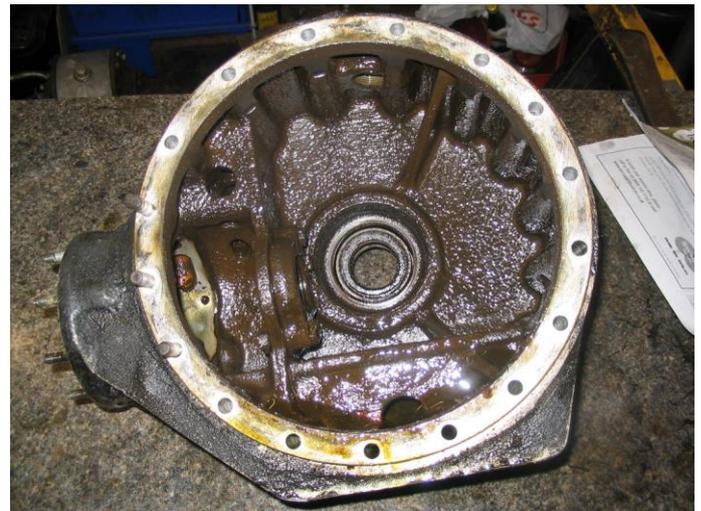
Fig 17. Similar to the previous view, note how the casting cores are inside of the Bentley MKVI axle case in comparison with the smooth internals of the Bentley SI axle case in Fig 20.

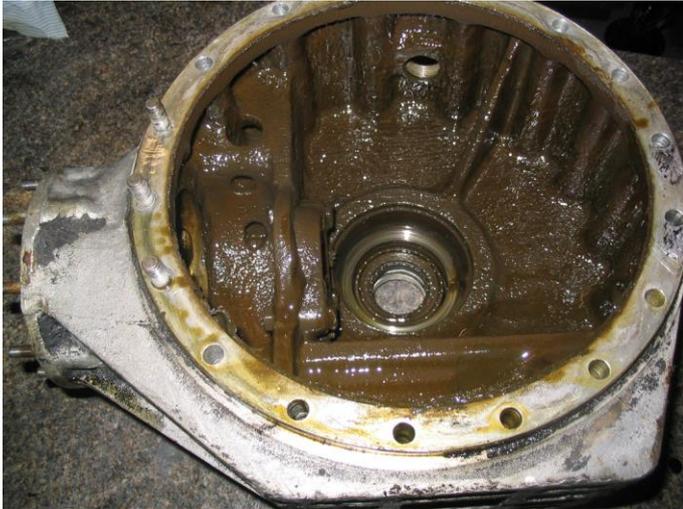
Fig 18. Yet another Bentley MKVI axle case, the amount of sludge is very consistent, just enough to finish off all the bearings!

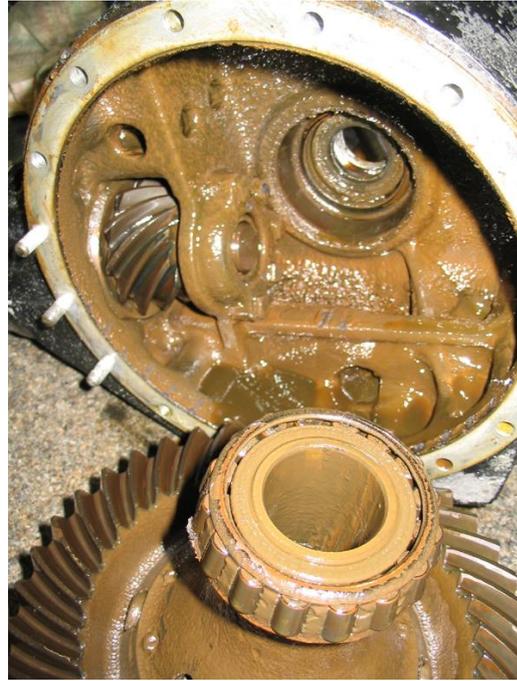
Fig 19. Sludge mixed with water in a Silver Dawn axle.

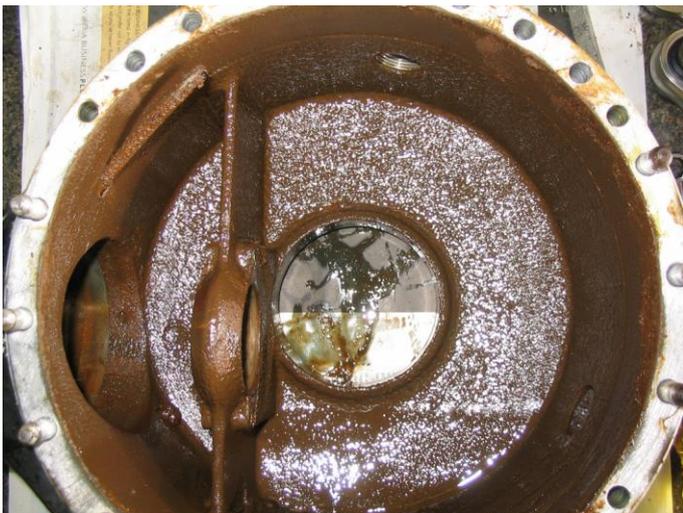
Fig 20. The smooth interior of the Bentley SI casing, unfortunately it does not stop sludge entering, and it stays unless the oil is changed frequently.

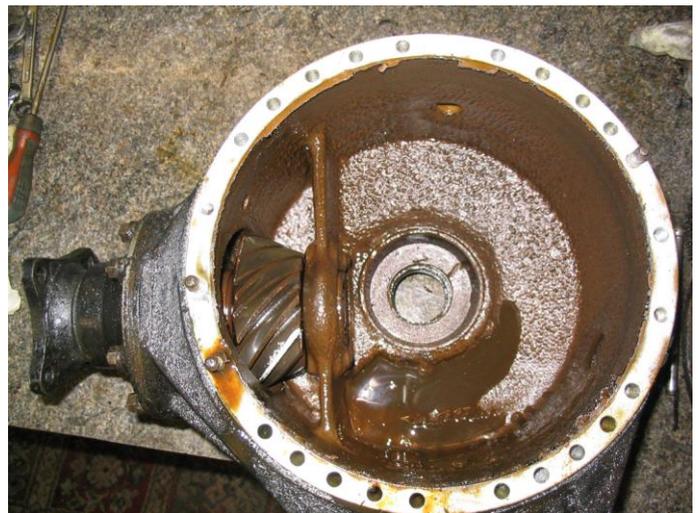
Fig 21. Strange, but the sludge tends to stay inside Bentley S2 axles as well as the Bentley SI.

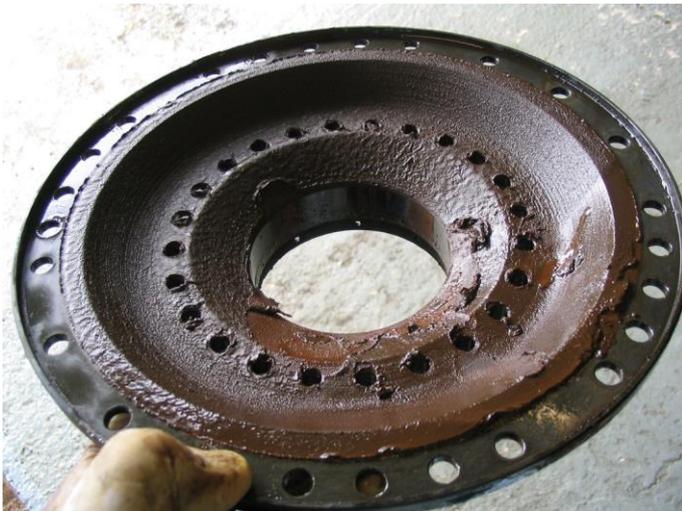
Fig 24. Sludged left hand side plate also from a nineteen-bolt case but in this instance a Bentley S3.

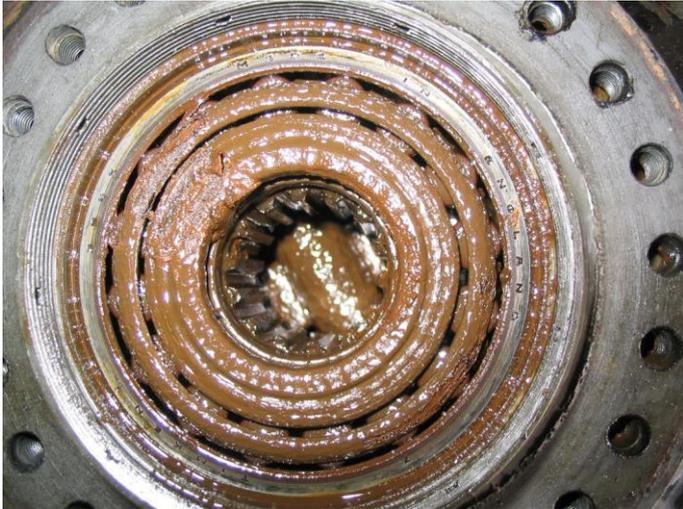
Fig 26. Clearly, the view through the left hand side shows this axle to be in trouble. At this stage of the game you should not be asking why? Counting the splines on the bevel gear shows this axle to be a Bentley S1 type before B590 FA.

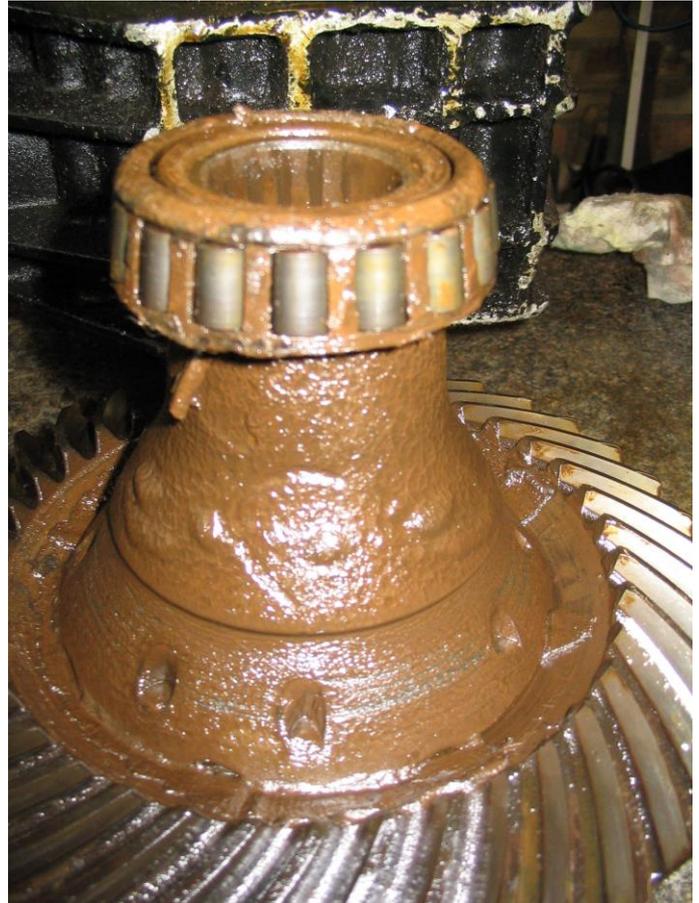
Fig 27. Just to prove again that Bentley S2 owners do not always change the axle oil and that later cars also suffer bearing damage.

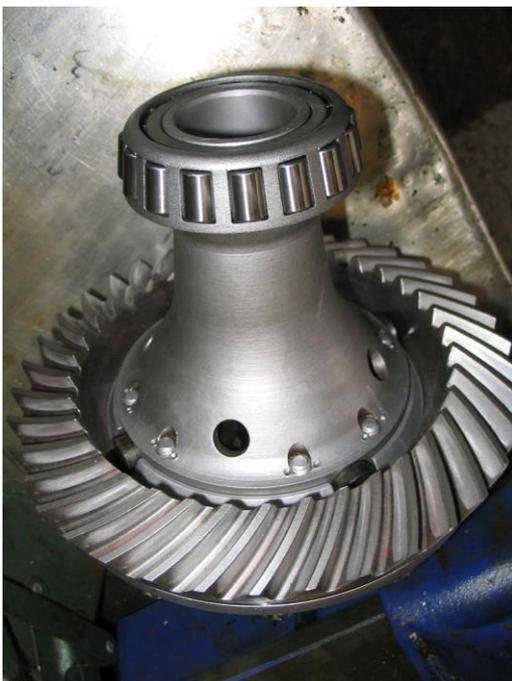
Fig 28. It is preferable to replace the Silver Dawn axle centre unit in this condition rather than leave it as shown in the former Bentley S2 image!

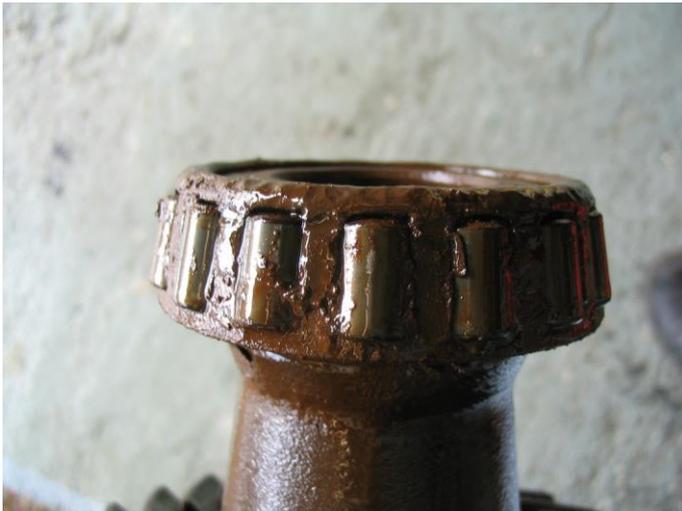
Fig 29. A close up of a Bentley SI right hand main axle bearing with a good quantity of axle destroying sludge.

All the axle sludge has a habit of coating the bearings with a brilliant grinding paste as exemplified in Fig 29. If the rear wheel bearings are worn the upward force at the outer end of the half shaft has an opposite downward force on the axle side bearing. Fig 30 shows the commencement of axle bearing wear caused by worn wheel bearings, typified by the destruction the outer and inner tracks in one place. This galling in one spot, is caused by point loading and prevents the oil film acting in the proper manner between the bearing rollers and tracks.

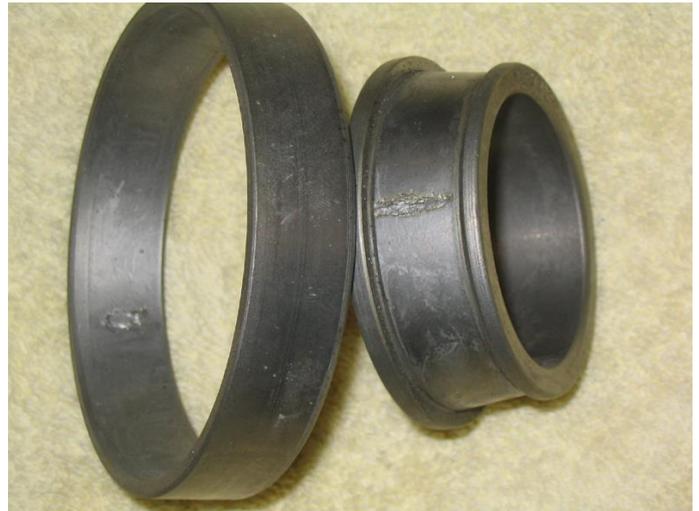
Fig 30. Showing what point loading produces on bearings when the oil film breaks down. This damage is also known to occur when axles have stood and not been rotated.

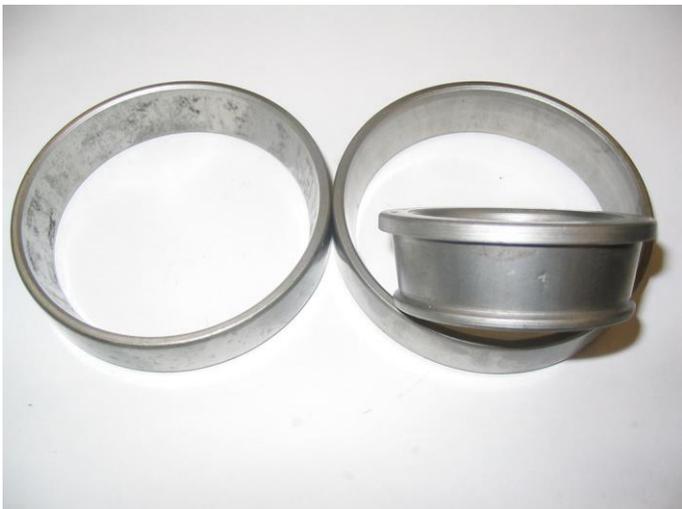
Fig 31. These cups and inner cone track have suffered unnecessarily.

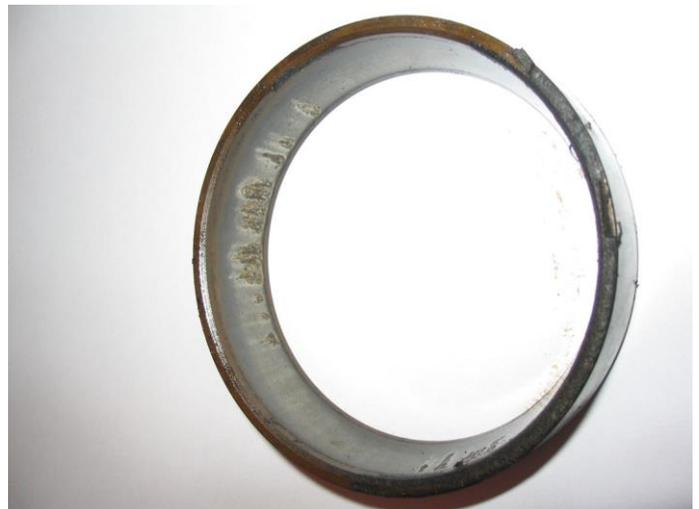
Fig 32. More bearing wear, felt as a vibration by the driver and sometimes the specialist and very frequently blamed on tyre flat spots. To the surprise of strangers to these R-R axles they cannot understand why the vibration seems to improve when the axle gets hotter, and therefore it must be the tyres. Wrong again, wait for the bang!

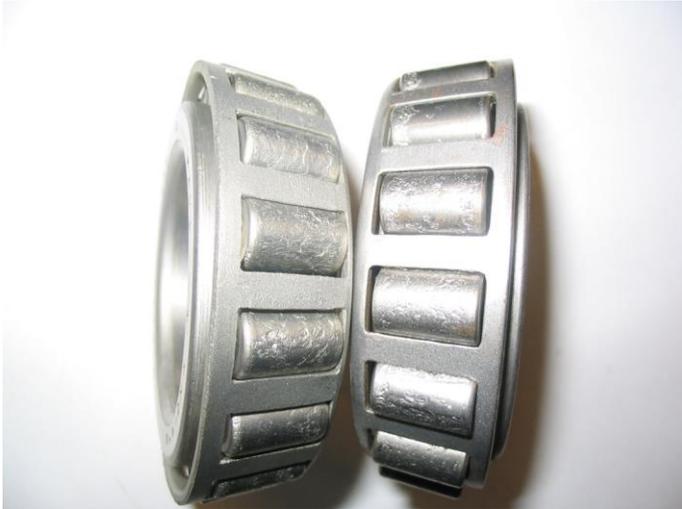
Fig 33. These bearings have been cleaned up for your enjoyment! A very common sight of the axle side bearings, and always the rear wheel bearings are equally worn. If the wheel bearings are not changed, how long before this is repeated again?

The presence of sludge hastens the matter along, as does the nut holding the steering wheel that for some reason calls himself a driver instead of my more appropriate term of Motor Mover! This driver continues to motor along believing that either R-R axles are indestructible or that he is going to detect any axle noise before it self-destructs, neither being true. Most probably the axle has leaked from the pinion seal for some time whilst our owner R-R expert is making his mind up about curing the leak, or guessing how long it takes for 1.5 pint to drain away. The answer is extremely quickly if you are driving downhill. Failure to arrest the trouble when the first minor floor vibrations take place or the belief that in the early part of the journey it is only the flat spots on the tyres that is causing the trouble leads quickly to the situation showed in Fig 31 through Fig 33, when wear takes place at an alarming rate.

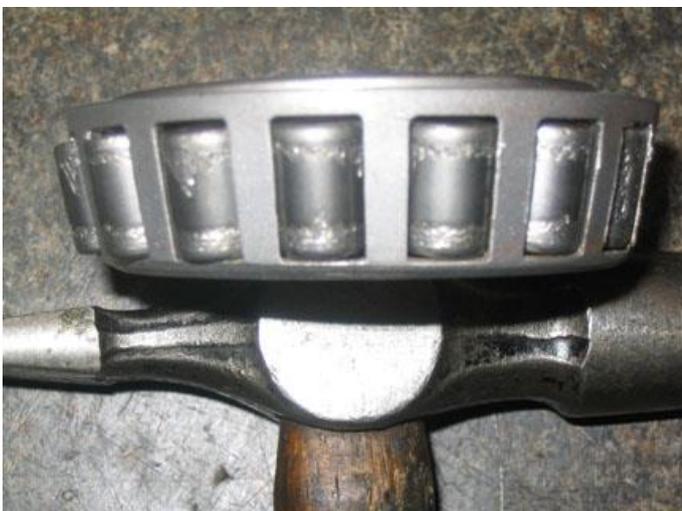
Fig 34. This bearing was pushed over the edge. The driver was either deaf or had no feeling, possibly both. It did the damage shown in the next picture.

Some driver's pass through this stage that is they actually make it without shearing the gear teeth, if the teeth do not shear the situation develops..... Fig 34 shows a typical right hand axle side bearing, worn out because the rear wheel bearings are unserviceable; typically it has commenced to bore itself through the right hand bearing spacer. The highlighted section in Fig 35 shows the bearing to spacer contact point. The bearing shown in Fig 34, after being cleaned up, actually did this damage. If you were to remove some of these bearing, you would usually have no trouble, all the rollers normally drop out of their cage, absolutely impossible on a good bearing of course.

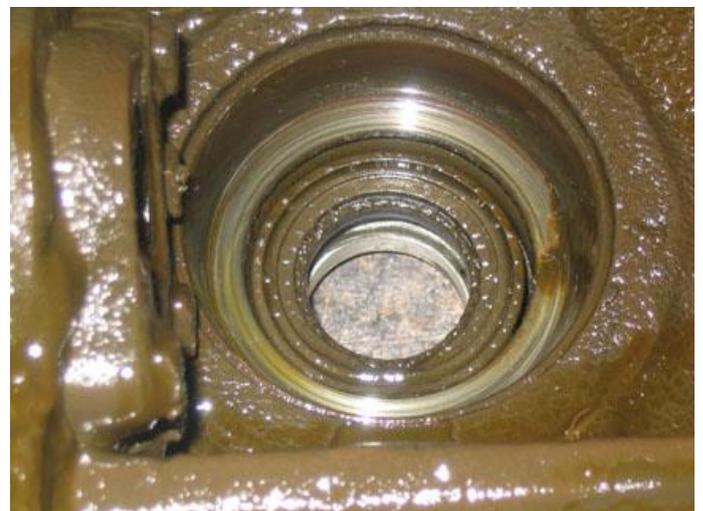
Fig 35. The shiny bit is the thrust washer, which takes half a ton of side spring pressure. Our worn side bearing has not quite bored through the washer to unleash the 1000 lbs of spring pressure. Nonetheless this Bentley MKVI's can stop damn quickly when the axle bangs.

Do not worry about the bearing actually boring through the spacer, you will have more immediate problems, I can assure you no bearing has yet made it through that spacer! I have seen axles completely disintegrate the inner case come through the outer, the crown wheel studs act like a circular saw on the nearside side case and gear sets strip. Possibly the car might be resting on its roof, the axle detached, and it goes without saying that the main axle case will be scrap as that bearing outer track runs directly in the axle casing. But never has that bearing made it through that spacer!

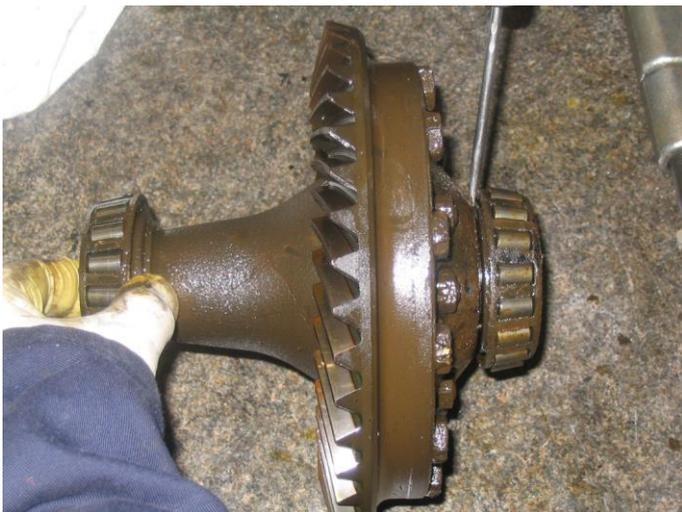
Fig 36. Yet another loose side bearing and the inside gear set will be just as bad.

Don't be fooled here, before you hand any R-R axle over to a repairer make sure that repairer has undersized and oversized bearings actually on hand to repair your axle. Certain of these axles nearly always need undersized bearings fitting and do not be put off by any repairer advising otherwise, if you wish to retain a reliable axle, walk away. Many an owner has been hoodwinked by being told oversize and underside bearings can be obtained fairly quickly, only to find out later standard bearings have been fitted when another size should have been selected. Fig 36 is typical of this situation.

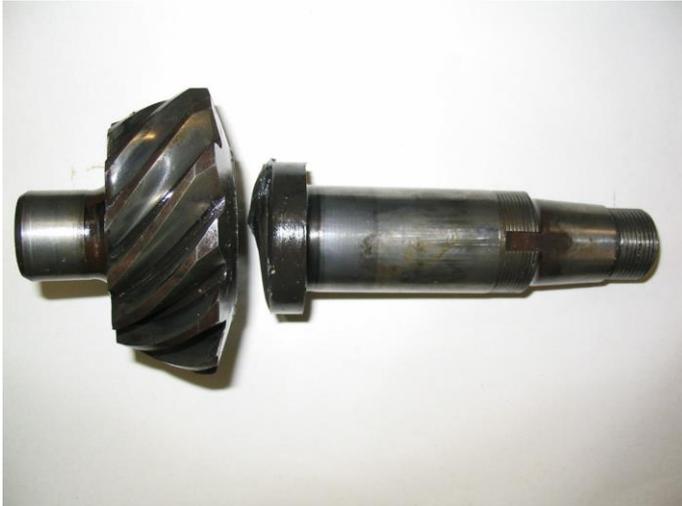
Fig 39. Sheared pinion from a Bentley SI Continental, the worst of the R-R post war axle designs. The evidence is here to prove the owner's story that the pinion failed as the car was driven out of its garage!

Fig 39, shows a SI Continental axle pinion with a headache! This one broke when driving out of the garage, no kidding and easily proved, but it still managed to jack the pinion head against the bearings and then through the main case web, see fig 40. Notice the small jagged white line commencing at the base of the nose bearing; this is where the alloy case surrendered under the pressure.

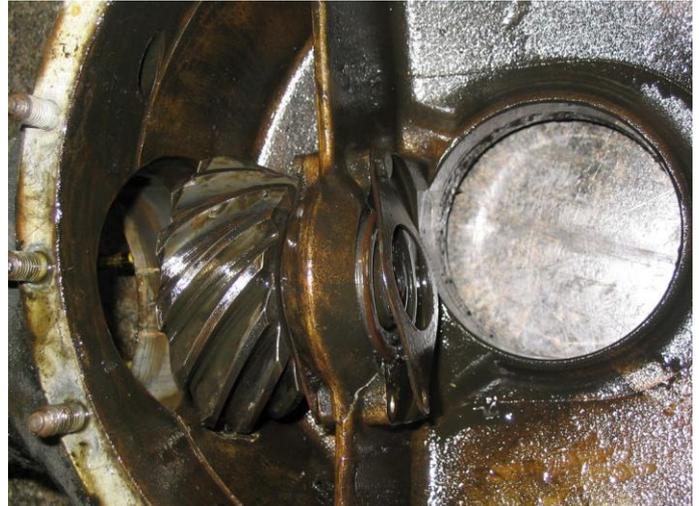
Fig 40. Look carefully, the pinion shaft has been removed along with the bearings but it is possible to see how the pinion head was jacked rearwards partly through the nose bearing casing web. New gear set and nineteen-bolt case needed at least!!

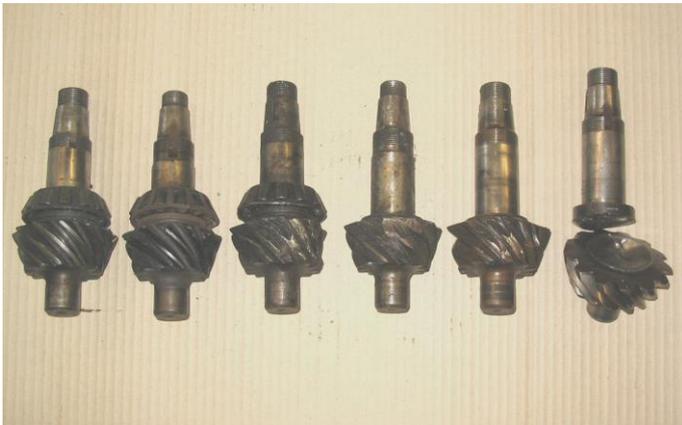
Fig 41. Just a few axle pinions from the scrap heap, these represent most post war axles. Nearly all have been driven many miles whilst making a noise. If an R-R axle can be heard it is in far more serious trouble than your average Ford with a similar noise, and your local friendly mechanic is not going to fix it.

If our intrepid motor mover should still pursue his weekend driving pleasure, ignoring the vibrations of the axle bearings that he has diagnosed must be flats spots on the tyres, he will eventually own an axle pinion just like one of those in Fig 41. All bear the evidence of trying to climb over the mating teeth of the crown wheel, of course they cannot, and usually loose two teeth in the fight. A number of other faults show up on these pinions, second from the left a later Silver Dawn pinion, notice the taper bearing rollers are worn so much they are dropping out of their cage, compare the bearing with the others on each side. Go back to fig 7

and see what eventually happens! All the nose bearing spigots are also worn heavily. These pinions represent R-R Silver Dawn, Bentley MKVI, R-R Silver Cloud I, Bentley SI and Bentley SI Continental.

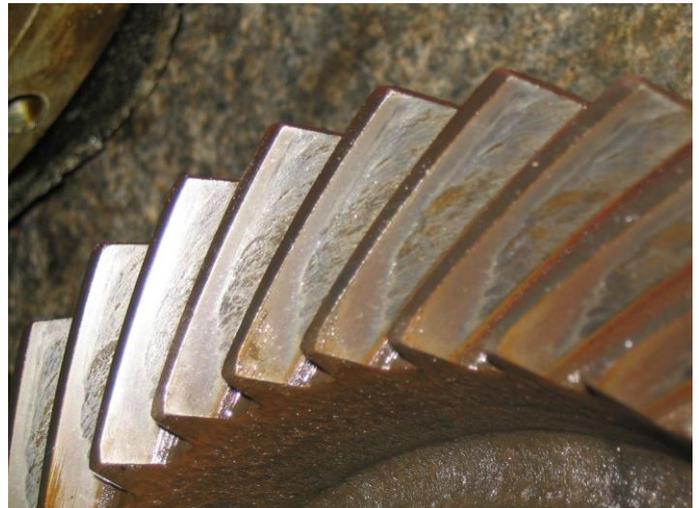
Fig 42. Showing Crown wheel wear on an R Type axle, caused by severe axle bearing wear. The resulting noise unfortunately does not give owners enough cause for concern. Very common on wedding cars when the owner thinks it is going to keep going. Wedding car, local run car, or not, the eventual bang is just the same!

Just before the gear set breaks, the out of alignment caused by worn side bearings will have attacked the crown wheel teeth, shown in fig 42. This Bentley R type crown wheel shows scuffing on each tooth where the pinion teeth have tried to climb up each tooth face. Most post war axles prior to the Silver Cloud II and Bentley S2 will not normally exhibit this wear, as usually the gear teeth will break off before heavy crown wheel wear takes place. The Silver Cloud II and Bentley S2, and later axles will however show this wear. In short, for reasons of design, the earlier axles will vibrate and break teeth and the later ones vibrate and are noisy over an extended period. The end result is the same, expensively busted, but with some variation in damage.

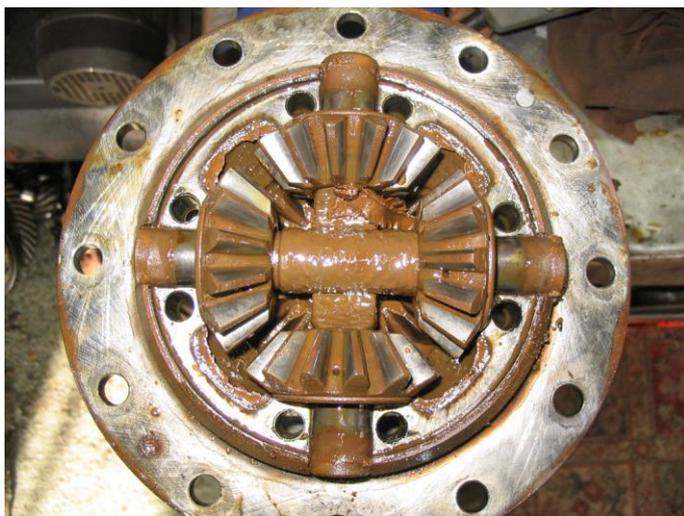
Fig 43. The normal sight when the centre differential case is opened up. This case is one of two dished shaped cases that are bolted together. Sludge cannot be flushed out of this inner case once it enters!

The average wear of differential pinion and bevel thrust washers is around 0.015 inch and this allows the differential taper gear wheels to move outwards. In taking up a position further out than normal they have in fact moved further out of mesh. In new condition the backlash in these gears was set at absolute zero, but when worn the backlash is tremendous. A major error by owner rebuilders is attempting to rebuild the axle with extremely worn trunnion shafts, which then support the differential pinions at an angle. Fig 43 and Fig 44 illustrate the potential pinion thrust washer wear. The thrust washers are position between each pinion gear and the inner casing, Fig 43 shows how the oil feed holes, in each gear, leading to the trunnion shafts and the thrust washers become blocked. There are six oil holes in each of these gears, from one position it should be possible to see at least four oil holes as shown in Fig 44. These images are not at all uncommon; they show the state of a set of typical differential gears as found on nearly all of these axles. Moral.... change your oil regularly. Fig 45 shows an R type assembly with one of the bronze thrust washers clearly in view whilst Fig 43 and 44 show an early Silver Cloud I with hardened steel thrusts.

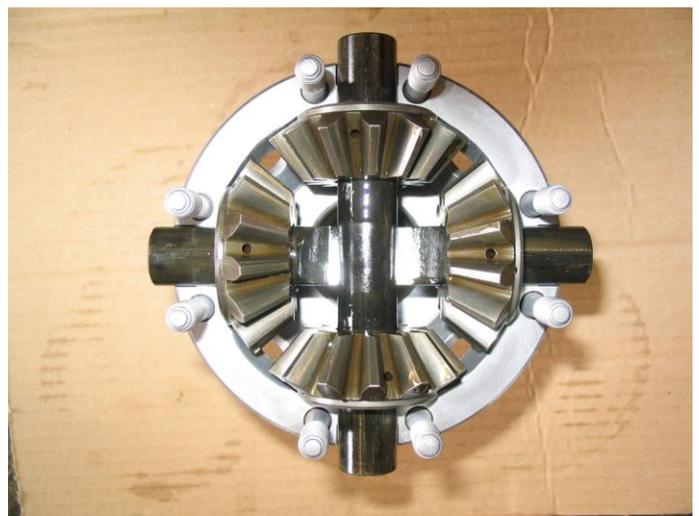
Fig 44. Change the oil at least annually, no matter what the mileage, and the centre differential will look about like this one after many thousands of miles.

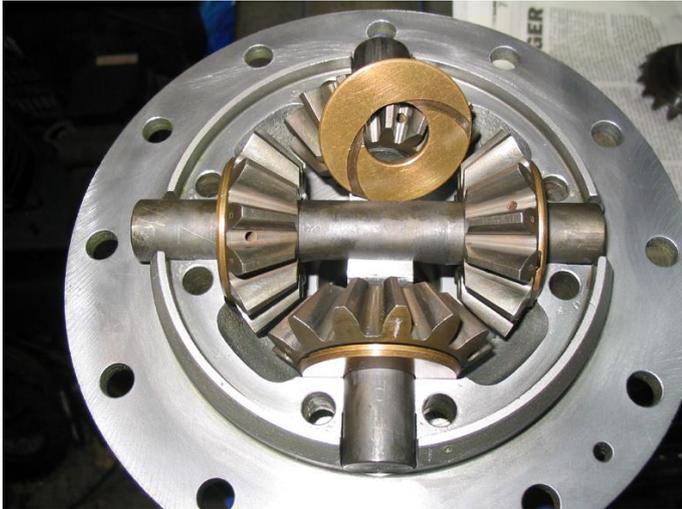
Fig 45. The inside of an R type inner differential case, showing the bronze thrust washers.
