FRONT BRAKES BUILT INCORRECTLY

R-R Silver Dawn, Silver Wraith BENTLEY MKVI, R type

N. W. Geeson

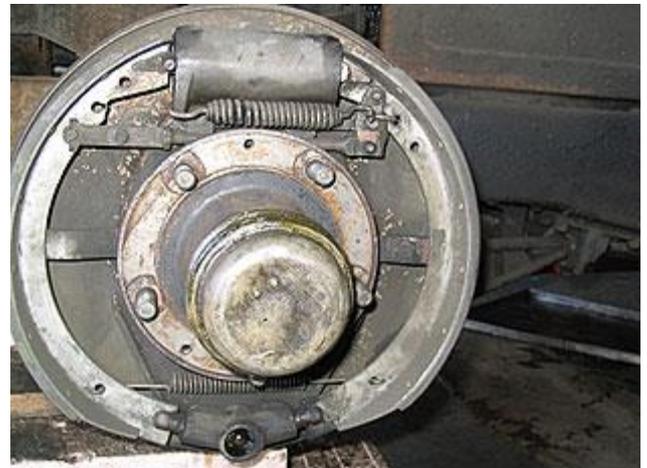
The STOP PIN fits through the FRONT brake shoe operating fork and abuts across the edges of the hydraulic cylinder, and this is the case whether the brake is left or right hand. This stop pin is much longer than the clevis pin fitted in the fork of the trailing shoe at the other end of the cylinder. The brake leading shoe cut out then locates on the half circular section of the stop pin.

A clevis pins fits through the rear fork and the trailing brake shoe cut out locates on the half circular section of the clevis pin.

A few minutes study will show what problems and dangers can arise when these positions are switched, and many have been.

Owners of cars with this type of front brake should check that the brakes have been built up correctly. Many of these brakes have been assembled incorrectly especially by foreign specialists.

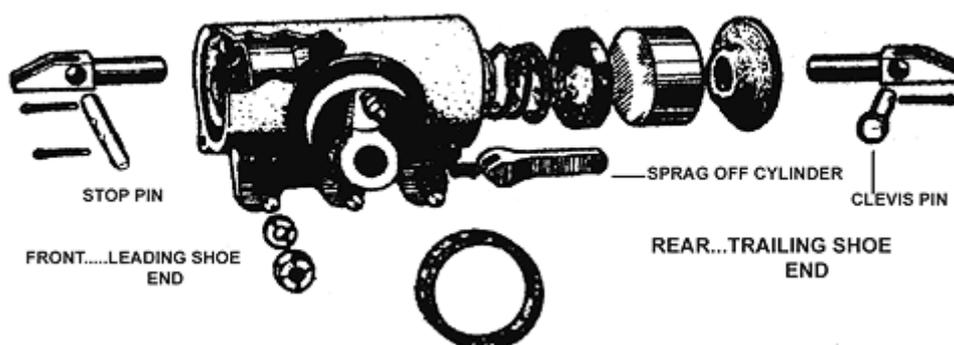
FRONT BRAKE HYDRAULIC CYLINDER ASSY....EARLY POST WAR CARS POST JUNE 1950

I have also seen many occasions when the "W" shaped anchor for the cylinder end shoe return spring has not been located in the hole of the steel strip behind the cylinder. This anchor should pass through the brake shoe, one end accepts the return spring the other locates into the hole in the steel strip which is trapped between the cylinder and back plate.

Note the correct relationship of the parts shown in the accompanying images, which do not appear in either the Workshop or Parts Manuals or Service Handbook. It is important to beware of the few images of these components in the manuals many of which are incorrectly shown or mirror imaged.
