# ROLLS-ROYCE BUILT “HYDRAMATIC” AUTOMATIC TRANSMISSION

David Chaundy

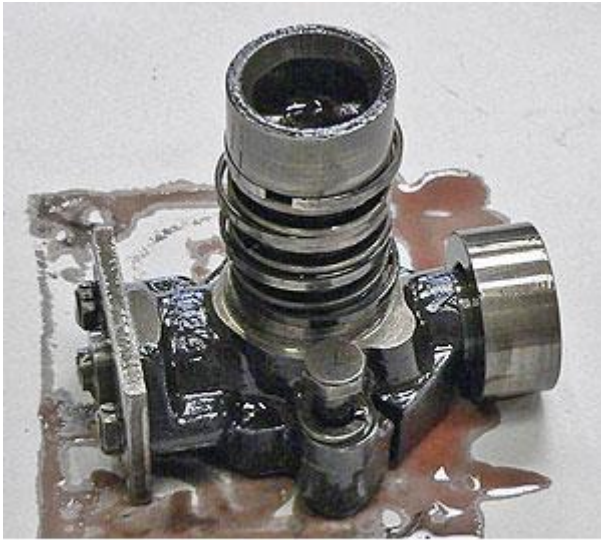
The governor assembly. Here can be seen the sealing rings. They look like piston rings sitting in their grooves at the top of the component.

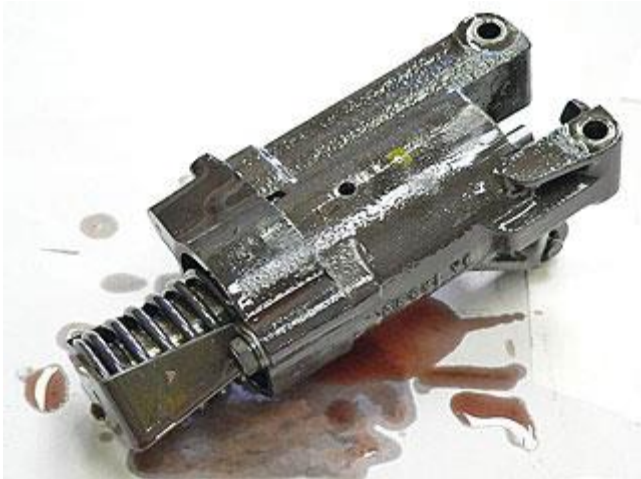
The rear brake band servo. ( A special tool is needed to dismantle and re-assemble this component)

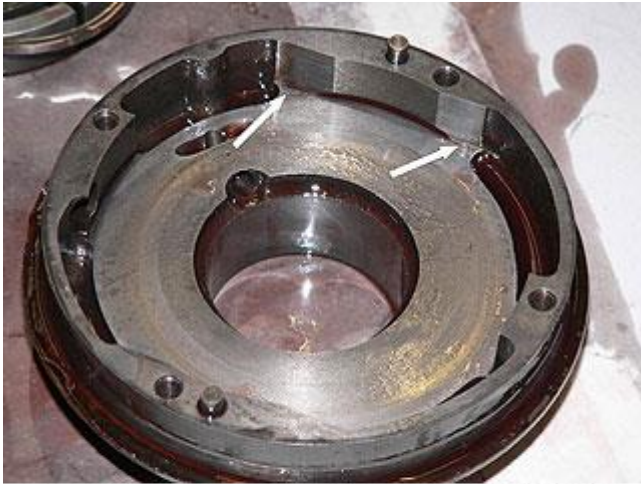
The main pump body. Problems can arise in the areas arrowed. It is impossible to machine into the corners of the casting. If the excess metal is not relieved from these areas with a rotary file or similar, the rotor can pick up causing the pump to seize.

It may often be seen by examining the inner face of the pump body that small areas in the corners of the casting have escaped machining. These areas need to be dressed with a small rotary file to ensure the oil control ring does not foul on the rough edges. (Please see arrows in the appropriate picture)

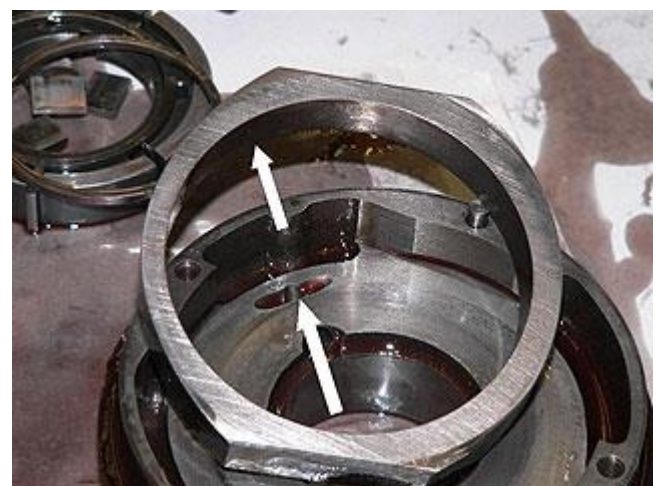
The pump body and oil control ring. The torus oil feed may be seen arrowed in the pump body. The spring loaded oil control ring covers this oil feed port when the torus is full of fluid. If the pump has been re-machined there may be the possibility that the oil control ring is no longer able to fully cover the port in it's closed position. If this happens, full main line pressure is delivered to the torus. This causes the torus to burst its seals and causes severe leaks. Make absolutely certain your pump is perfect before installation.

It is a very good idea to thoroughly check the main pump before assembly. Please see the picture showing the pump body and oil control ring. The end clearance between the rotor, the oil control ring and all of the pump vanes should be checked very carefully. They must run with a clearance of around 1 thousandth of an inch to be correct. If a straight edge is placed across the pump with its cover off the clearance may be measured. If less than 1 thou clearance is present the parts need to be surface ground to the correct dimensions.

The torus feed port is machined into the inner face of the main pump. Careful examination will reveal the port is undercut. This is done to ease the flow of fluid. This is not a problem until on a new correctly assembled pump. Problems arise if the pump is re-machined to remove scoring. The removal of metal sometimes prevents the oil control ring from fully closing off the port when the torus is full. If this happens the torus is exposed to full main line fluid pressure. If this happens the torus becomes pressurised, this will force fluid past the gasket

and will burst the main torus neck seal. It is therefore very important careful attention is paid when building the main pump.

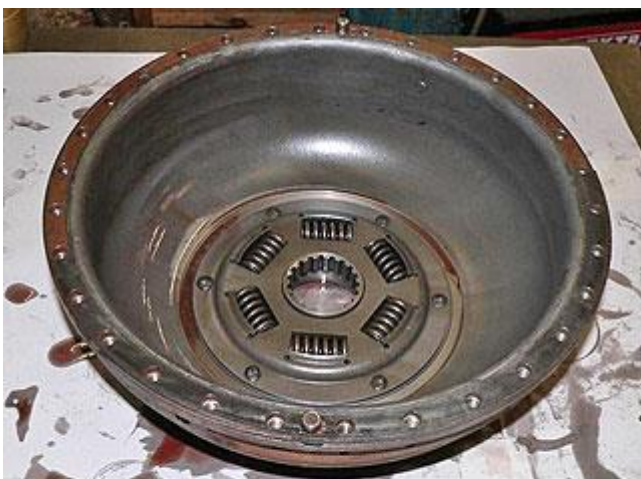
When the time came to mate the transmission with the engine I was very careful to measure the 2 mating dowels in the torus cover. These dowels are of slightly different sizes, the larger is about 0.030" bigger than its companion to ensure that the flywheel and torus cover mate in only one position. The flywheel and torus cover are finely dynamically balanced as a single unit in the factory. Any deviation from this original position will considerably upset the fine balance of the unit in service. Normally the transmission number is stamped on the flywheel, starter ring gear, and torus cover adjacent to each other when in the correct position, but this is not always the case, especially if the car has had a replacement starter ring gear fitted.

Several uninformed people have made the mistake of forcing the torus cover on to the flywheel in the wrong position. I have heard several stories of people trying to hammer the larger dowel into the hole for the smaller dowel, or force the two components together with the fixing bolts. Forcing the components together simply pushes the larger dowel out of the torus cover. The smaller dowel is then sitting in a hole that is too large to accurately locate the components. In such a situation the torus cover is left seriously out of square, and in some cases, the engine flywheel or the torus cover buckled permanently. If the torus is left in this condition catastrophic damage always results. Running a transmission in this condition will at least destroy the rear planet gears and torus seal Mounting the torus 180 degrees out may seem an unlikely mistake to make, but I have heard of several people doing just what I have described, including a Rolls-Royce main dealer in Germany! In all of these cases a badly damaged transmission was the result. In short, NEVER FORCE THINGS TOGETHER. If any vibration from the transmission is experienced following a re-build stop the engine immediately. DO NOT, continue to run it or drive it. Make absolutely certain the transmission is correctly assembled. If still in doubt seek expert advice, before the destruction of the transmission forces the issue.

The torus cover. Note the antishock damper springs in the centre, and the opposing locating pins in the outer mating face. The smaller pin is usually located near the torus drain plug

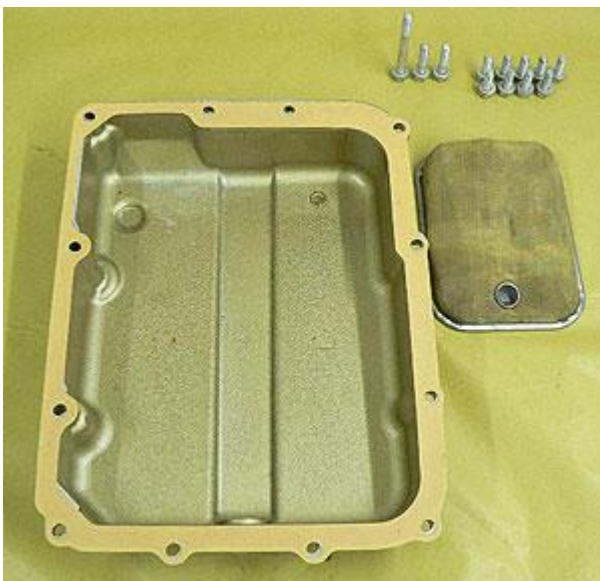
The sump and clean fluid filter from my transmission. Cleanliness is vital if reliability is to be preserved.
