# ELECTRIC CLOCK: BENTLEY R TYPE / R-R SILVER DAWN

N. W. Geeson

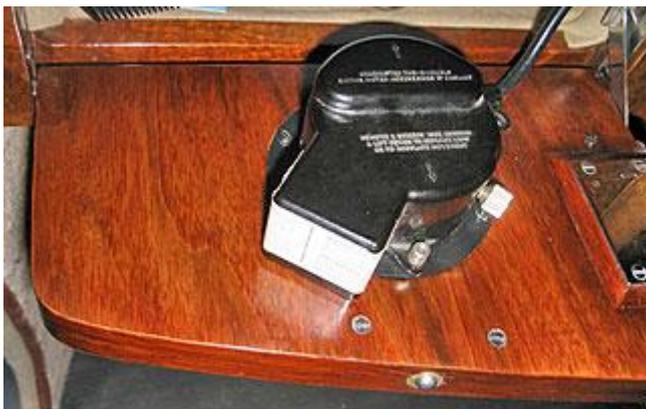
View as seen when the glove box door is opened

When the glove box door is lowered the owner will be faced with the view as shown in Fig 1. Note that the rear of the clock is enclosed by a cover held in position by two knurled nuts, as shown in this view.

Note in particular the large knurled knob at the 4 o'clock position in this picture. This knob is used to set the correct time initially, but another important function it serves is to start the clock by depressing the end of the knob. The knob may need depressing more than once to set the clock in motion, it must also be understood that if the clock is not started after the battery has been disconnected the clock unit is in a state of stall.

Obviously the clock will stop when the battery is disconnected and this will include when any battery master switch is moved to the 'off' position. The owner may not always remember to operate the re-start button and also specialist repairers do not always realise that the clock must be re-started immediately after the battery is re-connected, when the garage may have previously isolated the battery.

To safeguard this situation it is wise to isolate the clock by disconnecting the earth or feed wire, at the clock, before major repairs are undertaken. However if this route is taken by all means advise the garage accordingly that the clock has been disconnected. It is appallingly obvious that many of these clocks are in a stalled condition whilst the car is awaiting collection from the garage by the owner, a condition that the clock detests.

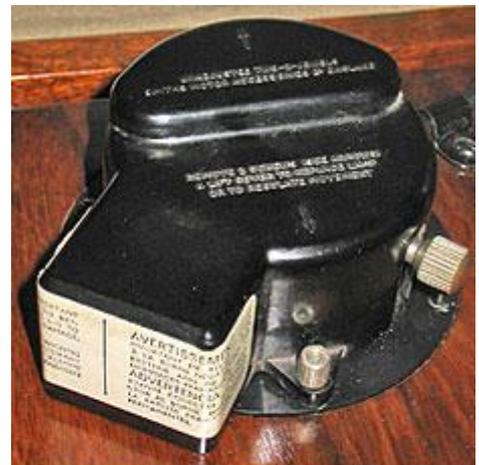
The rear end of the clock shown in close up

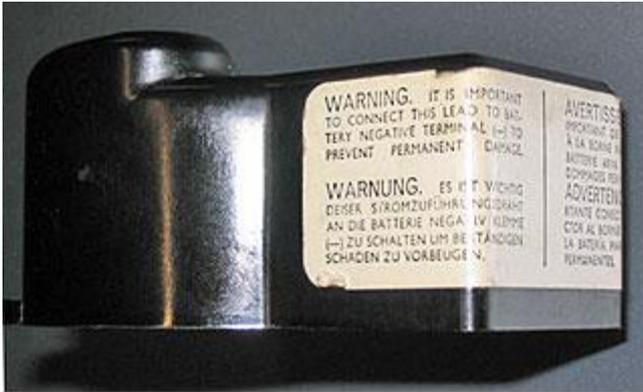
Clearly the label tells any reader what is likely to happen if the polarity is reversed or the wiring connected incorrectly. A clear "must do" wiring exercise is necessary to those contemplating changing the cars over to negative earth. If you must change to negative earth, please do not contact me with subsequent troubles!

**Do be warned, the label tells all**

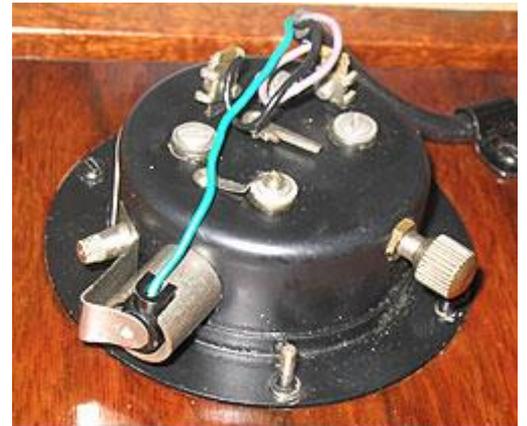
The view shown in figure 4 is that with which you will be faced when the rear clock protection cover is removed. Note the correct positioning of the wiring. Colours: Purple, Black and Green. The long lever in the centre is for fast or slow regulation of the clock.

**Get the wiring right**

It is wise to be warned that these regulators should not be adjusted unless the clock has been timed for at least 5 days whilst connected to a fully charged battery. If the clock runs and keeps time in that situation and yet loses time whilst fitted to the car firstly check the battery voltage and always have the dynamo regulator checked and adjusted before trying to adjust the clock regulator. In addition, be warned that on a car that is infrequently run the clock will always lose time.
