FRONT AND REAR ENGINE AND GEARBOX MOUNTINGS RENEWING

R-R Silver Dawn, Silver Wraith, Bentley Mark VI, R type

N. W. Geeson

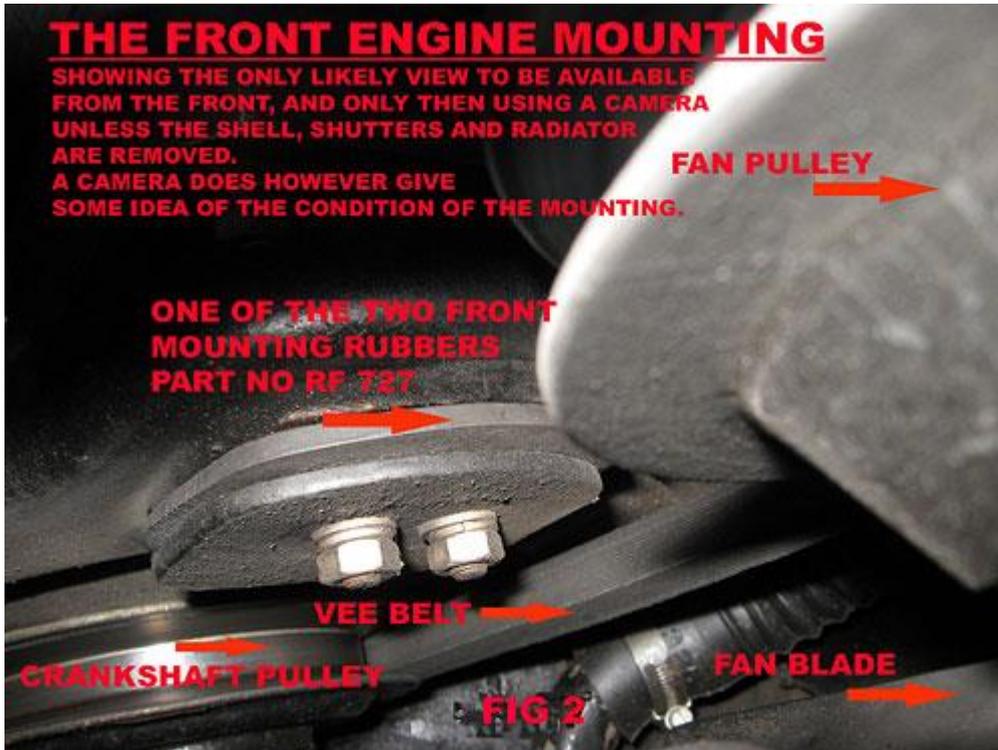
Fig 2 Showing a typical in situ view taken blindly by a camera

A camera pointed in the right direction may provide some light relief and it could produce the result shown in Fig 2. This clearly shows the mounting rubber in good shape. Provided this mounting has been replaced at engine rebuild time or whenever the radiator has been removed, all should be well. It suffers much less than rear mountings, which get contaminated with oil.

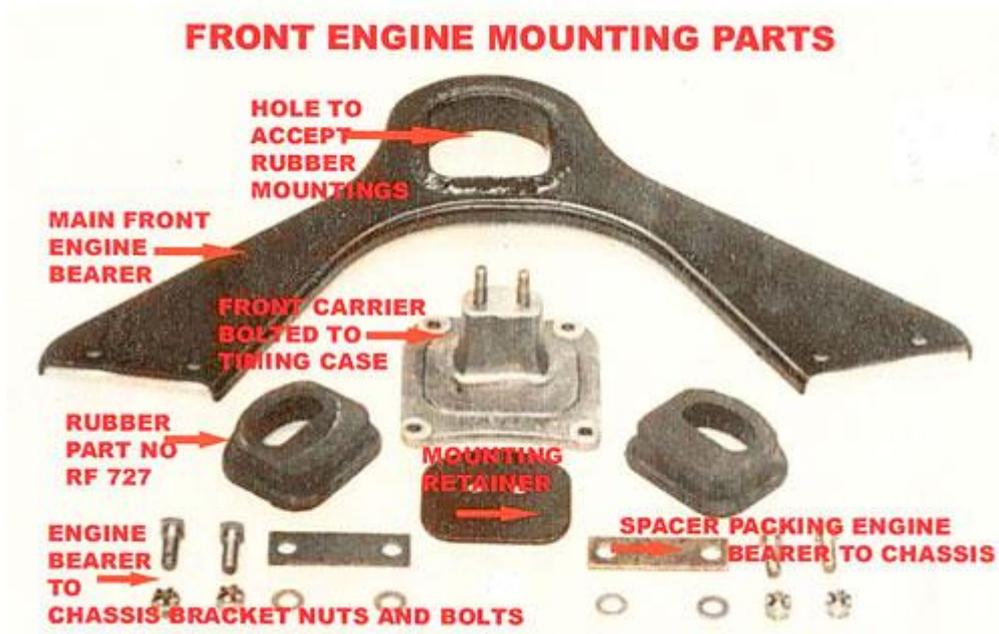
Fig 5. The various component parts that make up the front mounting

The production parts that originally made up the front mounting are shown at Fig 5. Once the radiator assembly has been removed, the fan and belt, and preferably the dynamo can be removed to improve access. At that point the front of the engine will look similar to Fig 6. Note in this view the arch bearer to chassis bracket four retaining bolts have previously been fitted back to front; their nuts should face to the front of the car.

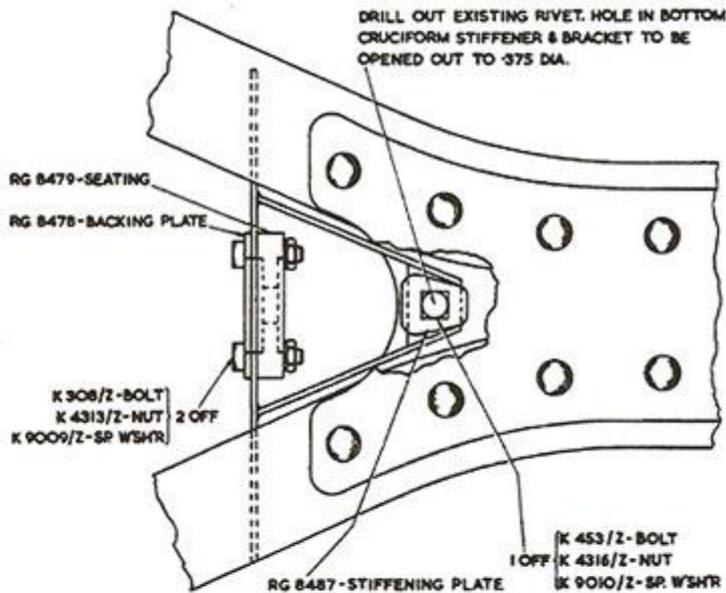
FIG. 1

On the earlier rivetted frame the tie-rod bracket is to be strengthened by the addition of a stiffener and a backing plate. The aluminium seating for the tie-rod rubbers is to be replaced by a steel seating.

VIEW LOOKING ON TOP OF FRAME SHOWING NEW RUBBER SEATING & BRACKET STIFFENERS FITTED

- (iii) Drill out the existing rivet securing the bracket to the lower cruciform stiffening plate (Fig.1). Enlarge the hole to .375" (9.52 mm) dia. Fit the bolt and stiffening plate. The stiffening plate fits between the bolt head and upper face of the bracket.
- (iv) Fit the new rubber seating and backing plate (Fig.1).
- (v) Discard the old rubber seating and refit the tie-rod.
- (vi) To adjust the length of the rod, screw up the adjusting nuts (X Fig.2) finger tight and then tighten them an equal amount until the distance piece Y is clamped. Tighten the locknuts. The adjustment should impose no fore and aft deflection on the gearbox rear rubber mounting block.

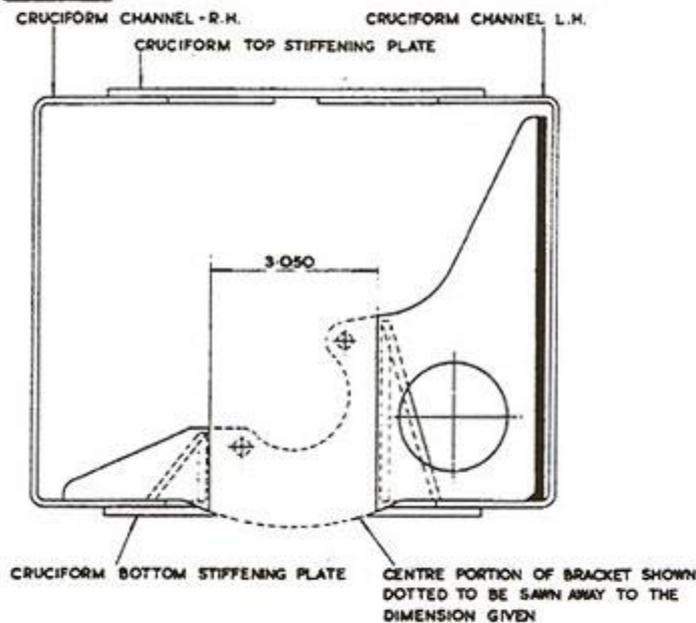
FIG. 3

On the later welded frame the tie-rod bracket is to be cut away and replaced with the Mark VI type bracket.

VIEW LOOKING FROM FRONT OF CAR SHOWING
MODIFICATION TO EXISTING TIE ROD BRACKET

- (i) Place the car on a ramp or over a pit.
- (ii) Remove the gearbox tie-rod by removing the two nuts and spring washers retaining the rubber seatings to the gearbox at the front end and to the mounting bracket at the rear end.
- (iii) Cut out the centre portion of the transverse mounting bracket with a hacksaw as shown in Fig.3. Clean up and paint the cut edges.

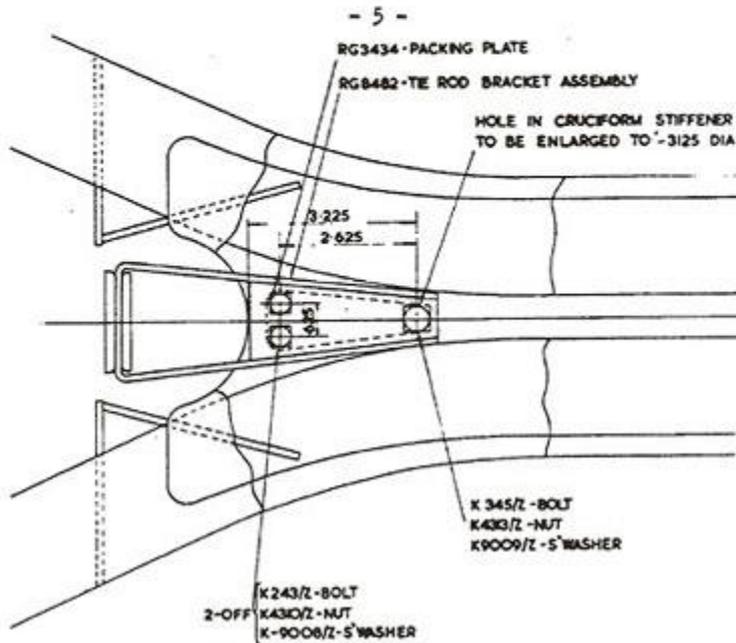
FIG. 4

VIEW LOOKING ON TOP OF FRAME SHOWING NEW
TIE ROD BRACKET FITTED IN POSITION

- (iv) Increase the diameter of the rear centre hole in the cruciform bottom stiffener plate from $\frac{1}{4}$ " (6.35 mm) to $\frac{5}{16}$ " (7.93 mm) (Fig.4). On some frames the three holes in the stiffening plate may not already exist and should be drilled in accordance with the dimensions given in Fig.2.
- (v) Fit the new bracket and packing piece to the top of the stiffening plate securing with the three bolts, spring washers and nuts.
- (vi) Remove the old rubber seating from the rear end of the tie-rod and refit the rod to the gearbox and bracket.
- (vii) Set the length of the rod as in para 2 sub.para (vi) above.

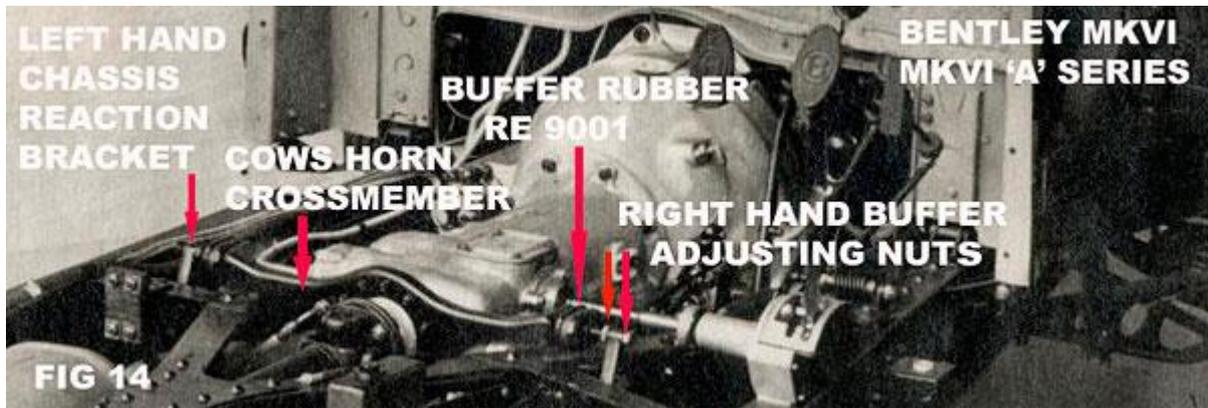
Fig 14. The high position of the buffers above chassis level can be seen here

Check that the buffer rubbers are still squarely in their holders, see Fig 14 and Fig 17, carry out the adjustment, feeling around each holder frequently during adjustment to ensure that the rubbers seat into position. The manual specifies very little pre-loading exertion force on the rubbers but it will be found that at least with new rubbers some 3 to 4 full turns of the adjuster will be required after initial finger tightening contact. For the record the official method suggests, full slackening both nuts, tightening up the inner one finger tight, then holding the cup holders square, tighten two more complete turns. Then tighten up the outer nuts. In service it will be found that the outer nut comes roughly level with the end of the adjuster.

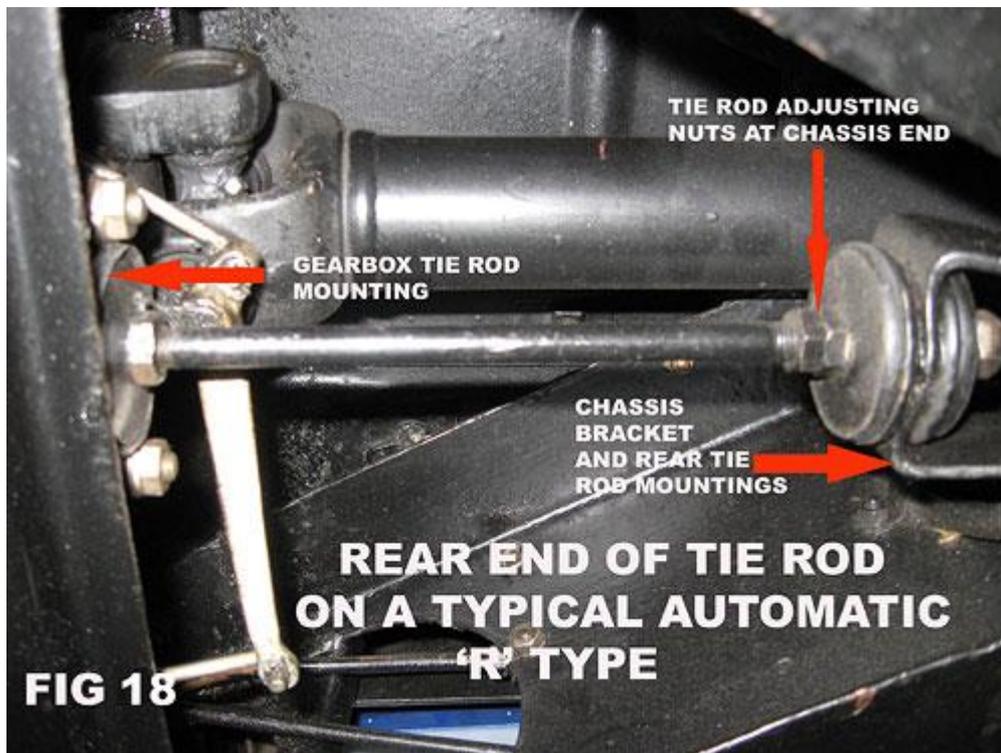
Fig 18. The rear end of the tie rod, showing the adjustment nuts at the chassis end

Examine the tie rod for being straight, if is visibly bent, do not straighten but renew the rod. If a genuine example is not available make one from EN24 or EN 19 round bar and thread to suit. When these tie rods are bent it is usually not from just an isolated instance but is the result of continual bending and torque reversals. This weakens the rod in particular immediately to the rear of the single nut at the forward end. Once bent there is no method of knowing how many reversals have taken place or when the rod may break. When the rod breaks there is no restraint of the engine or gearbox assembly either for or aft and upon the next hard brake application the gearbox is likely to move forward under the force of the braking load to the servo. Tie rods do break and under hard braking conditions severe damage should be expected to the engine and transmission couplings, in addition to the radiator.
