# REAR AXLE PINION OIL SEAL RENEWAL AND MODIFICATION

Applicable to all early post war cars up to and including Silver Cloud III / Bentley S3, but excluding all Phantom axles

N. W. Geeson

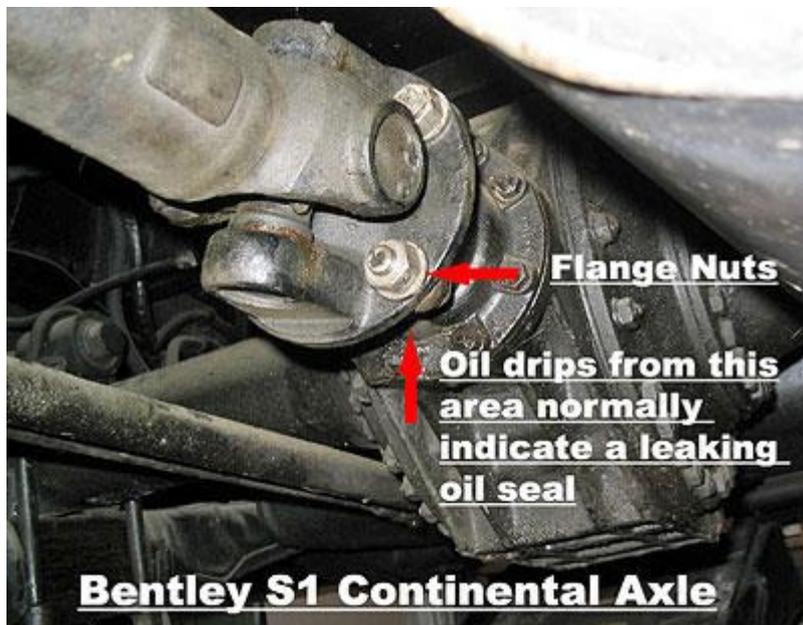
Fig 1. Showing the typical axle oil leak position

In the worst oil leaking situation the oil will be seen to readily drip from the oil seal housing just behind the axle drive flange, as shown in Fig 1.

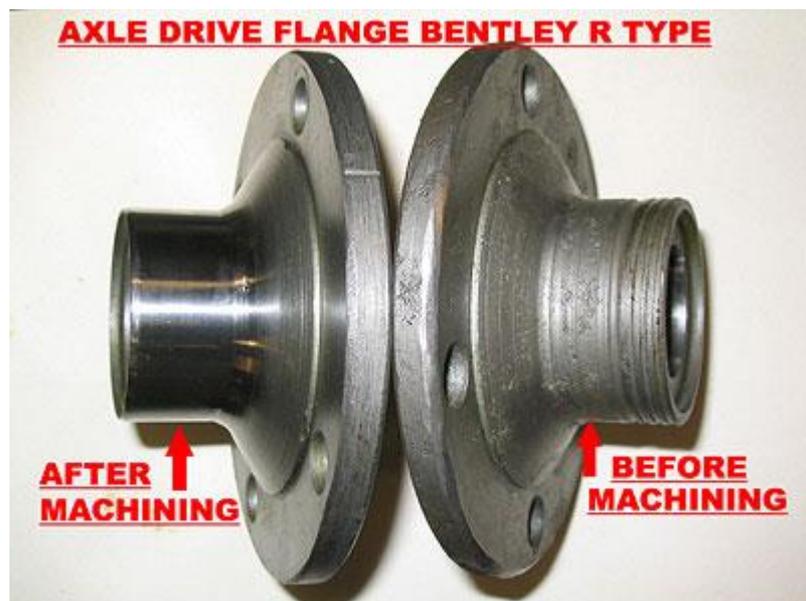
Fig 2. Comparison of old and remachined seal running surfaces on an axle flange

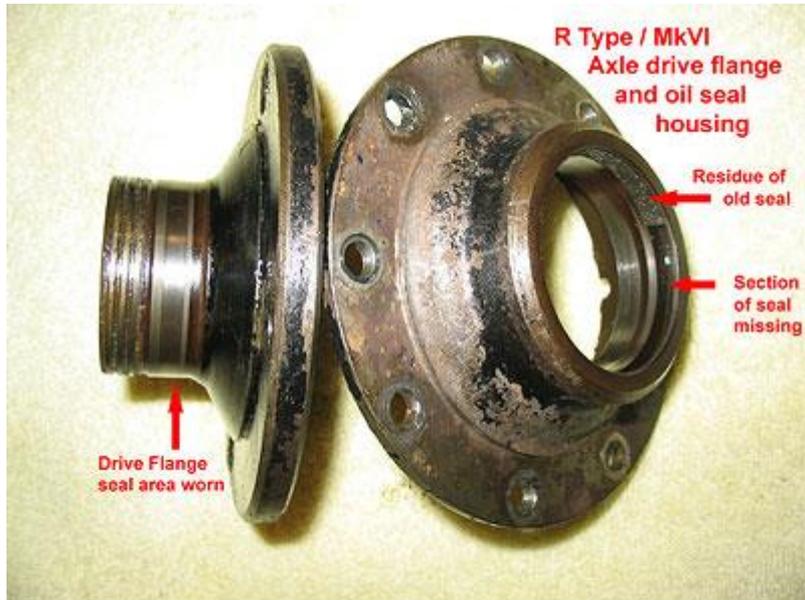
Fig 3. Typical felt seal deterioration

The original oil seals were felt and not the type of seal that is familiar to the majority of current owners. Reasons were simple in the extreme, until the early 60's modern rubber type oil seals perished very quickly and were not reliable, so felt did the job. The present day drawback is that the drive flanges have worn badly where the seal contacts the flange seal track and a straightforward felt seal replacement results in a torn up seal. Some oversize felt seals are available but they in turn suffer the felt seals original fate of trapping dirt and letting in water. In turn this wears the flange seal face quite quickly.

In any instance of the oil seal being replaced by a modern seal or oversize felt the drive flange will need machining, and depending upon the seal to be fitted, so will the seal housing. In practice there is little point in trying to replace an original type felt seal, even when new they would not pass an oil tightness test of inverting the axle on its flange end when the axle is full of oil. Fig 2 illustrates a comparison between a newly machined drive flange and one just taken out of service; the latter is in typical condition. Fig 3 shows the normal condition of the felt oil seal housing as removed from the axle, notice that most of the felt seal has been degraded or torn away.

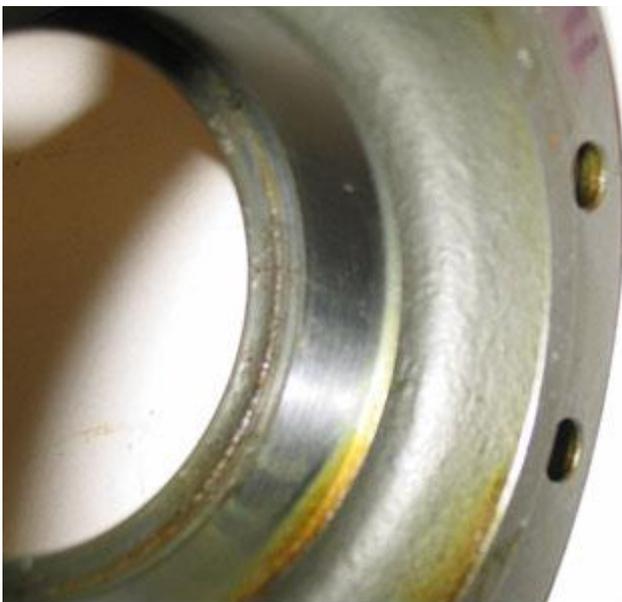
Fig 4. Oil seal housing machined from the inside face to accept a modern seal

Fig 4 shows an image of an oil seal housing having been machined from the inside, and before the oil seal is fitted. Once the seal is fitted the outer appearance will be as shown in Fig 5. Note how the original front oil seal abutment has been left when the machining was done from the inside, so that the new modern seal fits snugly against this abutment. Fig 6 shows the final appearance of the drive flange after painting, the oil scrolls have been removed and if ever the sealing surface wears again it can be fitted with a seal recovery tube to make it as good as new. Fig 7 charts the sizes of the machined housing, flange and oil seals for axles from the Bentley Mark VI to Bentley S3 and their respective R-R models.

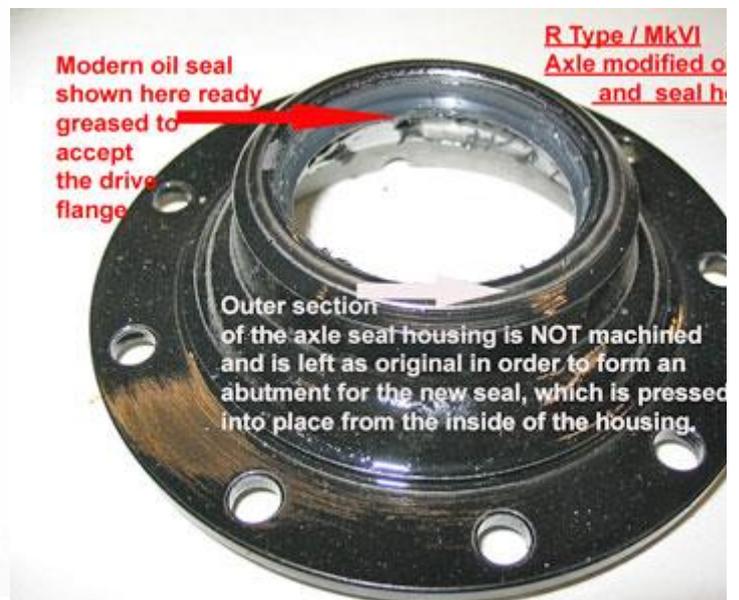
Fig 5. The housing after a modern oil seal has been fitted

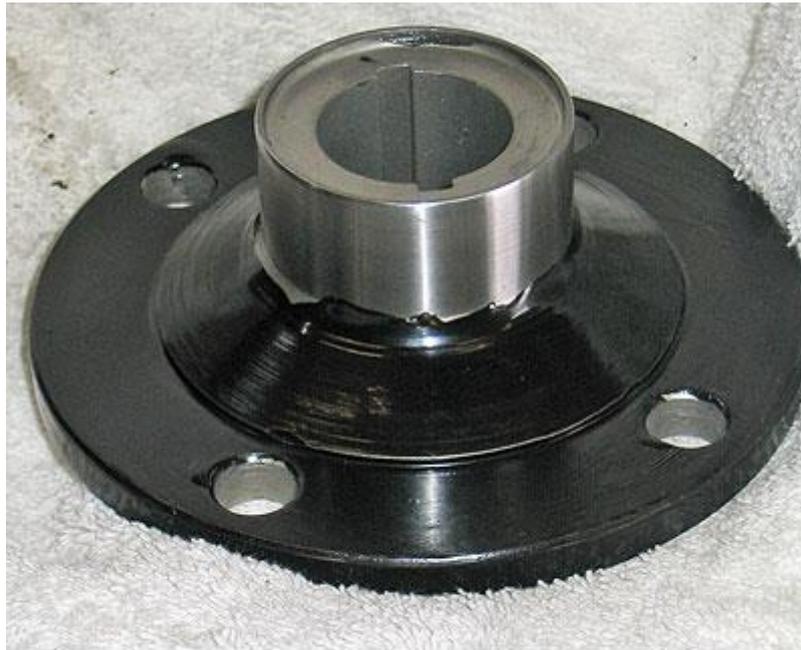
Fig 6. Drive flange machined to accept a new seal, and repainted

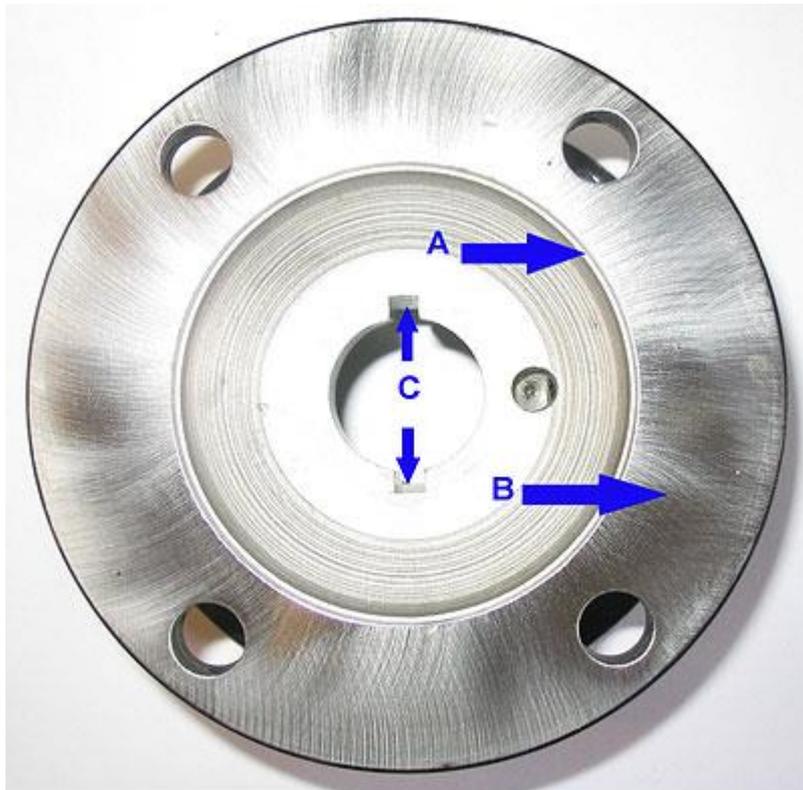
Once the bolts are removed detach the shaft and immediately examine the shaft coupling flange and in particular the locating ring that locates in the groove marked 'A' in Fig 12. Ensure that the machined locating ring is not distorted and will engage the axle drive flange correctly. Before proceeding further check the drive shaft mating face with a straight edge or even the machined face of the block puller. The object being that the drive shaft will eventually mate up squarely to the axle drive flange. Now tie the shaft safely to one side.

Fig 12 Drive flange locating groove, key ways and coupling face

The next job is to machine the seal housing and fit a new seal. Check the woodruff keys and key way grooves for wear as shown at 'C' Fig 12. Worn grooves and keys can and do eventually scrap a pinion, or at the very least cause the pinion to be removed and re-machined. The moral is, if the parts are worn replace them correctly now. Machine the drive flange sealing face as shown in Fig 6 and machine until absolutely true the flange face at 'A' in Fig 14 and machine groove 'B' as detailed.

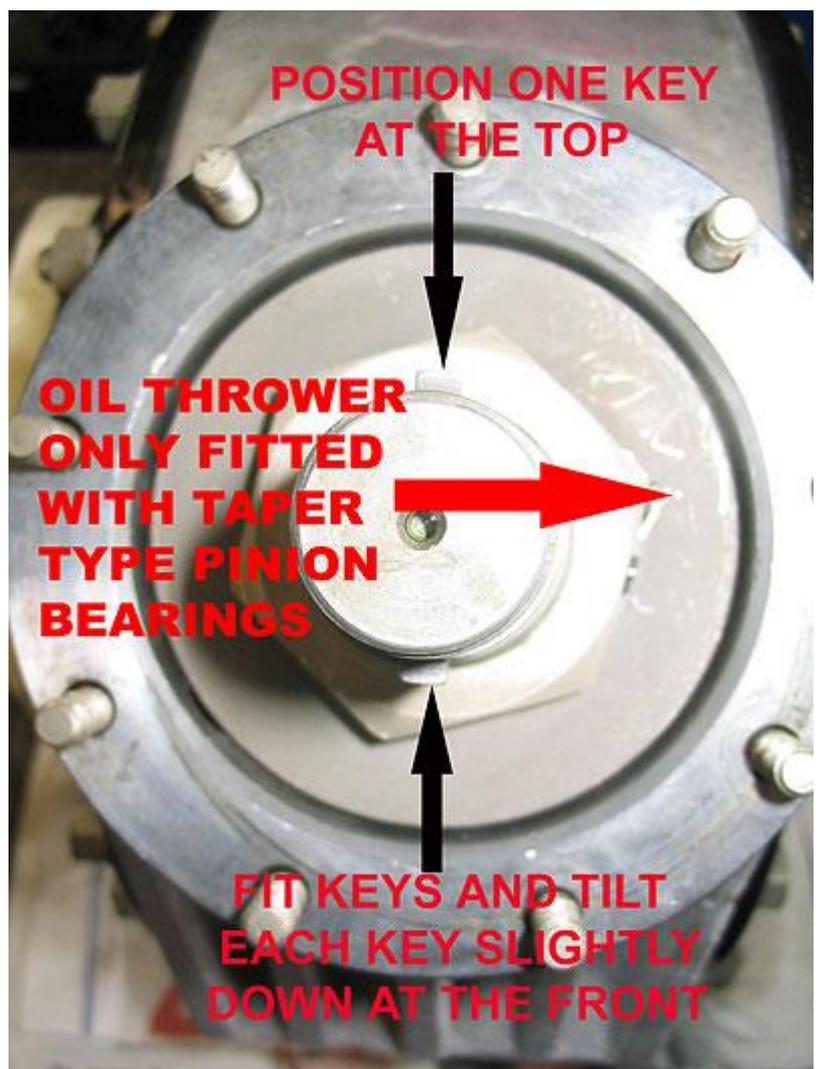
If the axle is pre-1954 it is likely that it may be fitted with a triple type pinion bearing. The easiest way for the casual mechanic to check the bearing type is to refer to the view in Fig 13 to see if the unit is fitted with an oil thrower as shown here. If the oil thrower exists the unit has taper bearings, if not it is fitted with the old triple type bearing. For example all Bentley MKVI axles would originally have been fitted with triple bearings. The point that is important here is that in this triple bearing arrangement there is a hardened bearing pre-load spacer trapped between the oil seal housing and the outer track of the bearing. This spacer is apt to rotate and wear the oil seal housing, if this has happened the seal housing needs machining square and a thicker spacer fitting. This will entail setting the bearing pre-load by selecting a spacer that when clamped with the oil seal housing in

Fig 13. Showing taper pinion bearing oil thrower

position and nuts nipped up leaves a 0.003 inch clearance between the oil seal housing and pinion bearing housing. It is important at this stage to carry out such work and/or renew the bearing. On the other hand providing the axle is good it is possible to convert the pinion arrangement to taper bearings. In my own particular daily job of overhauling these axles on no account whatever do I refit triple bearing arrangement to any axle and all overhauled axles are automatically converted to taper bearings.

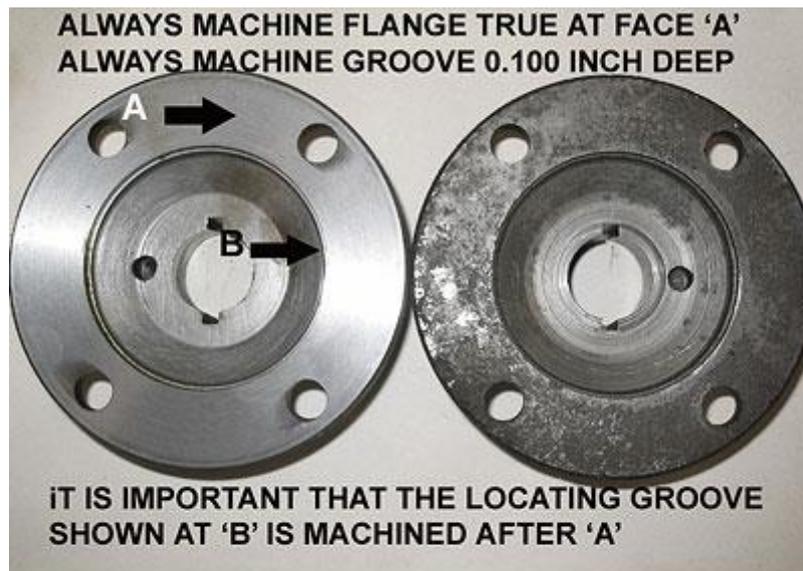
Fig 14. Drive flange machining details

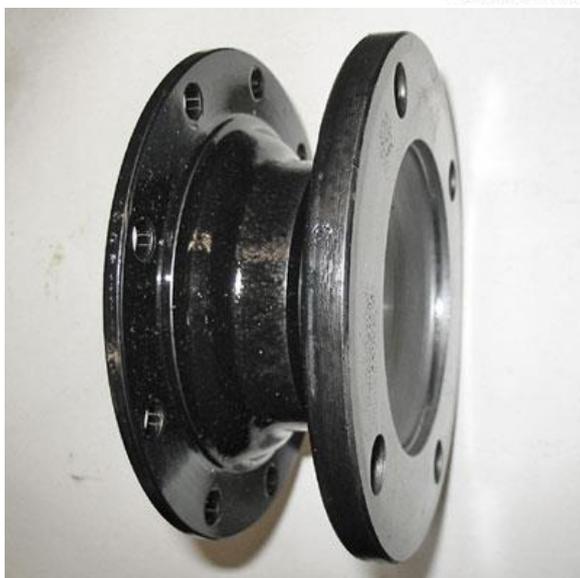
Fig 15. Drive flange positioned into the oil seal housing, ready to refit

Clean the face of the pinion housing, it will probably look like the outer face of the axle as in Fig 13, but in fact that is the pinion housing face, not the axle face. Clean the seal housing face and after ensuring a new oil seal is fitted, push the newly machined drive flange into position in the seal as in Fig 15. Set the key ways in the flange directly top and bottom and ensure the oil seal housing drain slot is at the bottom. Refer to Fig 16 and smear sealer half way up and in the top of each key way from the axle side only, as shown. Apply sealer lightly to the oil seal housing face, position the axle pinion so that the keys are as show in Fig 13 and then engage the drive flange key ways and the oil seal housing simultaneously on the pinion and nine studs. Refit the nine washers and nuts and cross tighten evenly. Fit two studs and nuts to two of the flange holes, and the assembly should then look like Fig 17. Note how the key way sealer has now been driven up the key ways without encroaching on the pinion taper interface.

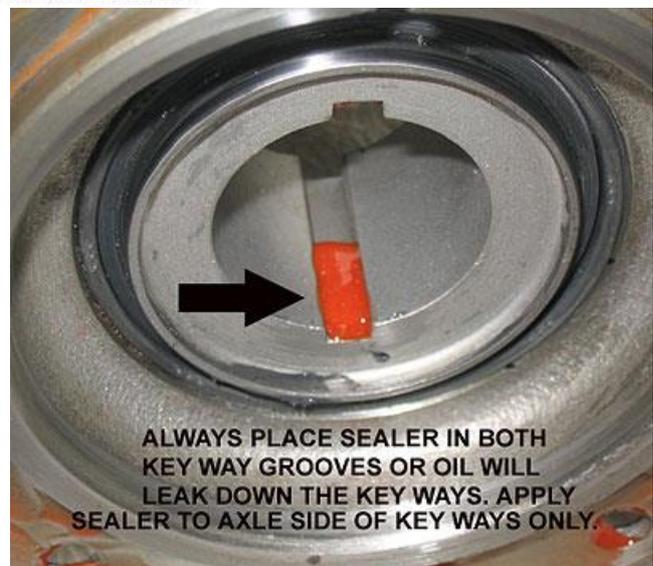
Fig 16. Sealer placed in the key way groove from the inside of the flange

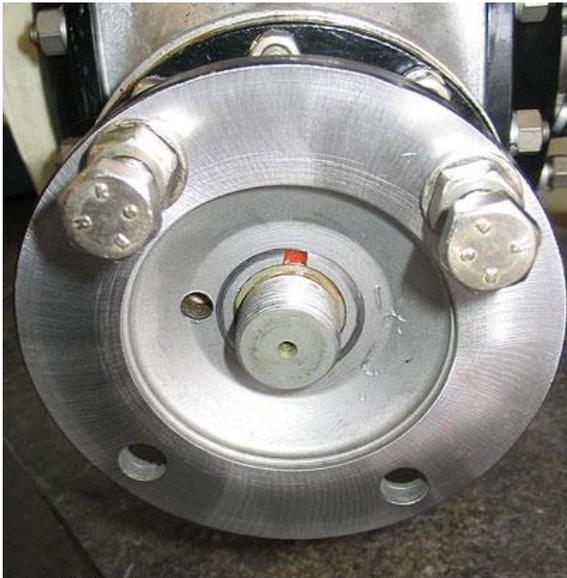
Fig 17. Note how the sealer has spread along the groove after fitting the flange

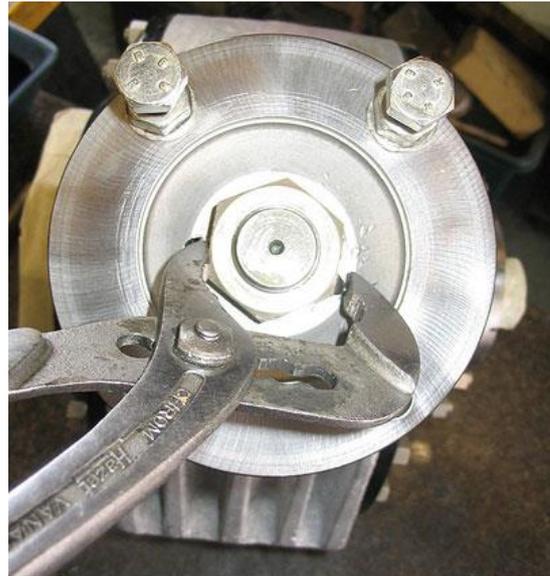
Fig 18. Finally pull over the lock tab onto the nut

DO NOT fit the lock tab at this stage. Once the parts are located, oil the face of the nut and screw it into position on the pinion. Tighten the nut to approx. 125 lbs. ft. using the method shown in Fig 11. Once the flange is tight loosen the nut, remove it and fit the lock tab. Oil the nut face again, refit it and tighten to at least 140 ft. lb. Ensure the edges of the socket do not foul the lock tab and keep checking to ensure the tab does not turn and rip the tang. Pull the lock tab over the nut see Fig 18. The method described above should ensure that the tab washer tang is not ripped when the nut is initially tightened.
