**GEARBOX**

SECTION G.G E A R B O X.INDEX TO  
SUB-SECTIONS.

## THE GEARBOX

### (RIGHT HAND GATE CHANGE)

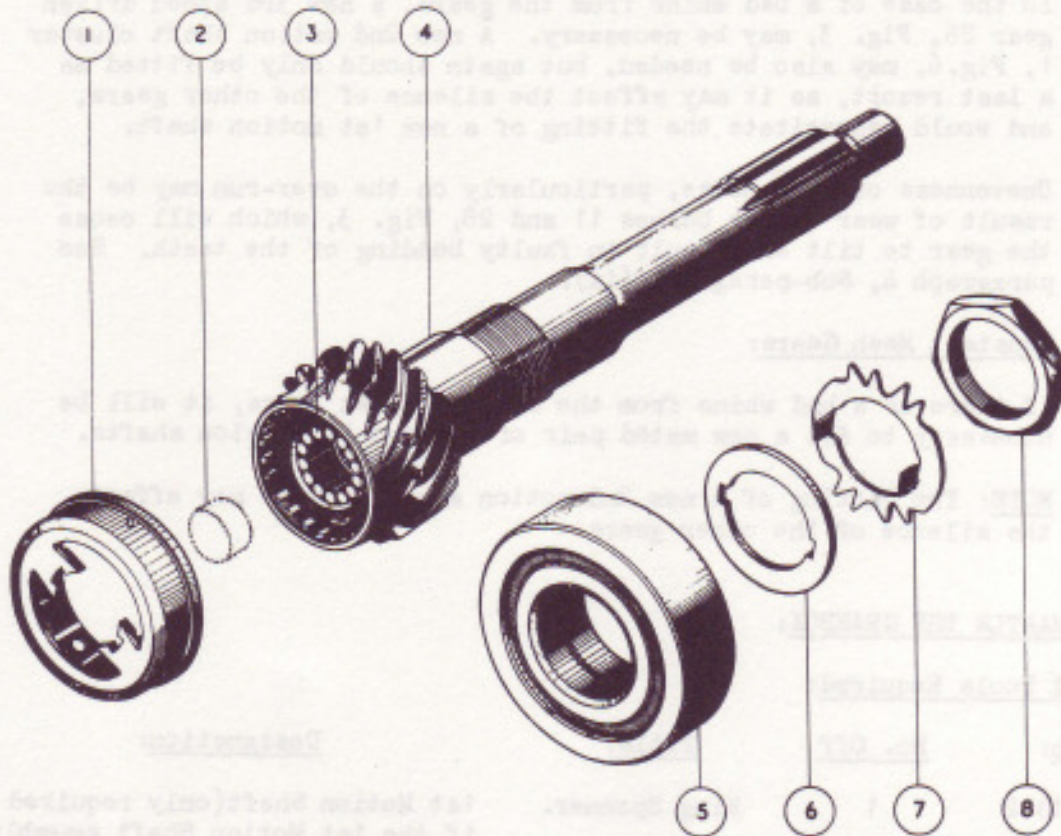
FIG. 2. EXPLODED VIEW - 1ST MOTION SHAFT.

| 1. Cone Assembly. | 4. Shaft - 1st Motion. | 7. Lockwasher. |
| 2. Roller Retainer. | 5. Ball Bearing. | 8. Nut. |
| 3. Rollers. (14 Off) | 6. Washer. | |

- (v) Remove the 6 nuts securing the front end cover to the gearbox and withdraw the 1st motion shaft assembly which contains 14 rollers, (3 Fig. 2). Recover any rollers which may have fallen into the gearbox, also the Bakelite roller retainer (2). It should be noted that the function of the roller retainer is to keep the 14 rollers in position in the 1st motion shaft during assembly to the gearbox. It is pushed by the nose of the 3rd motion shaft into the 1st motion shaft where it remains and plays no further part. Remove the cone (1 Fig. 2).

The special ring spanner 1641/T1002 should be used when removing the retaining nut 8, Fig. 2, from the 1st motion shaft, failing this, then use a long box spanner having 2.052" (52.12 mm) width across the flats. The part numbers of the new bearings are:-  
 RG-5958, Ball Bearing - 1st Motion Shaft.  
 RG-5959 - Ball Bearing - 3rd Motion Shaft.

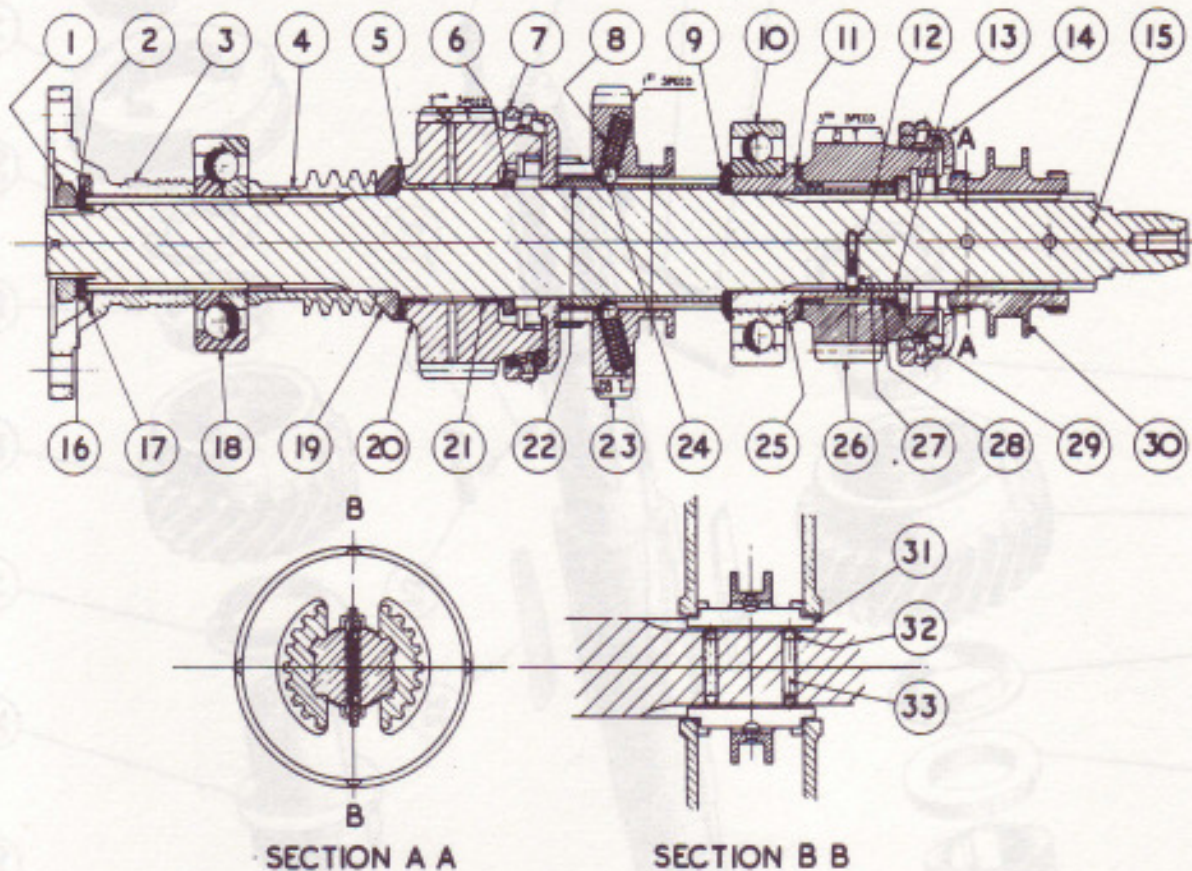
FIG. 3. SECTION - 3RD MOTION SHAFT. (EARLY TYPE)

| 1. Nut - Rear End. | 17. Adjusting Washer.(range off) |
| 2. Washer - Rear End. | 18. Ball Bearing - Rear End. |
| 3. Coupling Flange. | 19. Adjusting Washer (range off) |
| 4. Worm Gear - Servo Drive. | 20. Gear, 2nd Speed. |
| 5. Bush - 2nd Speed Gear. | 21. Bush - 2nd Speed Gear. |
| 6. Adjusting Washer (range off) | 22. Key - 1st Speed Gear. |
| 7. Cone Assembly. | 23. Gear, 1st Speed. |
| 8. Spring - 1st Speed Gear. | 24. Ball (2 off) 1st Speed Gear. |
| 9. Adjusting Washer (range off) | 25. Sleeve. |
| 10. Ball Bearing. | 26. Gear, 3rd Speed. |
| 11. Bush - 3rd Speed Gear. | 27. Pin - Locating Key. |
| 12. Spring - Pin. | 28. Bush - 3rd Speed Gear. |
| 13. Key, locating. | 29. Thrust Washer. |
| 14. Cone, assembly. | 30. Sliding Piece. |
| 15. Shaft, 3rd Motion. | 31. Key. (2 off) |
| 16. Lockwasher - Rear End. | 32. Ball.(4 off) |
| | 33. Spring. (2 off) |

- (vii) Cause: Stiffness of the two sliding keys 31, Fig.3, in the grooved splines of early type 3rd motion shaft, causing drag when changing from 3rd to top speed or vice-versa.

- (xi) Cause: Too much end float in the 2nd speed driven gear 20, Fig.3, or in the 3rd speed driven gear 26, Fig.3, or both.

Unevenness of gear noise, particularly on the over-run may be the result of wear of the bushes 5, and 21, Fig. 3, which will cause the gear to tilt and result in faulty bedding of the gears. See paragraph 4, Sub-paragraph (ix).

Unevenness of gear noise, particularly on the over-run may be the result of wear of the bushes 11 and 28, Fig. 3, which will cause the gear to tilt and result in faulty bedding of the teeth. See paragraph 4, Sub-paragraph (ix).

(vi) Temporarily fit a Jubilee clip to the front end of the 3rd motion shaft, i.e. against the sliding piece (30 Fig.3) so as to keep the parts at the front end in position during the removal of the shaft.

- (vii) Remove the nut 1, Fig.3, (which has a R.H.Thread) from the rear end of the 3rd motion shaft, using the box spanner, 1641/T1004 and the key STD-504.

- (i ) On chassis prior to (approximately) B-159-DZ, the gearbox 3rd motion shaft 15 Fig. 3 (Part No: RG-193) carried two grooved keyway splines at the front end. It is essential that these two splines should be subjected to a crack test as it has been discovered that cracks have occurred near to or where the two front cones contact the grooved splines. The area of contact on the side of these two splines will usually be found to be bright.

- (vi) Check that all keys are free from burrs and that the two keys 31, Fig. 3, slide easily in their grooves in the 3rd motion shaft.
- (vii) On the early type sliding piece 30, Fig. 3, there are two non-full teeth 'A' and 'B' Fig. 8, (shown in dotted lines) at the rear end i.e. the end which has the least number of teeth and which engages with the 3rd speed gear (26). These two teeth should be removed by grinding. It may be found however, that they have already been removed. If a new 3rd motion shaft with strengthened splines is to be fitted, as described in paragraph 5, then the above mentioned operation will not be necessary, as the existing sliding piece will have to be replaced by a new one of slightly different design.

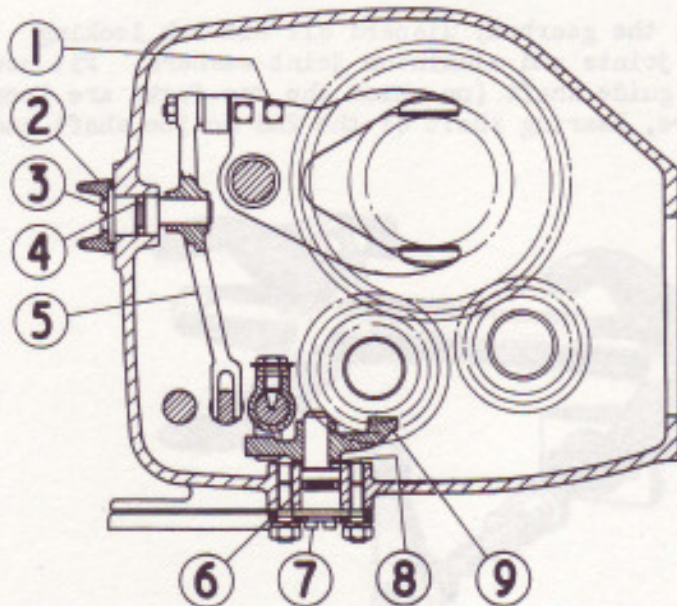
1. Operating fork.
2. Plate-eccentric pivot pin.
3. Eccentric pivot pin.
4. Rubber sealing ring.
5. Actuating lever.
6. Rubber sealing ring.
7. Eccentric pivot pin.
8. Washer (when required).
9. Actuating lever.

- (ix) Cause: Most probably due to incorrect setting of the bronze reverse actuating lever 9, Fig. 9.

(ii) Cases have occurred whereby the bronze reverse actuating lever 9, Fig.9, mounted on the eccentric pivot pin (7), have been fitted 180° out of position in relation to the forward jaw on the reverse selector shaft as shown in dotted lines on Fig.10. This could cause the radius portion of the lever to come out of contact with the reverse actuating jaw and lock on the edge of the latter with the flat on the end of the lever at point 'B'.

1/4" B. S. F. nuts (beneath the gearbox) securing the locking plate of the eccentric pivot pin 7, Fig.9, and with a screwdriver, rotate the eccentric pin

- (v) With the actuating levers 5, Fig. 9 and 4, Fig. 11, on their respective eccentric pivot pins, place the two forks loosely in the gearbox in their relative positions. Lightly smear the outer race of

Check that the 1st and 2nd speed selector shaft has approximately an equal amount of "over-ride" in the fully forward and rearward positions. Move the selector shaft into the 1st speed position and examine that the 1st speed gear 23, Fig. 3, is in full engagement (laterally) with its opposing gear. If correction is necessary, a small adjustment can be obtained by movement of the eccentric pin 3, Fig. 9.

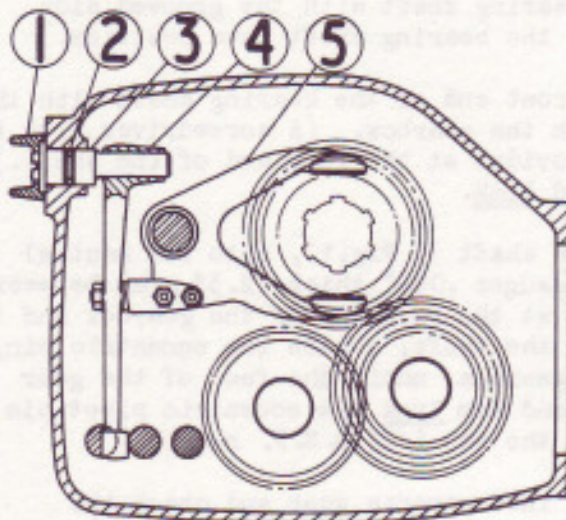
FIG. 11. SECTION - 3rd & 4th SPEED OPERATING LEVER ASSEMBLY.

1. Plate - eccentric pivot pin.
2. Rubber sealing ring.
3. Eccentric pivot pin.
4. Actuating lever.
5. Operating fork.

- (i) Remove the eccentric pivot pin 3, Fig.11, by first removing the retaining plate (1). Withdraw the eccentric pin with a pair of pliers. Remove the actuating lever (4).
- (ii) Remove the eccentric pivot pin 3, Fig.9, and the actuating lever(5).
- (iii) Remove the remaining eccentric pivot pin 7, Fig.9, and the bronze actuating lever (9) and the adjusting washer (8) if fitted.
- (iv) Invert the gearbox, remove the bottom cover plate(which is spring loaded), then the three springs, and the three .500" dia.balls. Remove the cover from the rear of the gearbox.

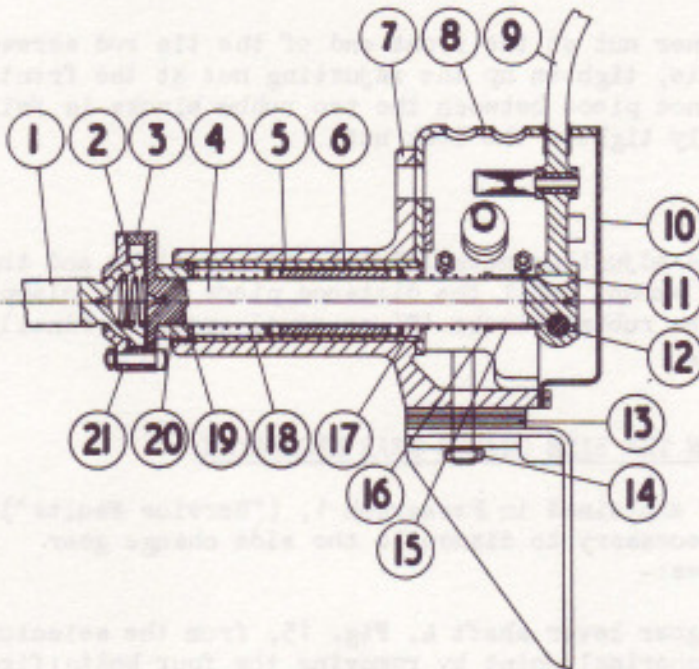
FIG. 15. SECTION - SIDE CHANGE GEAR MECHANISM.

- 1. Selector lever shaft.
- 2. Spring-spherical joint.
- 3. Driven member.
- 4. Change gear shaft.
- 5. Outer race-bearing.
- 6. Bearing assembly.
- 7. Bracket.
- 8. Gate-change gear.
- 9. Change gear lever.
- 10. Cover-gate.
- 11. Key.
- 12. Pinch bolt.
- 13. Packing pieces.
- 14. Nut and spring washer.
- 15. Ferrule.
- 16. Washer.
- 17. Spring } Identical
- 18. Spring }
- 19. Washer.
- 20. Rubber stop.
- 21. Spherical bearing.

- (iii) Cause: May be due to the omission of the spring 18, Fig.15, of the side change gear mechanism. The springs 17 and 18 are identical with one another.

- (iv) Cause: The rubber stop 20, Fig.15, of the side change gear mechanism too wide, causing the gear change lever to rub hard against the forward or rearward tongue of the gate when sliding into the 3rd or top speed slots in the gate.

Remedy: Remove the rubber stop (See Paragraph 7A) and should the overall width be found to exceed .485" (12.3 mm), reduce it to this length by carefully cutting the stop on its non radius side or fit a new stop Part No: RG-3332, having the reduced width.

- (iii) Remove the two nuts and flat spring washers (14) securing the gate bracket to the frame and manoeuvre the change gear unit past the floor board and out of position, leaving the packing pieces 13, (usually four) in place on the frame. These packing pieces are .036" (0.91 m/m) thick and are for alignment of the change gear lever shaft (4) with the selector lever shaft (1). It is advisable to temporarily wire them to the frame in the position found to prevent alignment troubles from arising on assembly, because in certain cases, tapered packing pieces may have been fitted.

- (vi) Remove the shaft complete with the rubber stop (20), and then the gate (8) from the bracket, secured by two bolts.
- (vii) Next remove the ball bearing assembly (6) and the spring (18). Tap on the outer face of the washer (19), removing it together with the outer bearing race (5).
- (viii) Thoroughly clean all dismantled parts.

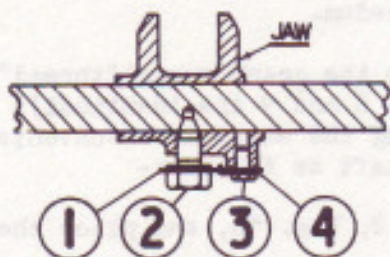
FIG. 16. SELECTOR JAW - METHOD OF LOCKING.

- 1. Locking plate
- 2. Locating screw.
- 3. Set - screw.
- 4. Lockwasher.

(i) Fig.16, shows the method by which the four selector jaws are locked to the three selector shafts. Invert the gearbox, remove the bottom cover plate which is spring loaded, and inspect that the tab of the lockwasher (4) fully locks the small setscrew (3) on three of the jaws. (The forward jaw on the reverse selector shaft can be inspected through
