TEE-ONETOPICS

Number 33 March, 2004

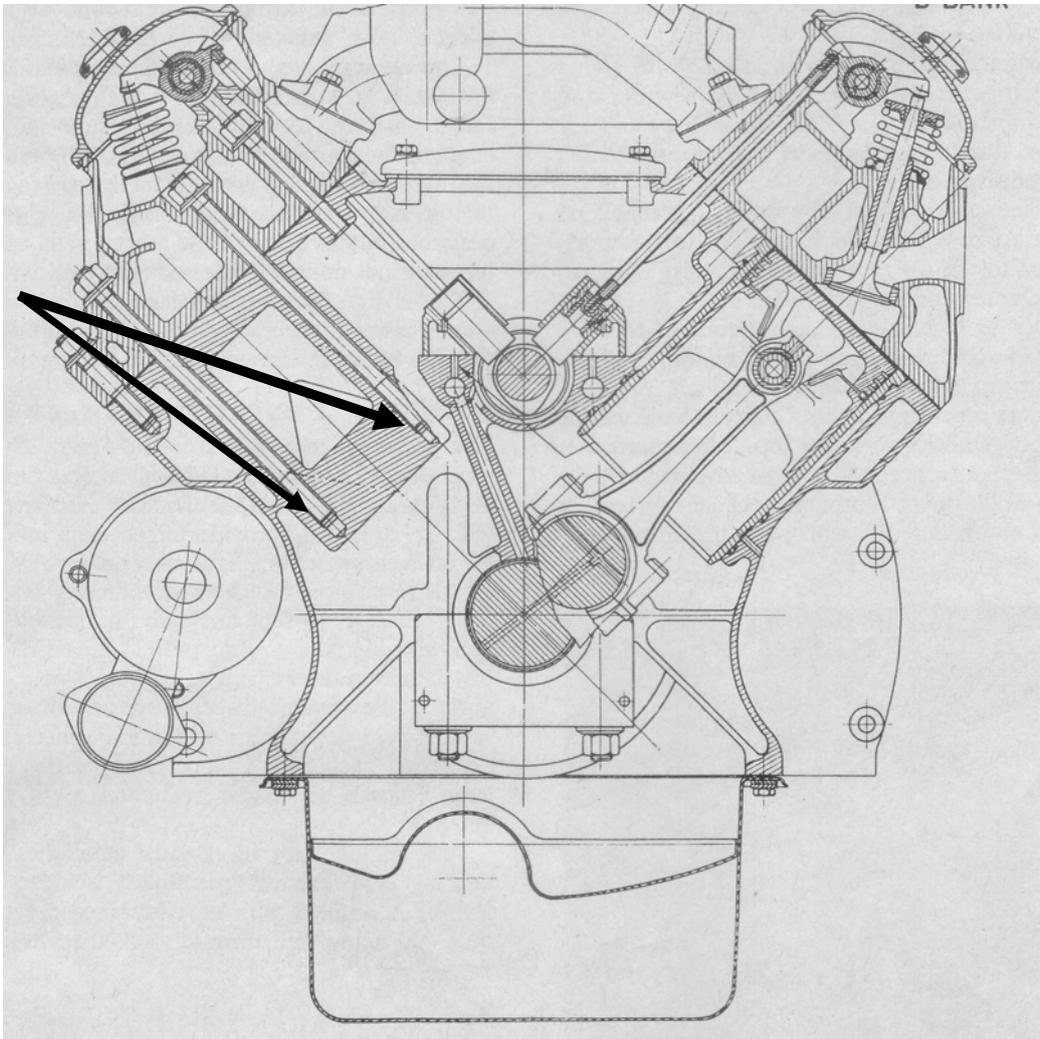
I recently purchased a copy of a paper presented to the British Institute of Mechanical Engineers titled 'The Design History of a V8 engine. Its author was of course A J Phillips, an engineer fairly well known to enthusiasts. The paper is particularly topical since more and more of these engines are starting to disintegrate. I will reprint the document elsewhere. One of the casualties on the recent Melbourne crusade apparently blew a head gasket in his Shadow. This is generally rare in my experience but then the examining specialist noted that the nuts on the head studs were literally finger tight. These studs are carefully fitted into the very bowels of the engine block and effectively not only hold the head down but hold the whole unit together. It seems that the main casting had lost integrity and the studs had simply pulled themselves out of the block. See arrows below.

I mention this to alert owners to consider any form of prophylaxis that can be taken to halt or at least slow the deterioration of the aluminium castings that are the very body of the engine. Presently I am trying to get the heads off a very early Shadow and so far have had no success. Unlike the old cast iron blocks one would not dare using pullers on these heads for fear of permanent damage so to date the treatment (on advice) has been to rattle the studs with copious quantities of WD40 in the hope that the corrosive grip will let go of the head casting.

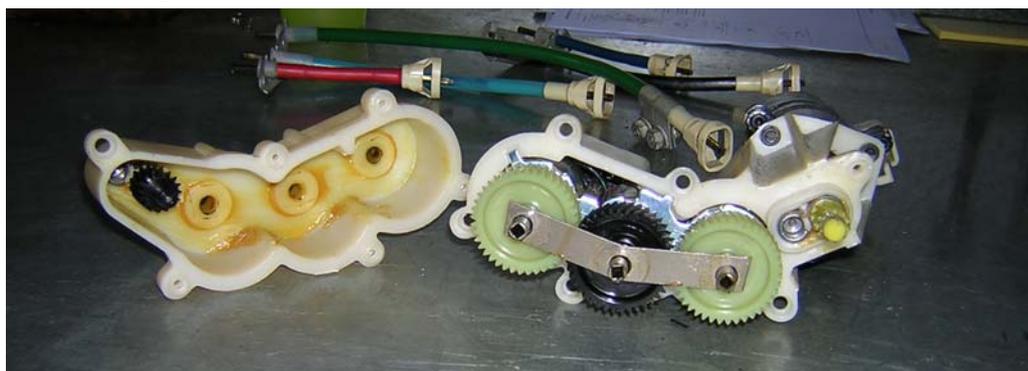
More on the seat motors for the SY and later cars. Apparently these assemblies are straight out of a 1980-85 Cadillac and are still readily available. But my informant tells me that the biggest trouble with the units was with them exploding!! Providing the flexible cables held, the gearing in the plastic cases when under great load, is trying to force itself apart and when push comes to shove the strain can be so great the plastic simply gives away, reportedly in a spectacular fashion. New casing and assemblies should be available from Kellow Falkiner. Noting the slip on three hole plate across the three axles in the picture below I imagine this was an attempt to support the gears when in their hour of need!

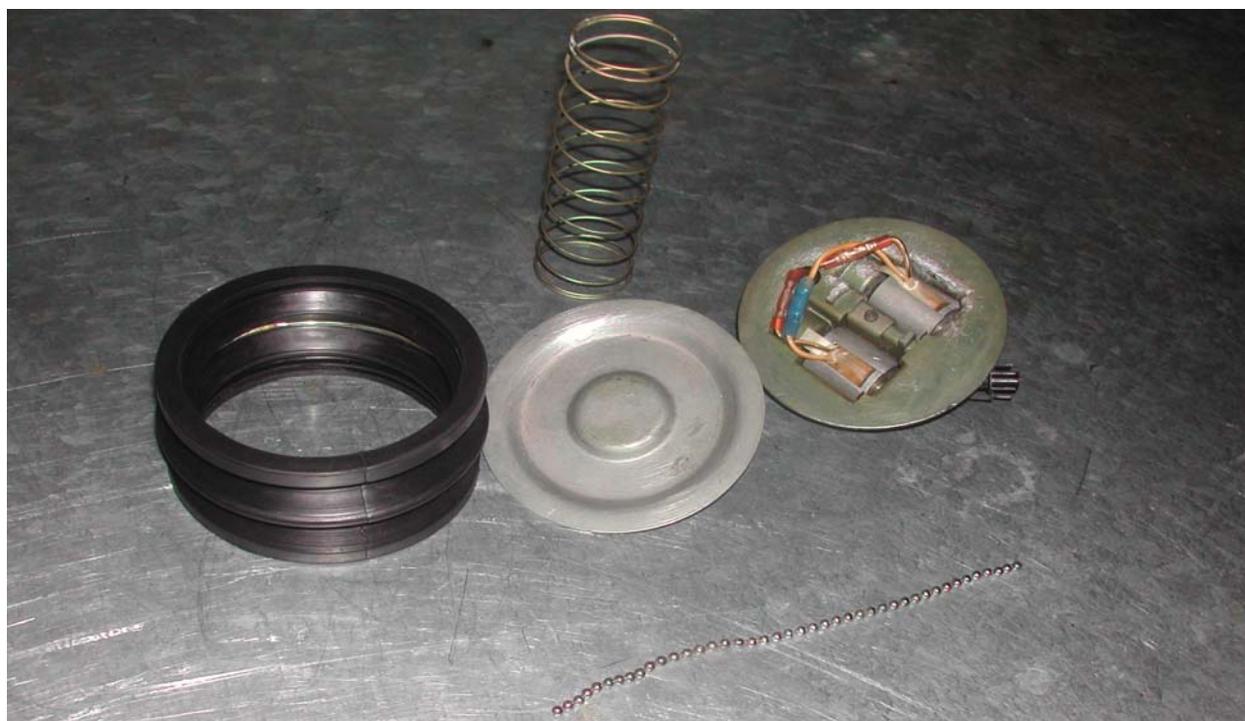
The simple bit of the speed control is the bellows which we have all seen perched on the engine. Here is one dismantled. The connecting chain which pulls the throttle linkage is at the bottom. The latter is a simple bath plug chain and readily available at any decent hardware shop. Although I am told with much assurance that the chain supplied by the Factory is more robust than commercial chain!! The most obvious malady with these gadgets is perforation of the bellows (the rubber bit at left!). This shows up as an inability of the control to hold speed; the higher the speed the worse the problem shown by the speedometer needle slowly dropping back. Another quick way to pick up a perforation is to simply squeeze the whole assembly. A good bellows will compress slightly but then resist further compression. If punctured there will be little resistance and you will probably hear air escaping.

The assembly to the right of the picture is the gadget that consists of two solenoid controlled valves. One opens up the bellows to the vacuum line from the induction system and the other opens to let in air. Sucking the air out of the bellows causes the bellows to collapse drawing up the round plate in the centre of the picture which has a hook on the back side via the bath chain

this pulls the throttle levers and the engine speeds up. Letting air into the bellows allows the internal spring seen at the top to push the bellows apart and throttle levers are released.

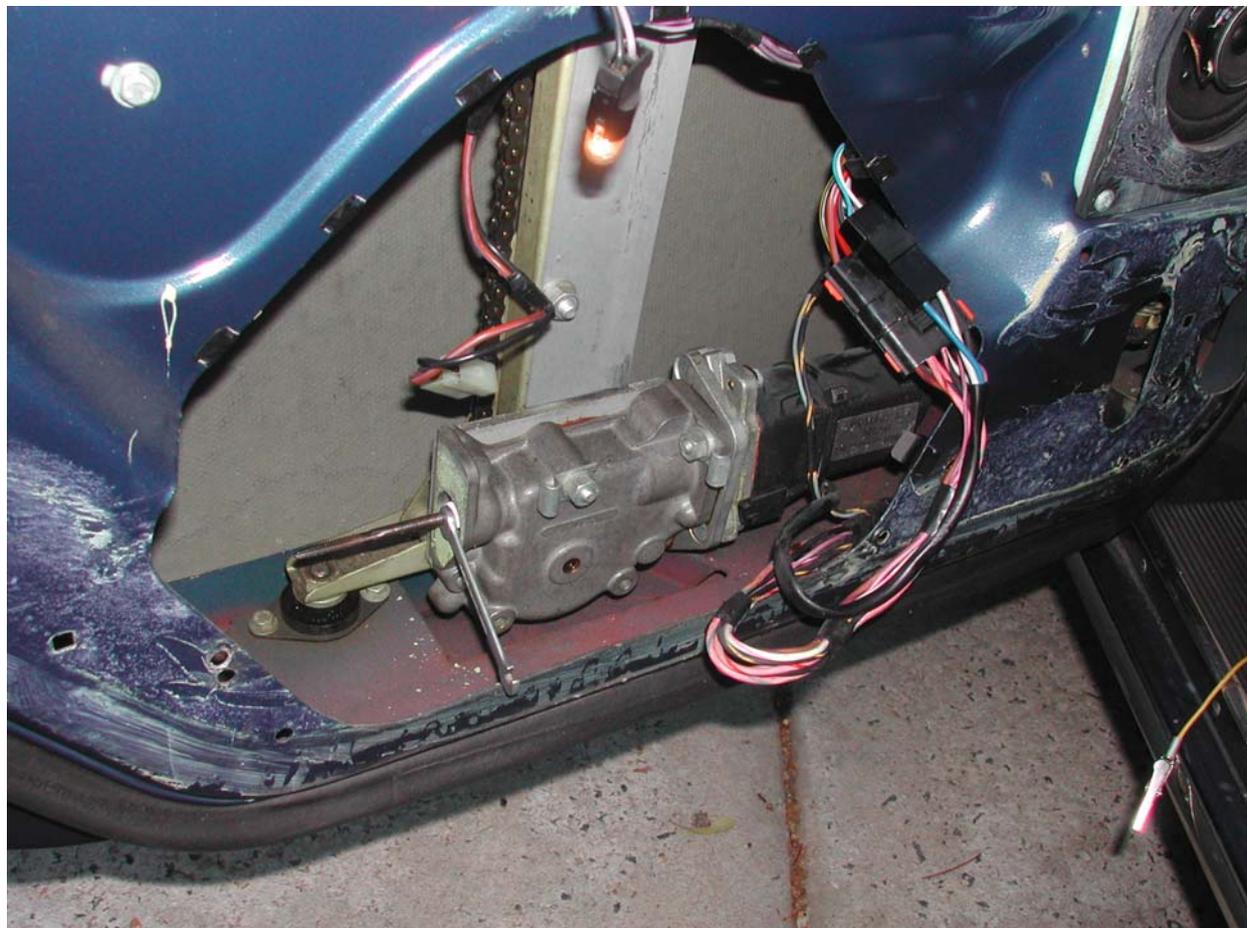
It is timely to corner the unsuspecting reader and explain how Rolls-Royce make windows go up and down! Noting the accompanying picture, the window is lifted and lowered by a simple bicycle chain with a few other bits keeping it square in the channels. The chain in turn is driven by an electric motor which exerts itself through a gearbox. Obviously the gearing has to be very low to accommodate the weight of your child who is desperately fighting the window to wave to the little departing friend at the kerbside, but it also needs to lift the window at a rate that hopefully allows such darling offspring to remove its head/hands or other appendages before it closes. Hence the need as I mentioned for 614256 turns of the drive shaft to raise the window fully. I exaggerate a little in this instance.

Again obviously the door only requires one motor to do this lifting and lowering business but to do so needs something to make the thing run backwards as well as forwards. The picture does not clearly show that there are only two wires entering the motor. Both are positively charged. The direction is achieved by earthing one of the wires which allows the remaining wire to exert its influence and the motor whirls appropriately! But in this case while earthing one wire

produced an impressive lowering of the window earthing the other achieved nothing other than a dull click. The cause of this I have yet to determine but given that the owner was about to drive to Beijing there was a need to close the bloody glass! Again referring to the picture one notices that the motor engages the gearbox from the forward side and that the end of its shaft runs in a bush on the opposite side. As luck would have it, the end of the shaft was covered by a piece of insulation tape and in the end of the shaft was a square hole which fortuitously accommodated the end of a small thread tap. This duly inserted it was wound in the correct direction some 614256 times or less and the glass was shut.

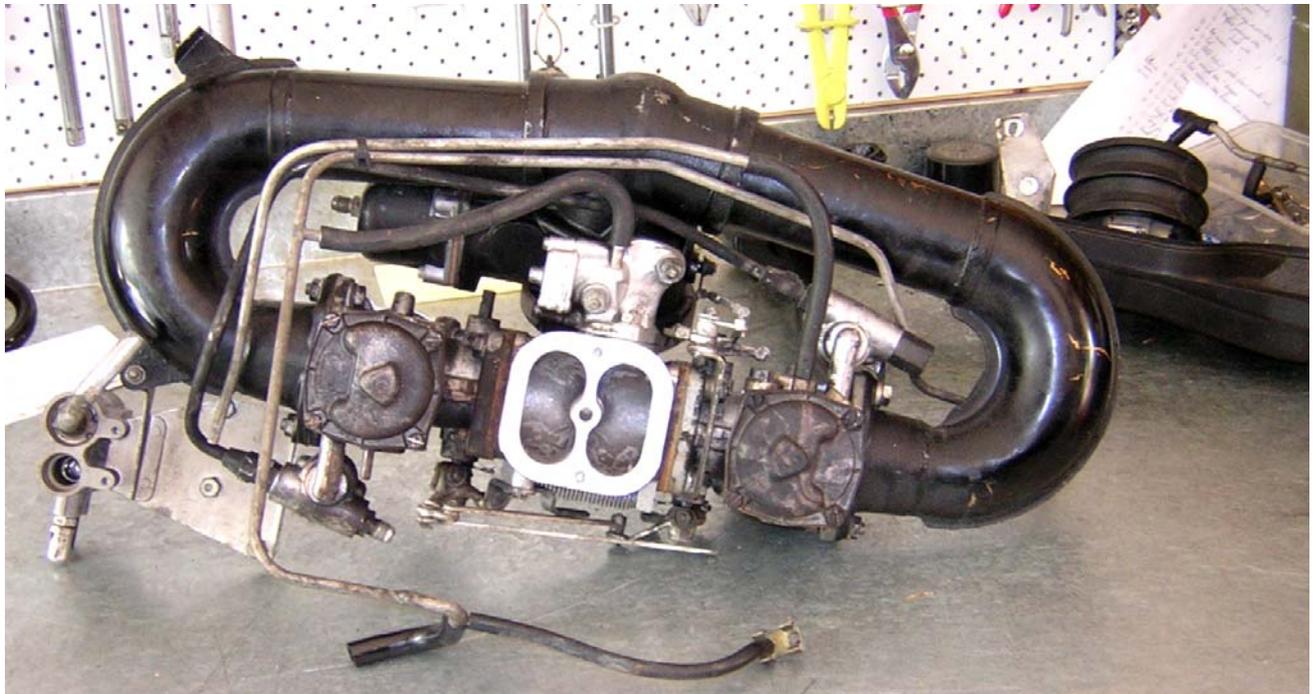
This is the underside of a Spur's induction system. That small hole in the middle surrounded by the kidney shaped ducts, accommodates a single bolt which holds the whole assembly on top of the engine. The car from the time I purchased it had a lingering smell of petrol. There was no obvious drip or clean spot but peering down into the induction jungle I was sure that I could see 'wetness' around the bottoms of the carburettors. A quick call to my friends at Midel, the SU carburettor agents and they confirmed that the leak was most likely between the bottom plate of the carburettor and the main body. Seems that these plates get very hot, planted as they are so close to the top of the engine proper and eventually they warp and allow seepage of fuel from the chamber above. The web of pipes and tubing not normally seen from above is to direct the supply of vacuum and fuel as required.

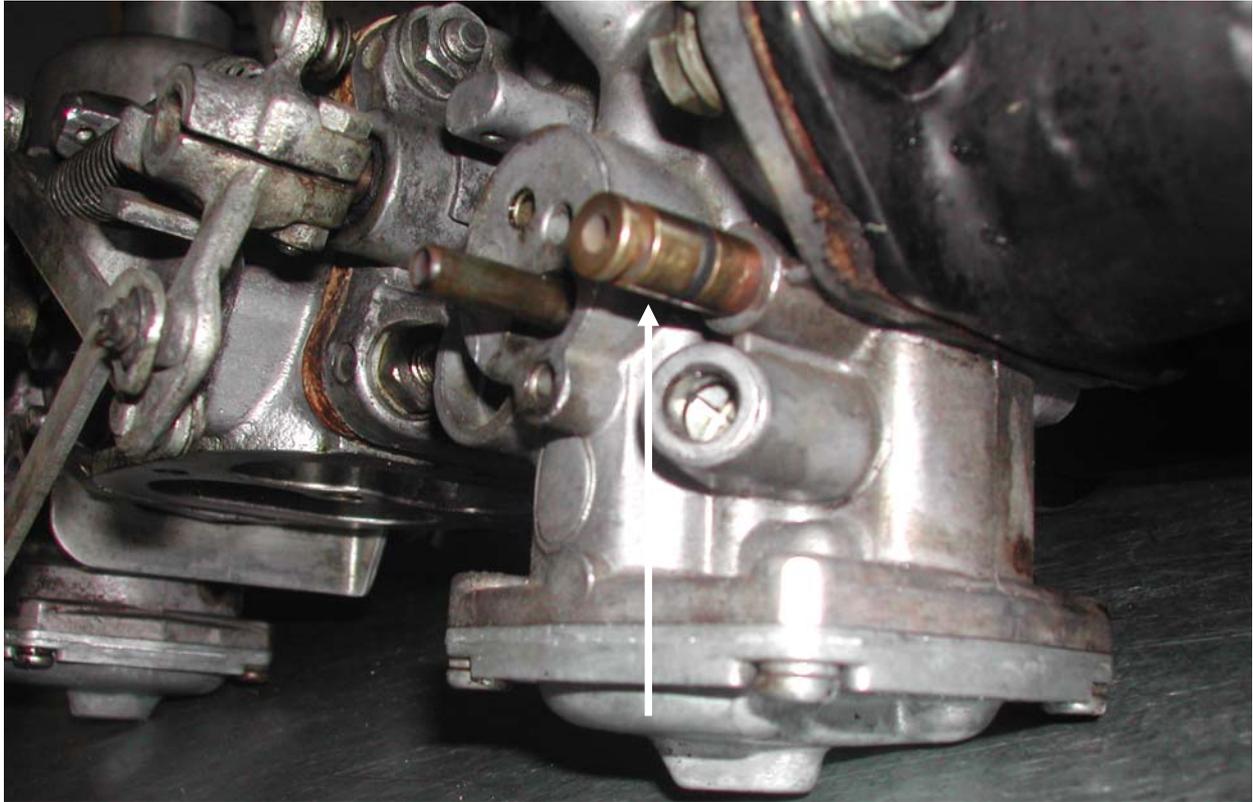
Here is a close up view of the bottoms of the carburettors this time the right way up. The new bottoms have been fitted with new 'O' rings. The tube arrowed is the inlet to one carburettor. To get fuel in, a special fitting slips over the tube and is held in place by a supporting bracket. Sealing is achieved with 'O' rings one of which is still on the tube. These had almost turned to glass with heat and age and were readily replaceable with after market items.

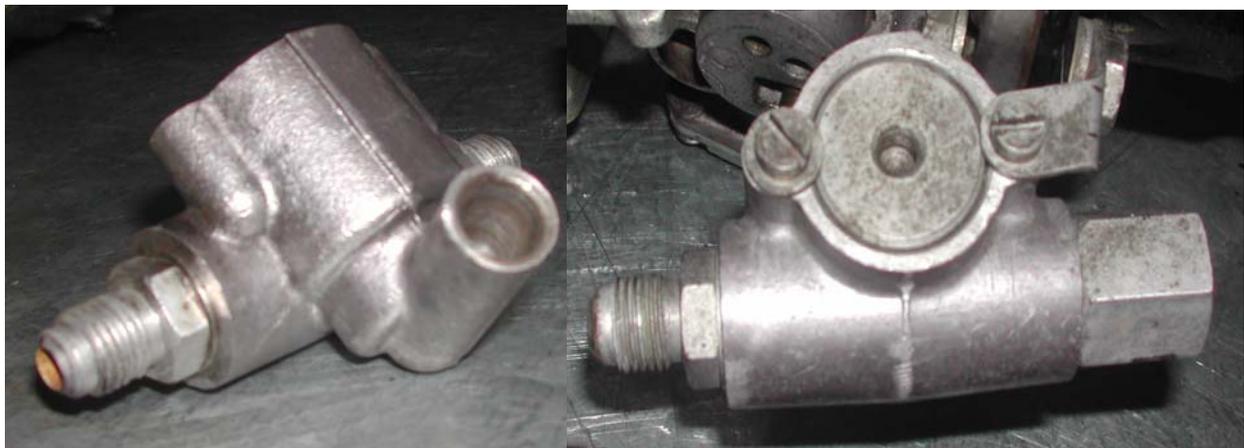
These are the fittings that feed fuel to the carburettors. The fuel feeds initially into the 'A' bank carburettor and that which is not required there passes on to the 'B' bank unit. Here there is a small restrictor that ensures that there is a small pressure in the system to feed the float bowls. From the 'B' bank unit the fuel returns to the main tank. This helps avoid fuel vaporising through sitting in hot lines. Both of the above units have filters located under the large plug that should be changed regularly.

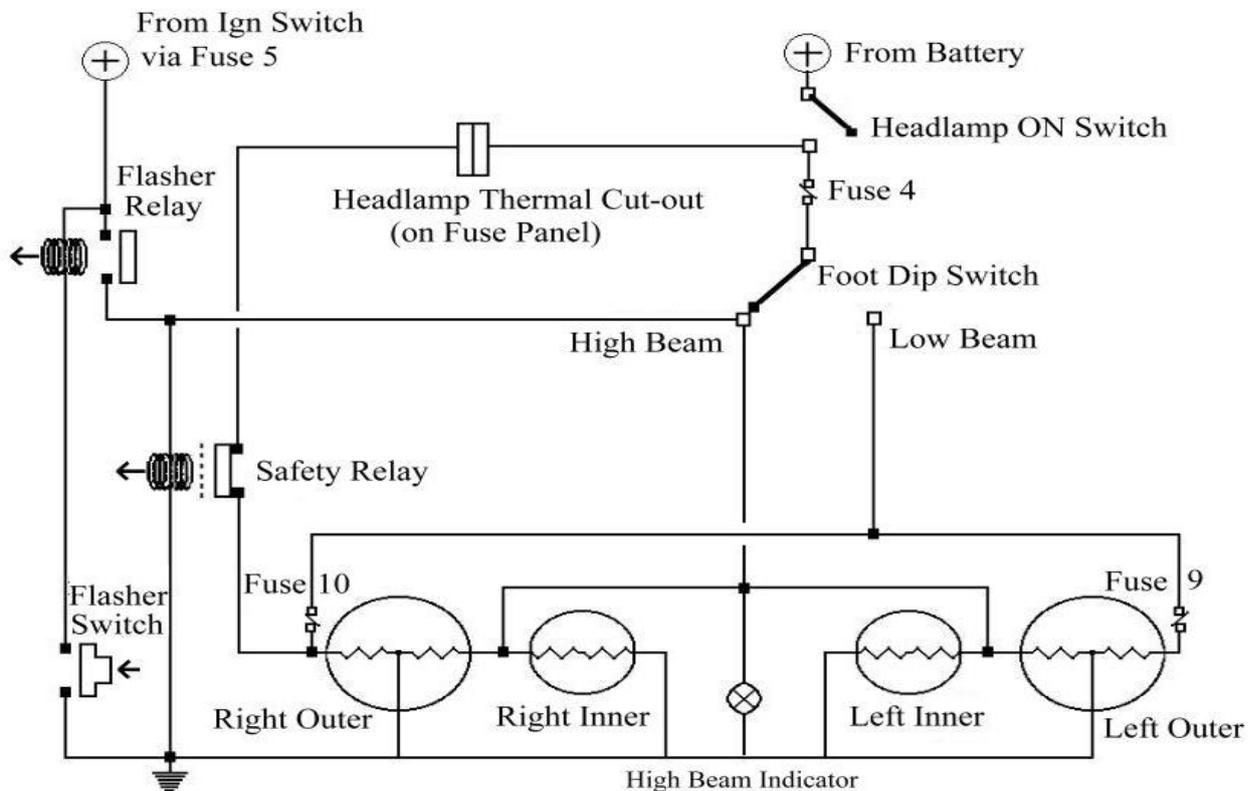
Shadow 1 Headlights Operation

Purpose of Safety Relay

- Maximum current is drawn when the headlights are on high beam. If Fuse 4 blows at this time a dangerous situation of no headlights could occur.
- However to prevent this situation if Fuse 4 does blow the Safety Relay will de-energise, allowing current
- via the Thermal Cut-out to at least one of the low beam filaments (or both if Fuses 9 and 10 are OK)
- Because the Safety relay is not energized when the headlights are on low beam, the same protection applies.
- The Safety Relay is also energised when the headlight flasher switch is operated, to prevent
- filament overload.

Note: The above diagram and the one following were supplied by John Kilkenny the owner for many years of a very ancient but much loved and cared for Silver Shadow.

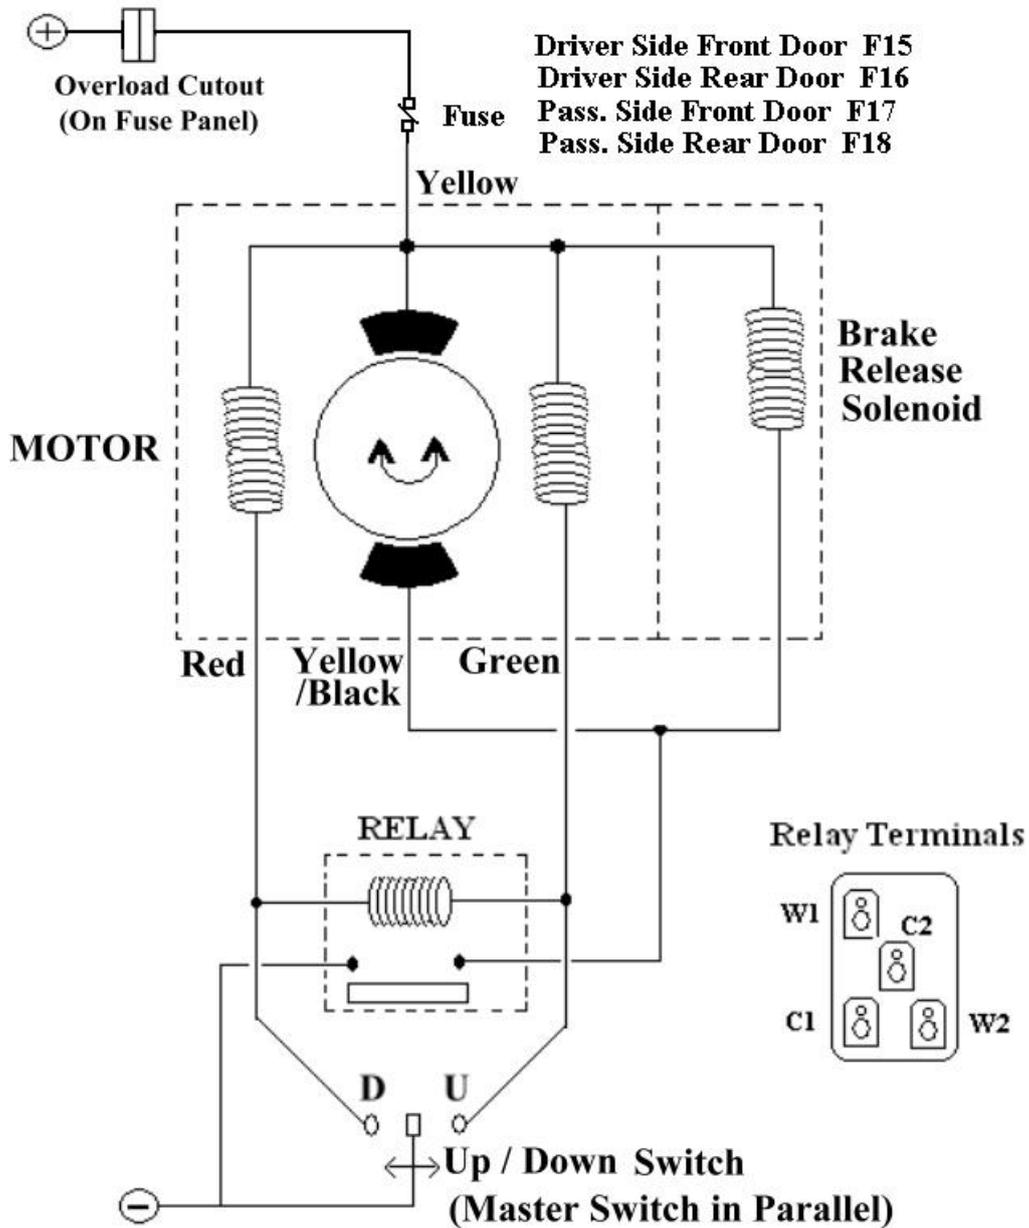
Shadow 1 Electric Window Operation

- Because the resistance of the relay is several times that of the motor field windings, the Up/Down switch will energize the relay but only one of the motor field windings will get normal current.
- The armature winding and brake release solenoid will be energized via the relay contact.
