TEE ONE TOPICS

Number 42 March, 2005

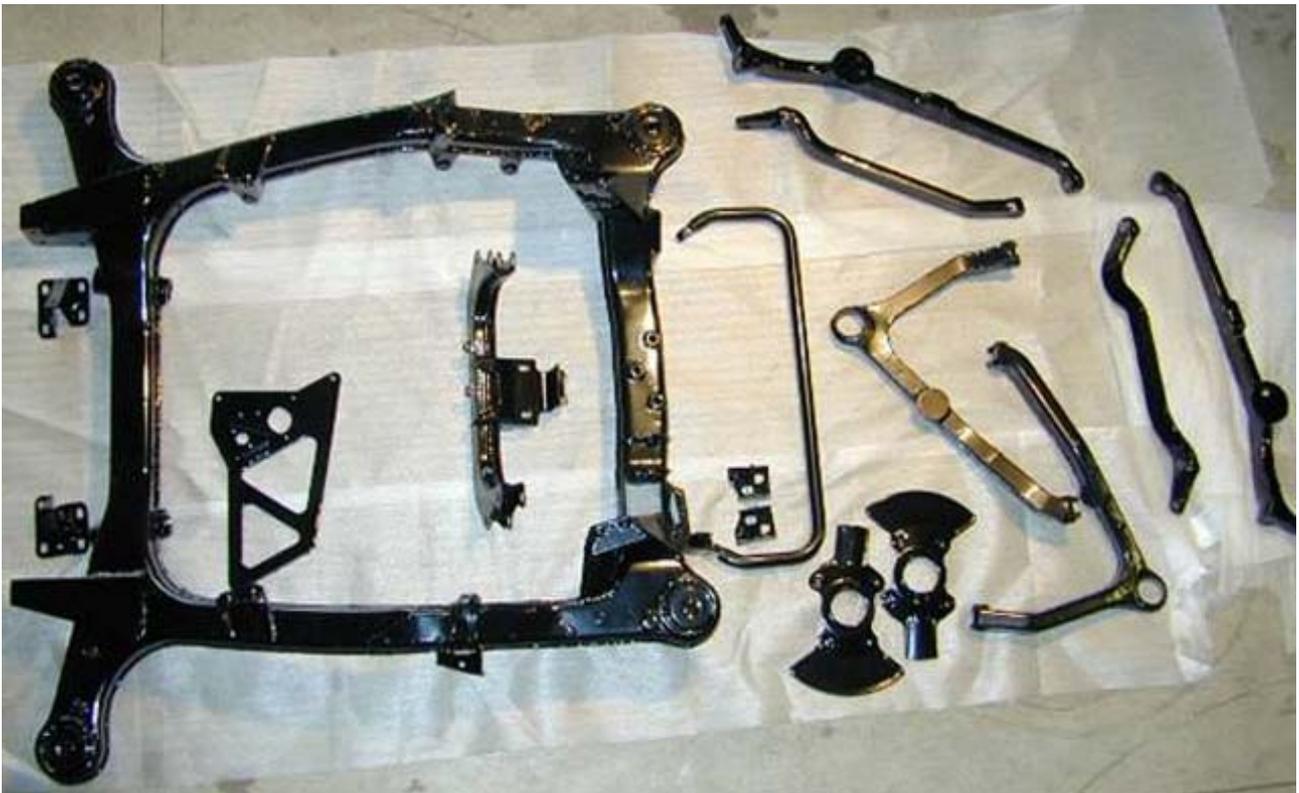
CONCOURS SUSPENSION

Having had arguments with judges as to how clean suspension should be, I have this fantasy that I will have my Shadow towed to the Concours, placed on jack stands, and then lay the suspension out like the above. I am sure there is a rule about it but no matter. This is an excellent line up of components of an early Shadow's front suspension all nicely powder coated. It is hard to imagine that the sub frame not only keeps all the suspension in place but carries the engine with all its stress demands as well.

This is non compliant suspension and owners of these cars, (chassis before early 1974) should take an interest in the mounting points for the suspension arms where they bracket onto the sub frame. The brackets on a number of cars tore their welds out in this area. Most cars that went through dealers hands for some time after the warranty period expired, had their brackets strengthened.

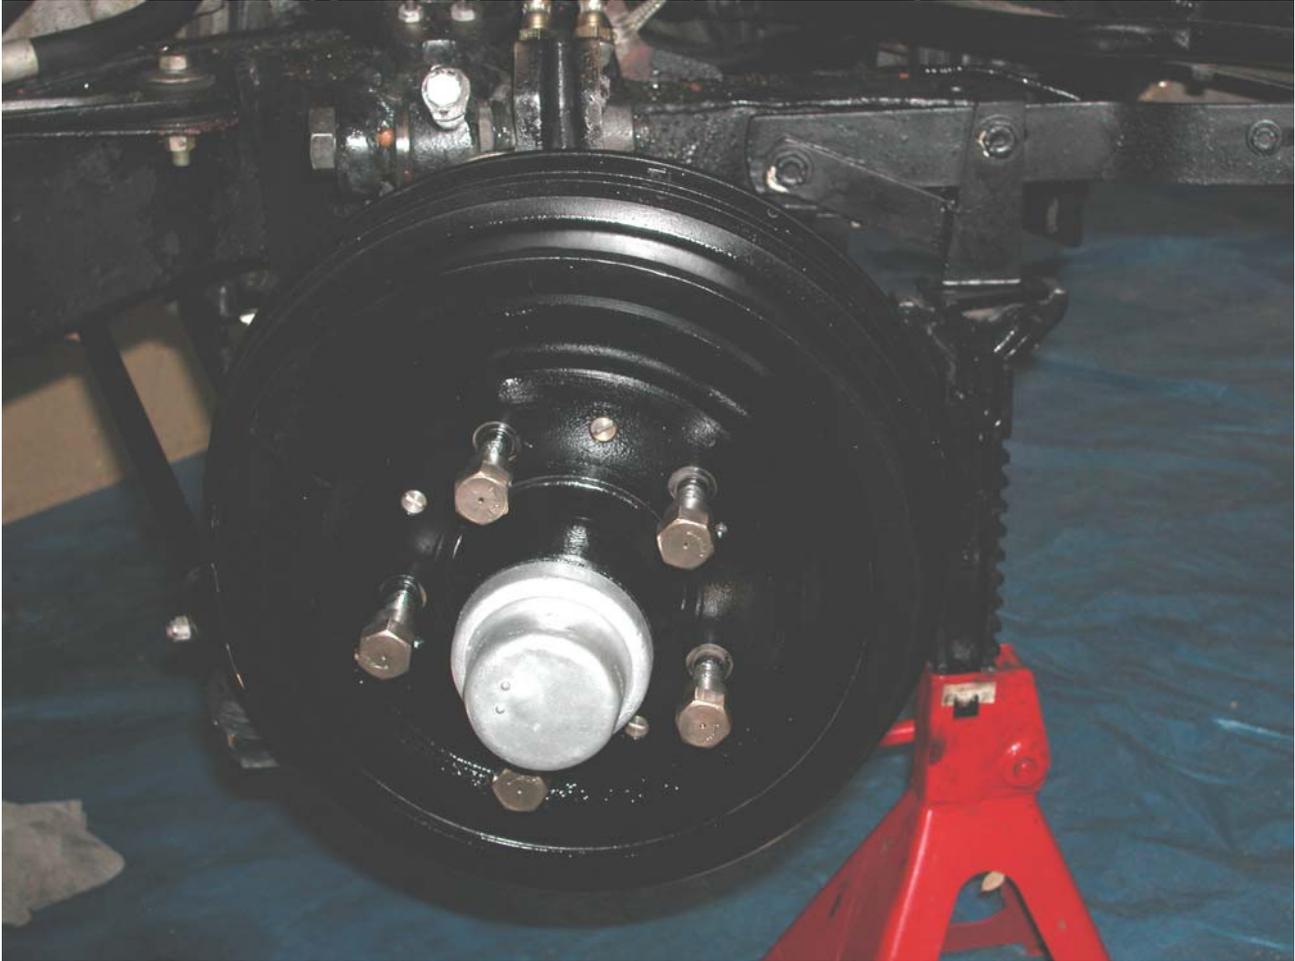
From the Silver Shadow onwards the Factory dispensed with the vented enclosed nuts but retained their manufacture in brass and still stamped a direction for removal on them. The nuts themselves have two functions, one is to hold the wheel on, the other is to centralise the latter on the hub. To do this in a practical manner the nose or open end of the nut is spherical which engages a stamped hole in the wheel with the same spherical dimensions and shape.

Inspecting the ‘nose’ of the nut whether the earlier closed version or the later Shadow ‘open’ type you will note that the inside of the nose is not threaded. At least it should not be. Take your car to the local tyre emporium and get a pair of new tyres fitted. If you rage at the right moment you may

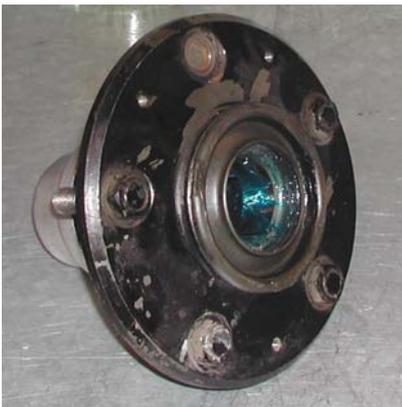
Some little time later you have occasion to change a wheel yourself. Having found the jack and wheel brace you get the wheel with its flaccid tyre off the hub but just when you are about to refit the spare you decide to give the stud threads a wipe and discover that two of the studs are quite loose in the hub. At left there is a picture of one of these studs removed! How can this be? Well our recent rattler friend in merely over tightening the wheel nuts not only damaged them but actually pulled the studs through the hub body. After all they are only held on with large half nuts.

So the next time you go to your tyre place, lock the car and find the manager and explain that you have a procedure statement for inserting his operator's skull in his own rectum if he goes anywhere near your car with a rattler. The wheel brace supplied with the car used with maximum force by a 'normal person' can tighten a wheel nut to 50 foot pounds which is the recommended tension.

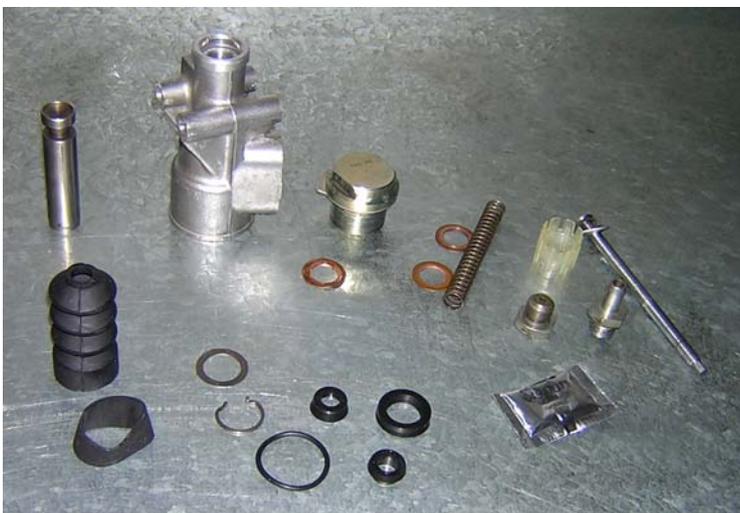
At left:- The smaller of the two master cylinders dismantled. The circular seals at the lower part of the picture swelled to the point of jamming the piston seen to the upper left.

Removal of the master cylinders the second time revealed that the new seals had swollen and were causing the piston in the secondary master cylinder to jam forward preventing replenishment. Finally, advice from Patons Brake Replacements who make most seals in this country confirmed that modern seals were incompatible with silicon.

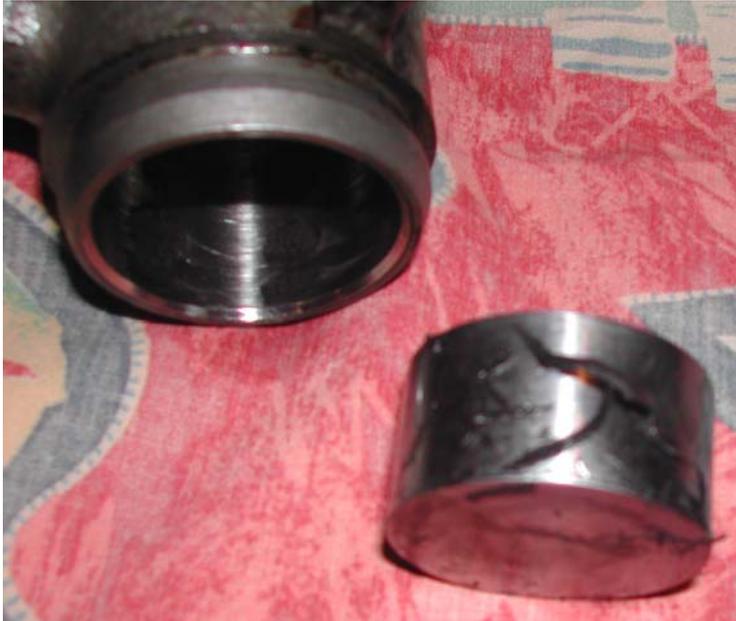
Below:- One of the front brake pistons and cylinders showing the shredded internal seals that had swollen and almost jammed the pistons.

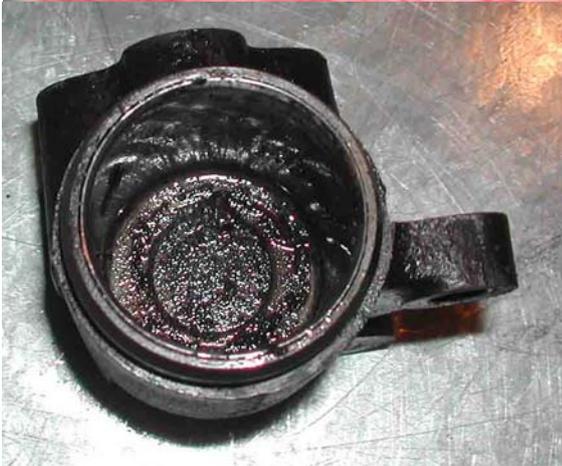
At left:- The residue in the wheel cylinder which was apparently 'dissolved' rubber from the seals.

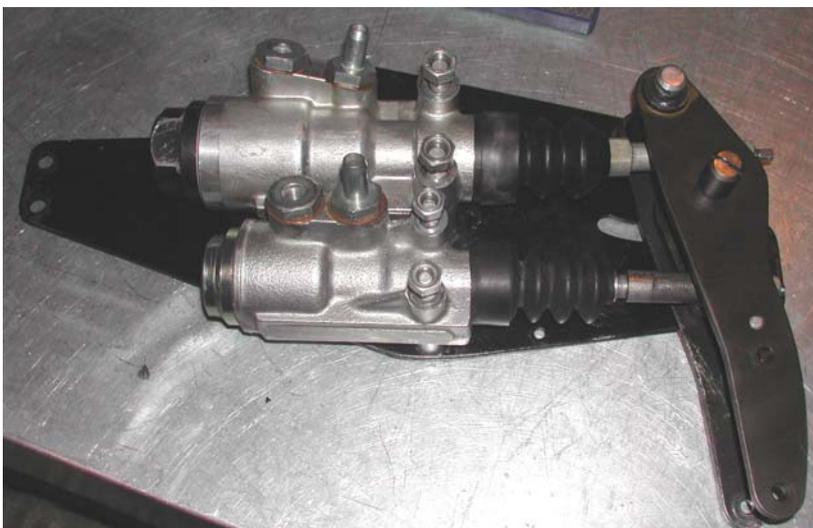
At left:- The two master cylinders assembled to their backing plate for installation. The push rods for the pistons swivel on a trapeze pivoting about the large slotted pin seen protruding at the right on the operating arm.

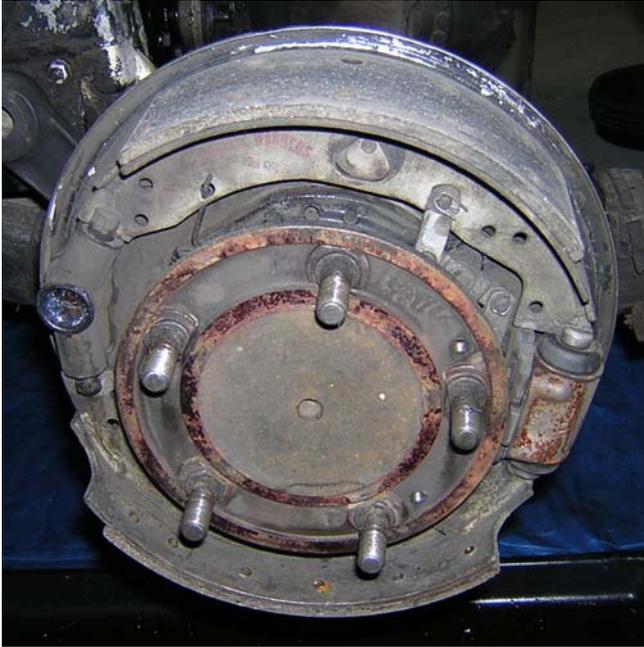
At left:- The left rear brake assembly. The adjuster to the left was partially seized and the hydraulic and mechanical expander to the right was in need of lubrication. Here too the seals were notably spongy.

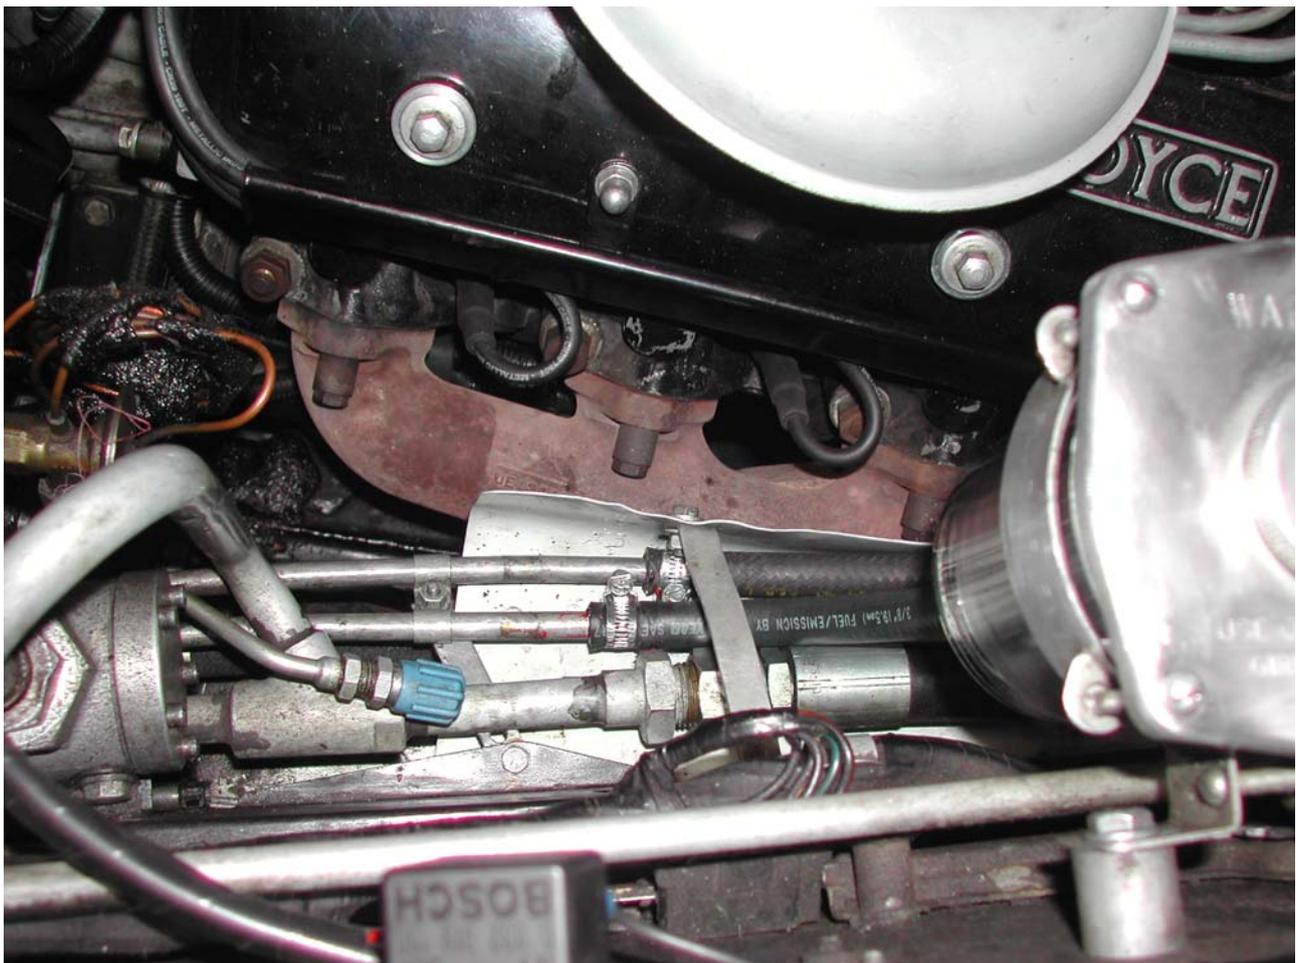
Below:- Both reservoirs to the right were dismantled and thoroughly cleaned and fitted with new gaskets. The supply pipes for the master cylinders can be seen resting on the heat shield in the middle of the picture being fed by the special flexible hoses

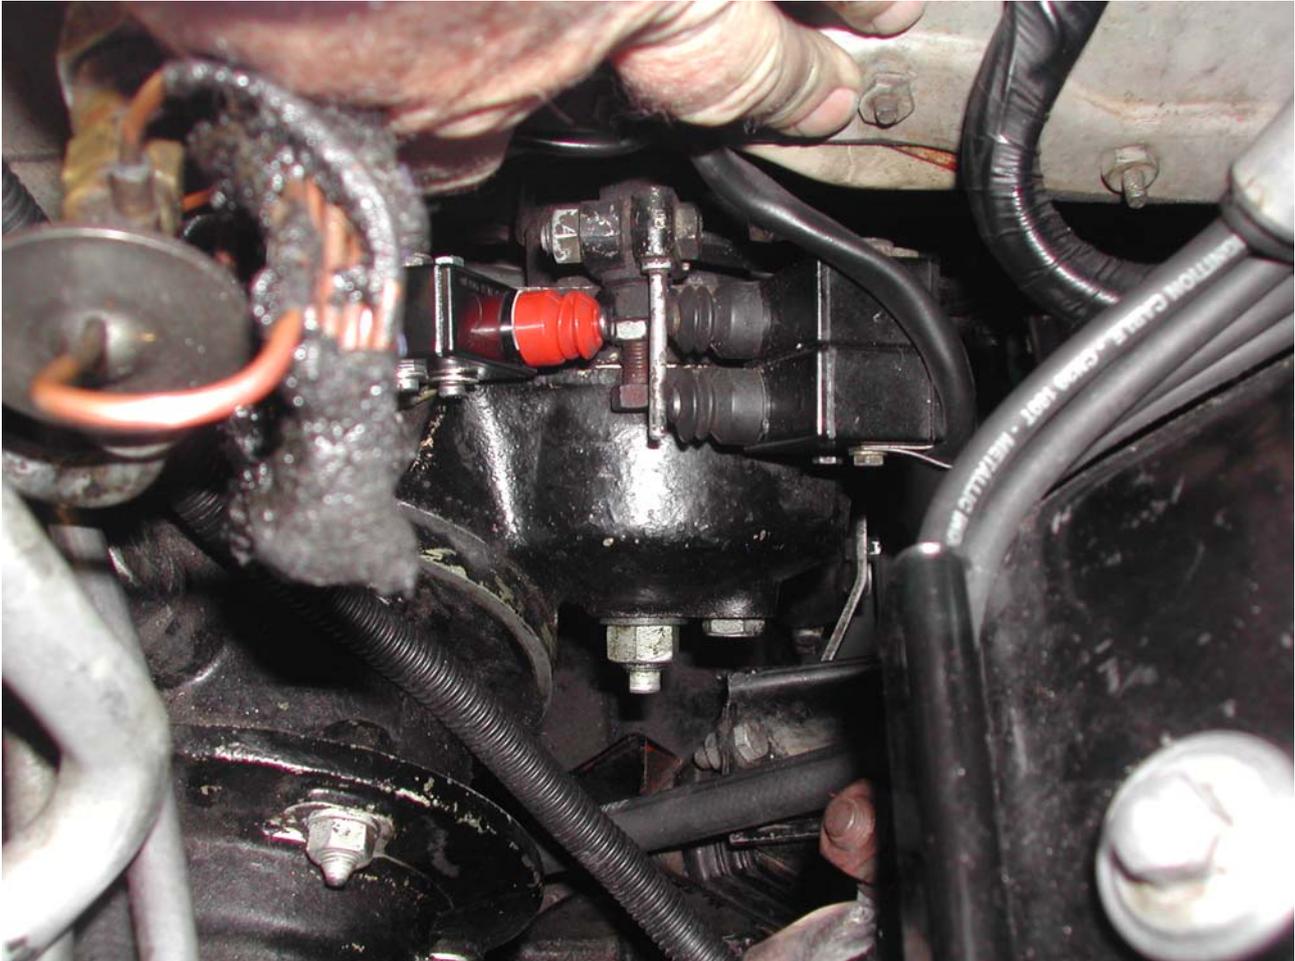
THE CASE OF THE BENT FINGER

And so they popped a nice frame complete with adjustment holes around the base of the steering column and installed some well tried Burgess plunger switches. As the Chinese say, "One picture etc" and above you have it. Beneath my gnarled finger are three switches each with a plunger protected by a concertina rubber boot – see them? Good.

Between the plungers is a metal finger pointing to the bottom of the page or the radiator depending where you are! That finger is screwed to the gear change shaft that you fiddle with when you have made up your mind whether you are going to go forwards or backwards! Now the switches on the right are normally only one, what the other one is for in this application I have no idea but it looks good. The single switch however completes the circuit between your ignition key and the starter motor. If the switch is not depressed – there is no starting and the only way to depress it is to move the gear selector to ‘N’ and the finger swings over and depresses!!!

I appreciate this is very technical but bear with me. When the driver wants to turn on the reverse lights he has to depress the switch on the left hand side and this is done by moving the selector to ‘R’ thereby swinging the lever to the left depressing the plunger on the reverse light switch.

It couldn't be simpler or more reliable eh! Ah but things wear and move. In this case the neutral start switch on this car apparently moved a little away from the finger and much lemon sucking as there was no starter noise coming from the engine department. Both switches are held to their mounting bracket by two screws each. They simply need to be loosened and the switches slid across until they close sufficiently to make a good contact. The screws are then tightened. This is what should have happened on this car but it seems the repairing chap didn't have a spanner (4BA) to undo the screws so his solution was to bend the finger to the right so that it pushed the neutral switch in further. Not neat but effective, but what about the other side.

I first noticed that the car had no reverse lights so I turned on the ignition engaged reverse and made like I knew what I was doing with a very impressive meter. It was when I touched the reverse light switch and suffered second degree burns (I am a bit of a wimp) that I realised something was wrong. There was also the smell of cooking Burgess! Bending of the finger had of course worked the neutral start switch but when the finger was swung the other way it almost pushed the reverse light plunger in to light the lamps – but not quite. And so we have arcing and a potential fire hazard. The switch needless to say was burnt out but was replaced and the finger straightened all switches adjusted and life was better!

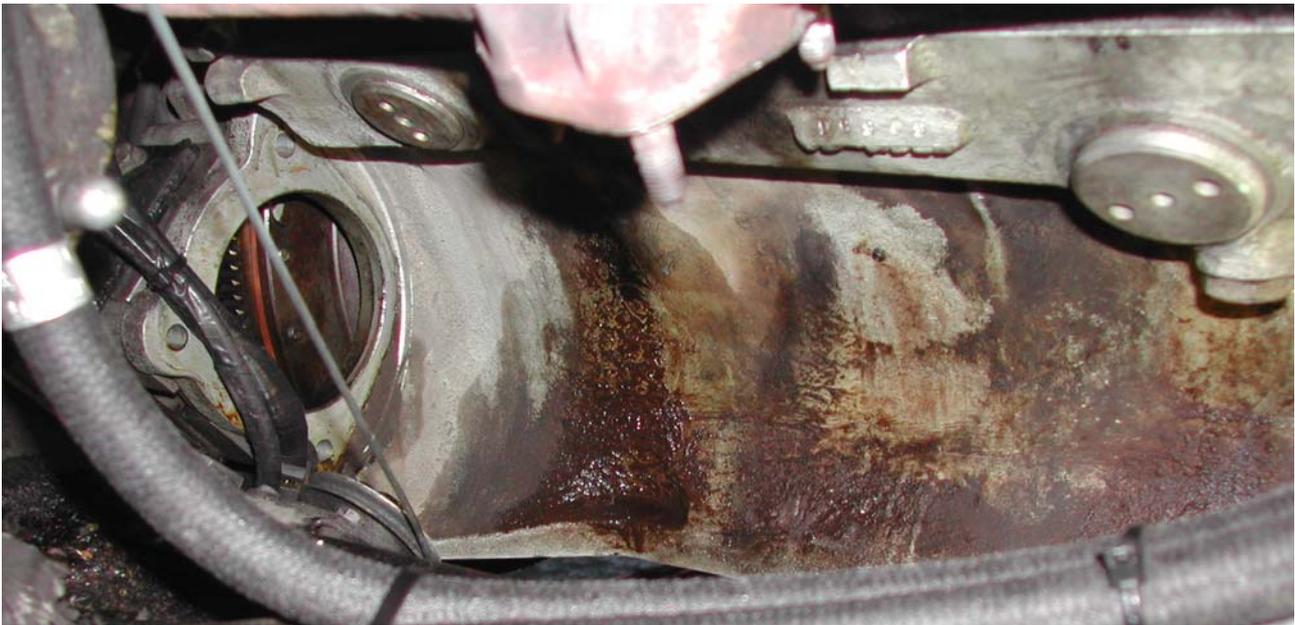
INCONTINENT CRANKCASES

We all know about those ingenious little holes the factory thoughtfully cast into the side of the vee eight engine blocks to warn us that seals were failing around the bottom of the cylinder liners but then I showered much words on the topic on page 580. Well the above is a crankcase I 'doctored' some 500 miles and three months ago. Being fundamentally lazy I balked at pulling the starter and blocking the remaining hole behind it. Conscience finally got the better of me and out came the starter. The evidence of the weep is plain to see compared with the one next to it which can be seen with its little grub screw firmly planted in it.

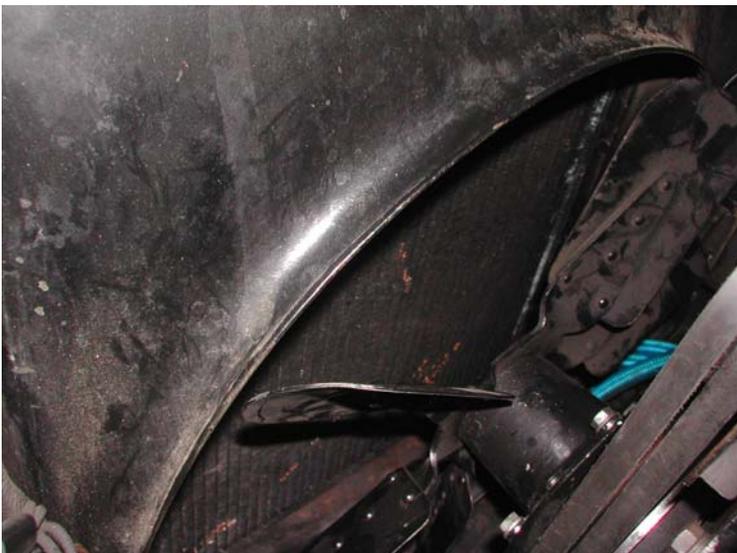
PUTTING A CLOUD ENGINE IN ITS PLACE

The recent upheaval of our local Silver Cloud III through having its sump removed resulted in a movement of the engine location to the right. The clearance seen above is of the order of 3/16"! On the other side seen below we had a good inch to play with. There is no adjustment and indeed we would not have noticed the situation had we not had to do a very abrupt left turn during the first post-operative test drive to avoid running down a herd of rhinocerii which tend to roam the streets of upper Kambah! The shriek that came from the engine room must have woken the dead and certainly caused the driver and I to wonder about our last meal.

What had happened was the fan had tried to shred the radiator cowling when the engine leant that little bit over to the right. No damage fortunately. The solution was to undo the four bolts holding the front engine mounting cradle to the chassis side rails as well as the four bolts securing the engine mounting itself to the engine and the cradle. A bit of 4 by 2 hardwood was then applied as a lever and holding the lever hard to the left all the above bolts were re-tightened. Magnificent!

There is now a 3/4" clearance all around the fan tips!! It is well to remember that with the

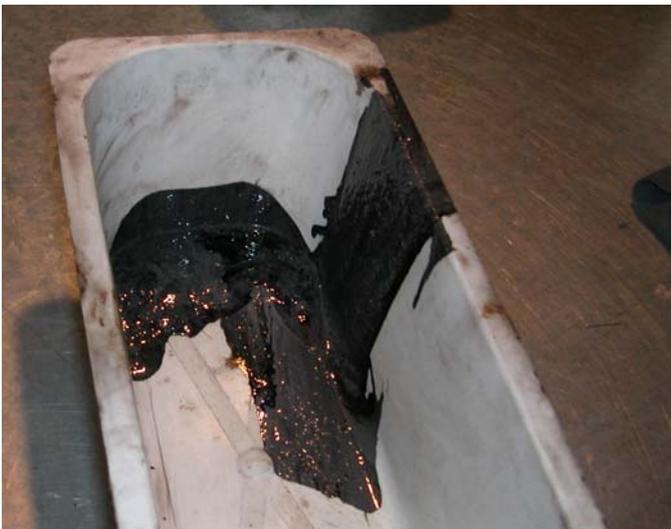
ENGINE SUMPS

Many owners wonder what lurks in that container that hangs under the engine. Well I can assure you it is not pleasant. The picture is a typical vee eight sump. The front is very shallow to encourage the oil to get to the back as quickly as possible and also to allow the steering rods and levers to do their thing without smacking the engine. The level of the front is carried to the rear by a baffle which helps to stop the oil sloshing around too much and more importantly holds the oil down while the car is going up or down very steep inclines. The alternative is to have the big ends at either end of the crankshaft

belting the puddle of oil and whipping it into a froth which is not good for lubrication and also gives the rings a harder job to scrape off excess oil.

The large hole in the baffle accommodates the oil pump pickup. You will recall that on the vee eight the oil pump is right at the front driven by the crankshaft pinion. But as you will see above the bulk of the oil is at the back of the engine, so a pickup pipe goes back to a primary mesh strainer and intake. Lastly the 'hump' to the left of the large hole, accommodates the float for the oil level sender, the hole for which can just be seen peeking below the lower edge of the unit in the picture. George Shores demonstrates this problem with a shaped coat hanger that he pokes through the drain hole and drags out whatever sludge he can rake out. A couple of mechanics observing this at a self help session, observed that it was quite harmless and a waste of time at which remark George asked whether he should pour the muck back into the engine. It was not appreciated!

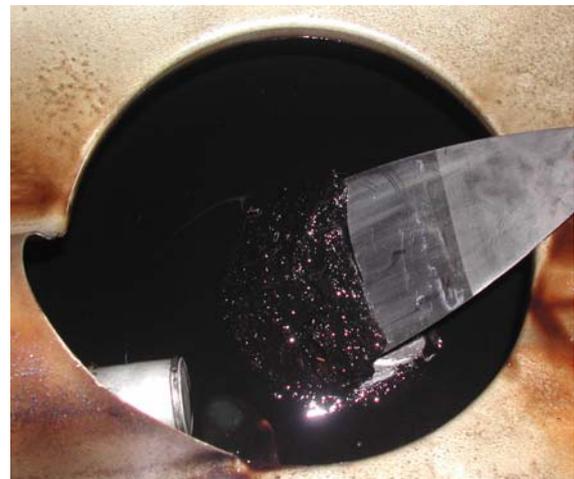
And here is the rewarding sight you have after removing the sump. The round strainer is the pickup point for the oil. From here it is sucked up the large pipe to the pump at the front of the engine. Note that the clearance between the bottom of the strainer and the bottom of the sum is only a fraction of an inch. Some gentlemen have been known to jack a car up by the engine with the jack under the back of the sump which believe it or not will dent! Conceivably, dented far enough toward the strainer which is fixed could restrict the inflow of the oil!!!

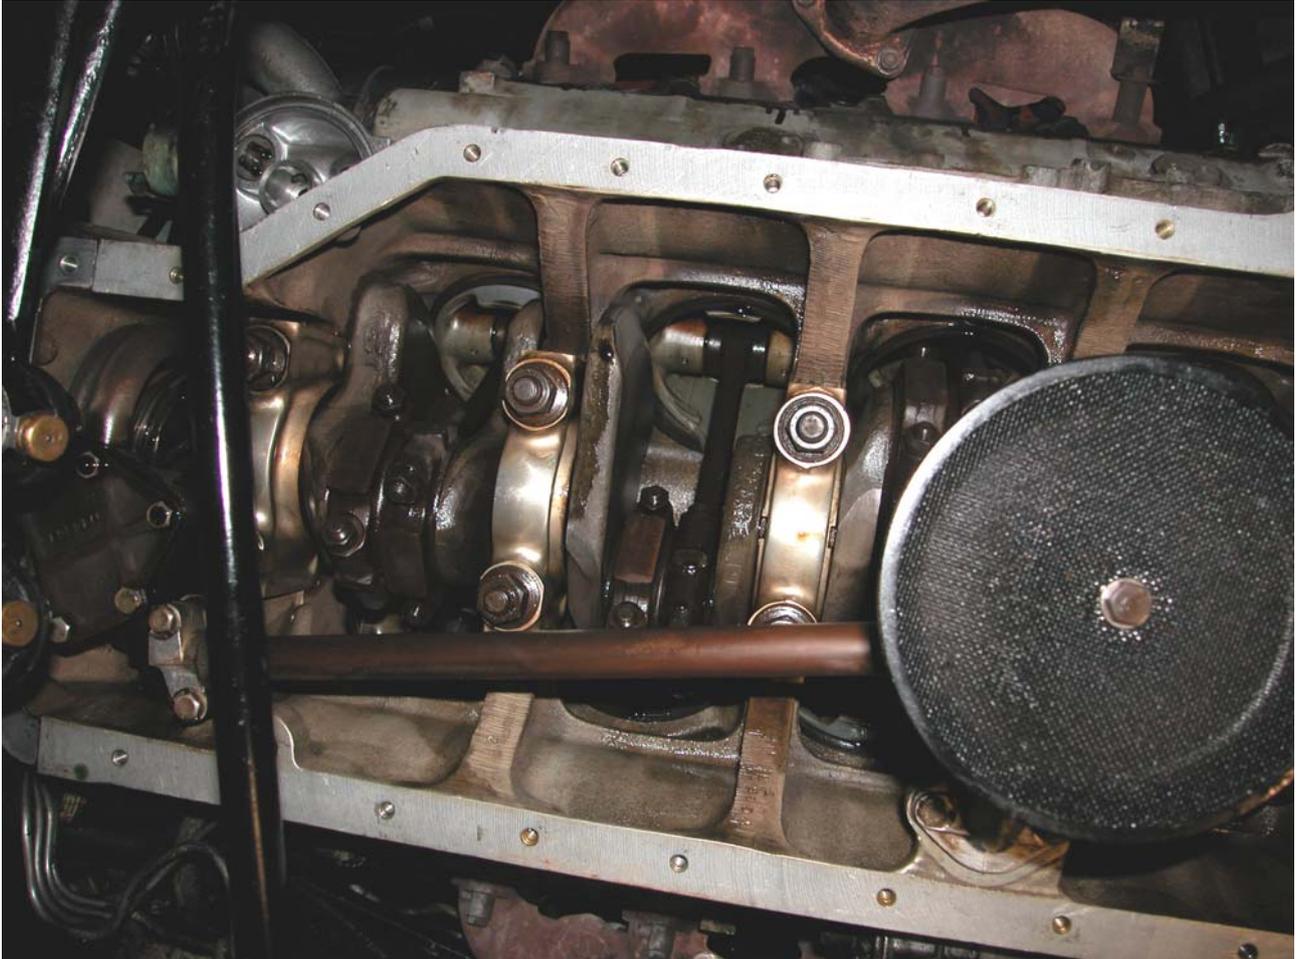
Above:- A nice clean interior suggesting little compression blow by and regular oil changes. At top left is the filter head used on all vee eights until the Shadow II. Apparently it is a simple job to change the heads over to give an earlier car the benefit of spin on filter changes and possibly better filtration.

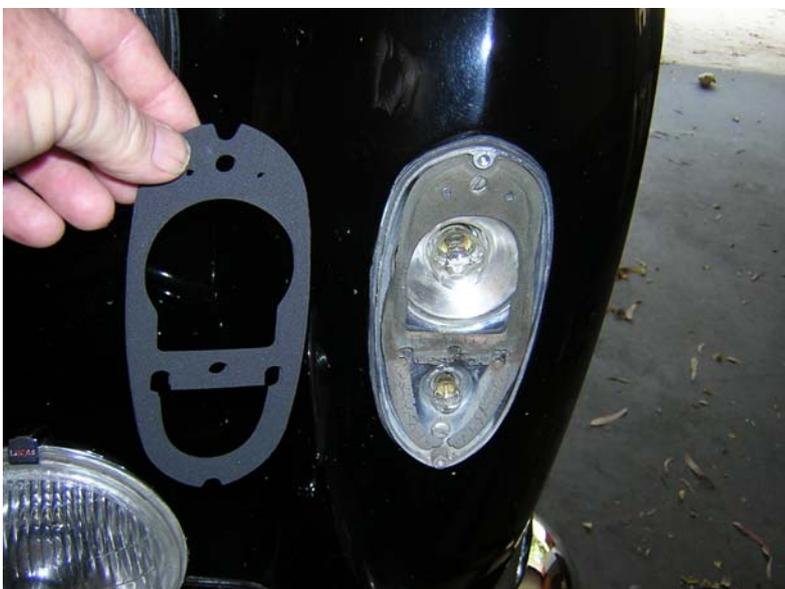
A FAIILY SIMPLE HOUSEKEEPING TASK

These parking and flashing lights were first used on Cloud III's then on every Shadow and Phantom. They are not fancy – diecast bodies and cheap reflectors with plastic lenses but they are unique and hence expensive so look after them. One obvious precaution is to ensure that the gasket is intact and not shrunken as this one was. They are readily available.

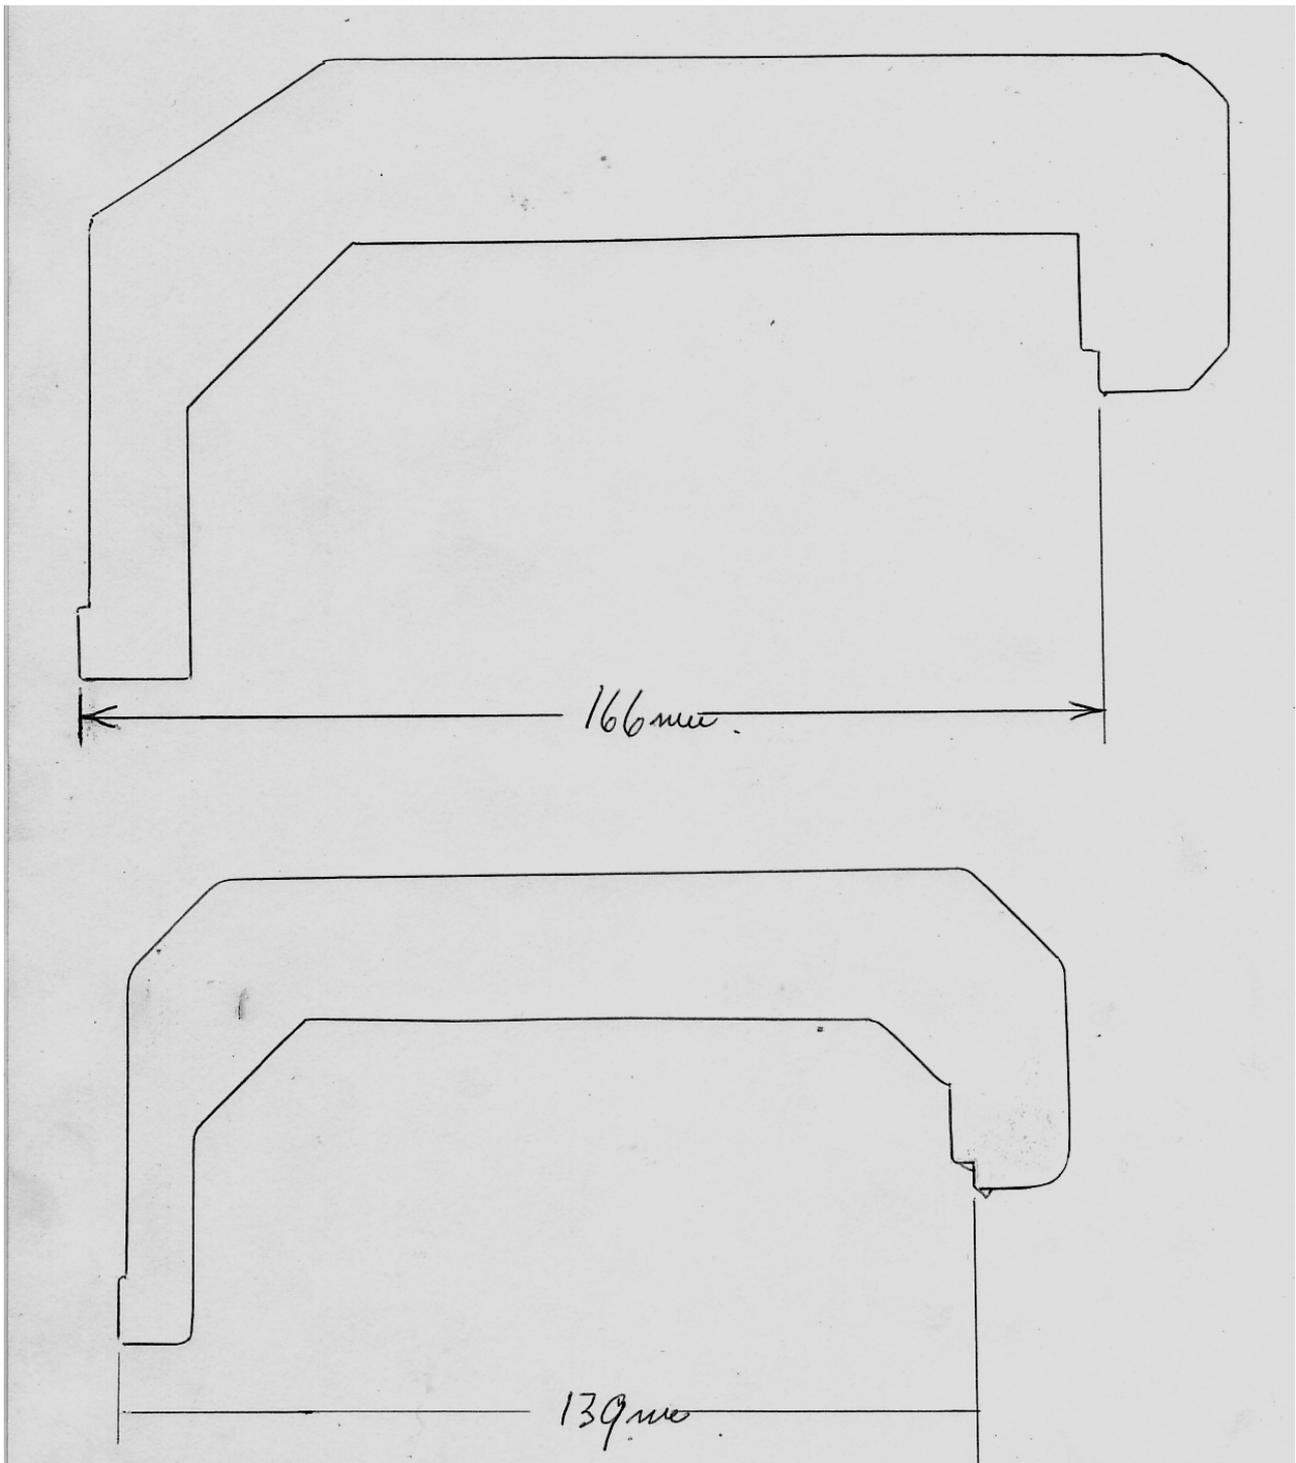
which can be readily manufactured. Of the two shown the larger one is for the Silver Shadow box and the smaller one is used for all other boxes. The critical dimensions only have been shown.
