The ramblings of an amateur enthusiast to be shared with others who own, drive, mind or repair Rolls-Royce and Bentley cars, or those who simply love them.

SAVILLE ROW SUITS AND DIRTY UNDERWEAR

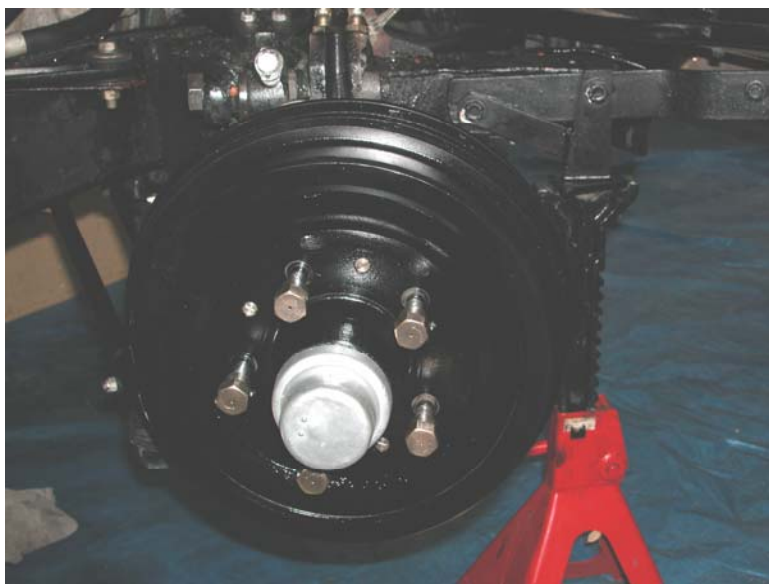
For those still into drums you will be aware that the English practice of separating the drum from the wheel hub saved disturbing the wheel bearing settings. And unlike later rotor and pad systems you have to remove the drum to inspect the linings and make sure there are no leaks and at the very least blow out the brake dust that accumulates there!

Sometimes the drum is quite tight on the hub which means screwing a couple of 1/4" UNF bolts into the holes provided with enough thread length to get the thing off. These are screwed in evenly until the drum is clear. On Pre-Cloud cars of course the thread is BSF – but you knew that didn't you!

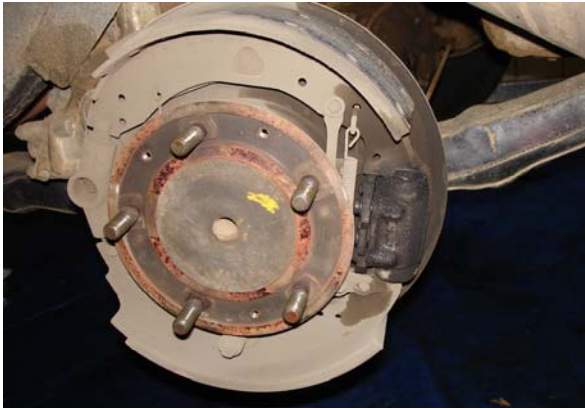
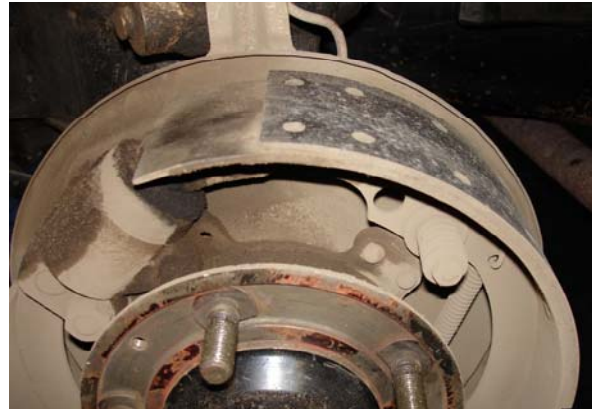
Brake fluid and brake lining dust abound. The left hand picture of a rear brake shows the working end of the adjuster. It is the other end of this thing that you twiddle to reduce the travel of the hand brake lever to avoid de-kneecapping yourself when you get in the car. These adjusters are packed with high melting point grease on assembly and it is not practical to lube them in the meantime. These ones were almost seized. Note the riveted linings an echo from the past. Nowadays all linings are glued to the shoes which takes away that quaint grooving effect when the linings wear to the rivets and the latter then gouge furrows into drums.

All cylinders were bored out and sleeved in stainless steel and the whole lot rebuilt with new seals and boots. Flexible hoses were replaced and new linings bonded to the brake shoes. These cars have a complex braking system but following the book the amateur mechanic should fare well with care in the exercise. And he should be able to drive the car anywhere regardless of its looks confident that it will stop as intended by the Factory!

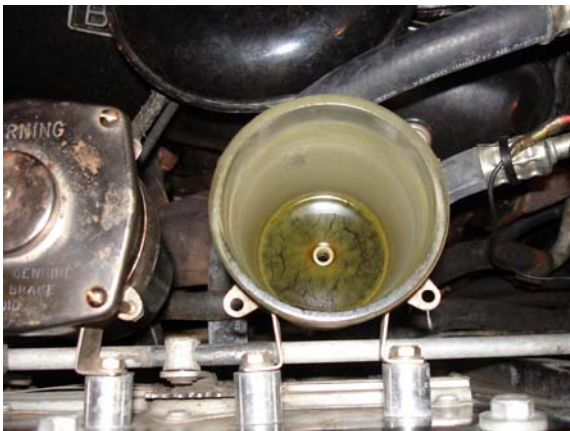
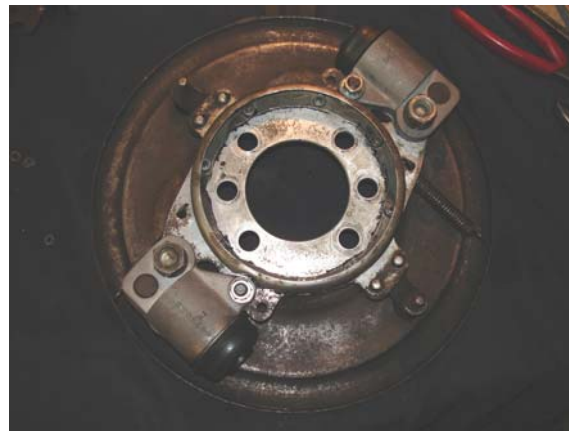
The gloomy picture at the right is the complete front brake assembly removed. This is a necessity to get the wheel cylinders off to re-sleeve. Given the neglect this car had had in this department removal stripping and cleaning was probably essential. At left is the muck in the bottom of one of the 'jam jars'. An interesting story heard from the antipodes:- apparently some bright gentleman was touring in his Cloud at 100 mph for a considerable time in an ambient temperature of over 40 degrees C. It was apparently too much for one of the jars which cracked with the heat and dropped its contents all over the red hot exhaust manifold starting a terminal fire!!

The tops of the reservoirs were removed, the brake fluid sucked out and lo, there in the bottom was a nice little pool of rusty water. The master cylinders were the final straw. They each had about half a teaspoon of silt in them so much so that the lower or smaller of the two master cylinders was jamming and the piston could not return far enough in the cylinder to replenish its fluid holdings. In short the car had about 55% of its normal braking power.

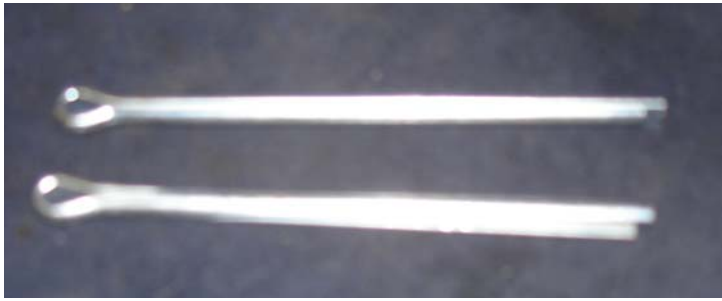
But one area in all conventional Rolls-Royce hubbed cars does demand split pinner of the highest order and that is the item used to hold the large nut securing the front wheel bearings to the stub axle. All post-war cars have a spring loaded contact riveted to the inside of the front wheel bearing hub cover. The contact rides on the centre of the stub axle. The last thing it needs are the stout legs of a 5 mm diameter split pin to be rotating about its contacts. The solution is the 'twisted' pin. And I note that there appears to be some query as to whether this is an approved method.

The above drawing from our Mark VI manual should settle that argument. Item '3' is the split pin duly wrapped around the nut! Note the sprung contact '2' which would be quickly wiped out if the pin was fitted the 'right' way as illustrated above.

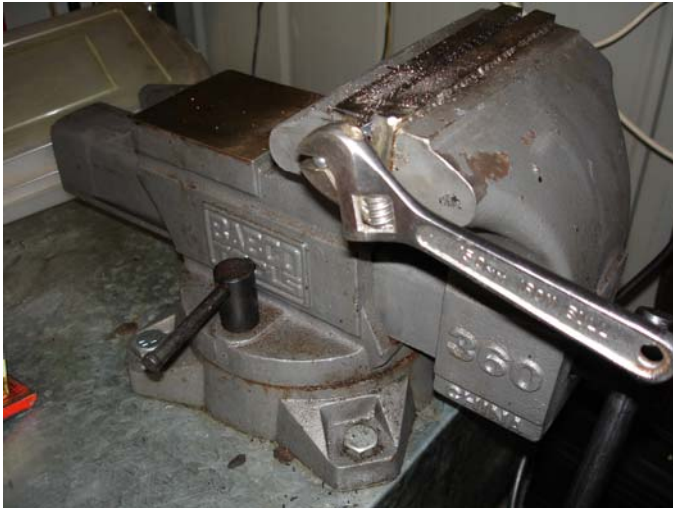
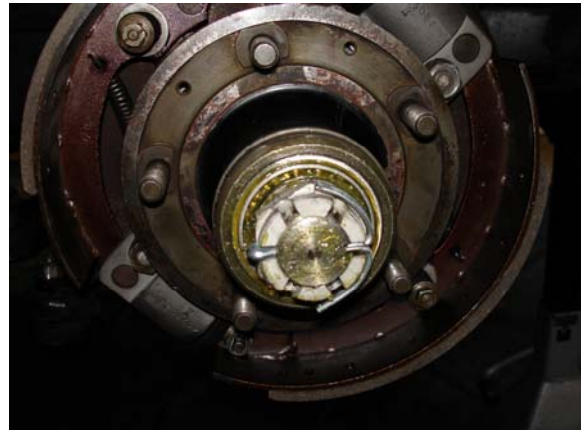
These are the pins for the front hubs. They are available from most machine shops and specialty fastener shops. They are tough little mothers (5mm diameter) so be prepared for a struggle in bending them.

Below is the method I use. Clamp the pin tightly with the 'slot' vertical in

the vice and at about half way down the shank. Avoid trying to twist near the head as it will probably shear off. Turn the head through 90° and fit the pin as seen in the right hand picture. If you want to be really neat clip the tails so that the ends can be tucked into a castellation. You never know it might win you a point. Actually I have wasted a good deal of carefully selected expletives on split pin installers and their Mothers! Small items I usually give up trying to remove and simply undo the nut and shear them off, poking the bit in the middle out later. But large pins you can't do this and if Jeremy Posthewaite the renowned restorer of fine cars has spent an hour fitting a split pin it will usually take two hours to get it out. Henry Royce and his little helpers seemed quite unaware of the value most people attach to time!

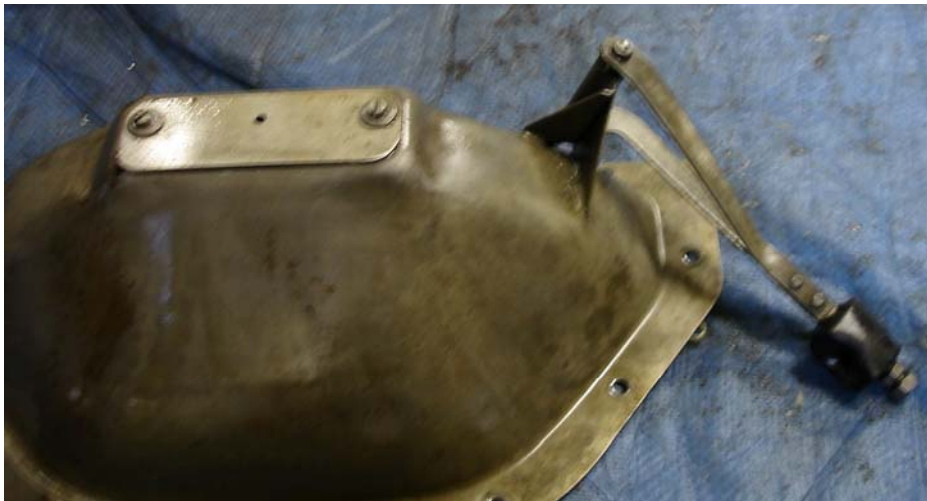
At left is the most simple component. It is the cover for the flywheel. The bracket swiveling off of it supports the whole mechanism.

the body was mounted on rubber as was the engine, the steering column and as far as possible the control mechanisms for the transmission. Hence the bolt seen through the pivot on the cover above had two small top hat rubber grommets fitted as insulators. Invariably these are missing, immediately giving rise to transmitted noise and looseness in the gear change mechanism. They are still available.

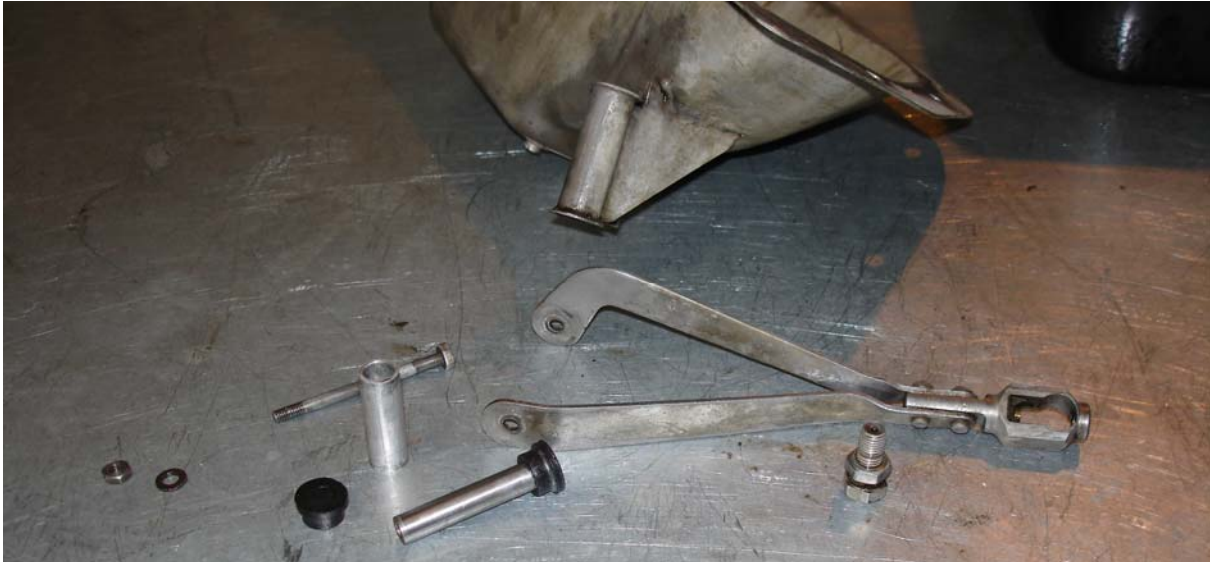
Above is one of the linkages with its adjusting nut. What is not shown is the ball joint that the end of the linkage grips. Look closely and note the hardened button at the bottom of the joint. The base of the bolt is similarly shaped, both are designed to accommodate the ball joint. The adjustment needs to remove all internal movement and with the slightest nip. The whole assembly is packed with high melting point grease and covered with a rubber boot. If the latter is damaged in any way replace it

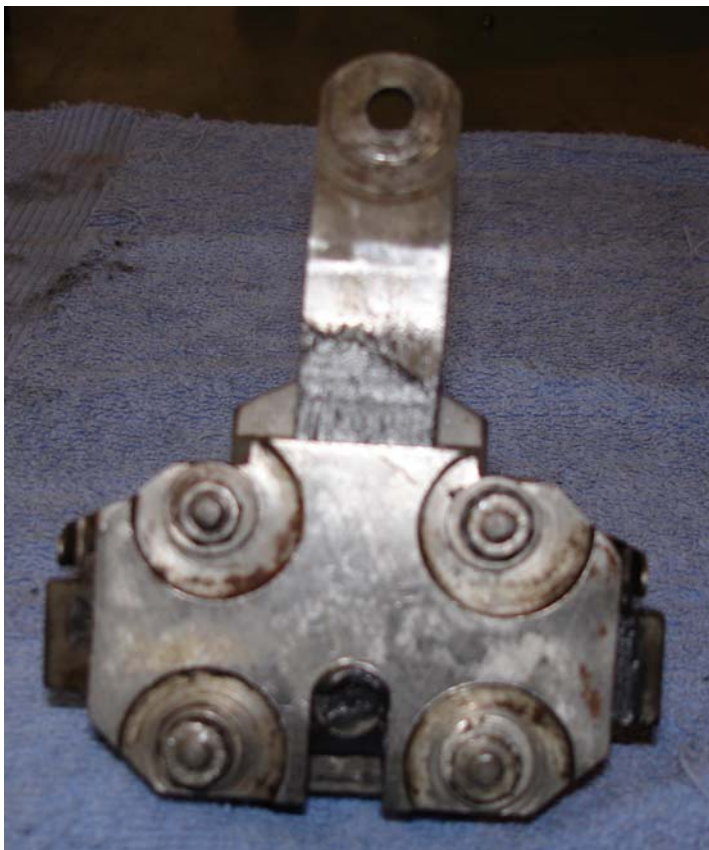
Fig. G28 Expander unit — exploded view

And here it is exploded! It is a combined mechanical and hydraulic expander used on the rear wheels of the Cloud series of cars. Some owners may not realise that most of the braking needed on any car is on the front wheels since most of the weight is there. But there is still some effort required at the back wheels which is why the braking bits there are much smaller. But this installed system goes one step further and uses the mechanism for the handbrake immediately before the hydraulics start doing their thing.

Item 12 is a very strong bit of metal with the end that you can't see, because it is under item 6, is connected to the brake rods from the mechanical servo on the side of the gearbox and at the

Pulling this same bit of metal forces the plungers (9) outwards applying the brakes. At the same time the hydraulic plungers (5) are also pushing on the toe of the brake shoe.

This is all very well when it is put together with some high melting point grease. The four nuts you see in this picture sit on spacers which keeps the whole assembly reasonably loose and avoiding early gumming up. Overall it is a bit primitive but effective. If there is no evidence of leaking in the hydraulics, consider a couple of cans of brake cleaner available at your local friendly car bit place, put a tray under the hub and get stuck about the whole assembly with the good fluid. This will also clean the brake dust out. Using a small screw driver when the assembly is dry you can replace the lubricant by poking a bit into the faces between the handbrake plunger and the cams. While you are there check the

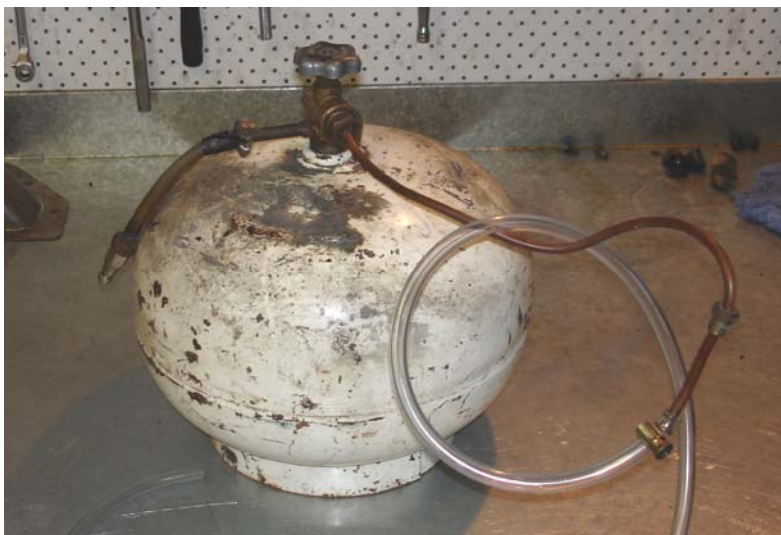
The background to these words is the filter cloth I used in flushing out the lines of a Cloud that had quite a bit of water in the lines. I initially blew them out with compressed air then rigged up a pressure vessel I normally use to check engine lubrication in a newly built engine. I filled the tank with about 10 litres of acetone and put it through using compressed air at about 60 psi. This was followed with a similar amount of methylated spirits and then blow dried. Hopefully this removed all the loose rust and future annual brake fluid changes will prevent further corrosion.

Crude but effective. An old barbecue cylinder adapted to the task. The air line is to the left and the out line controlled by the valve is to the right front. This can be filled with engine oil hooked up to the engine oil gallery with a suitable adapter, the air pressure regulator can be set to the pressure the oil normally runs at and the valve is opened. Turning the crankshaft slowly will give a very clear indication of which bearing is getting oil and how much. A flood coming out of a bearing (usually a

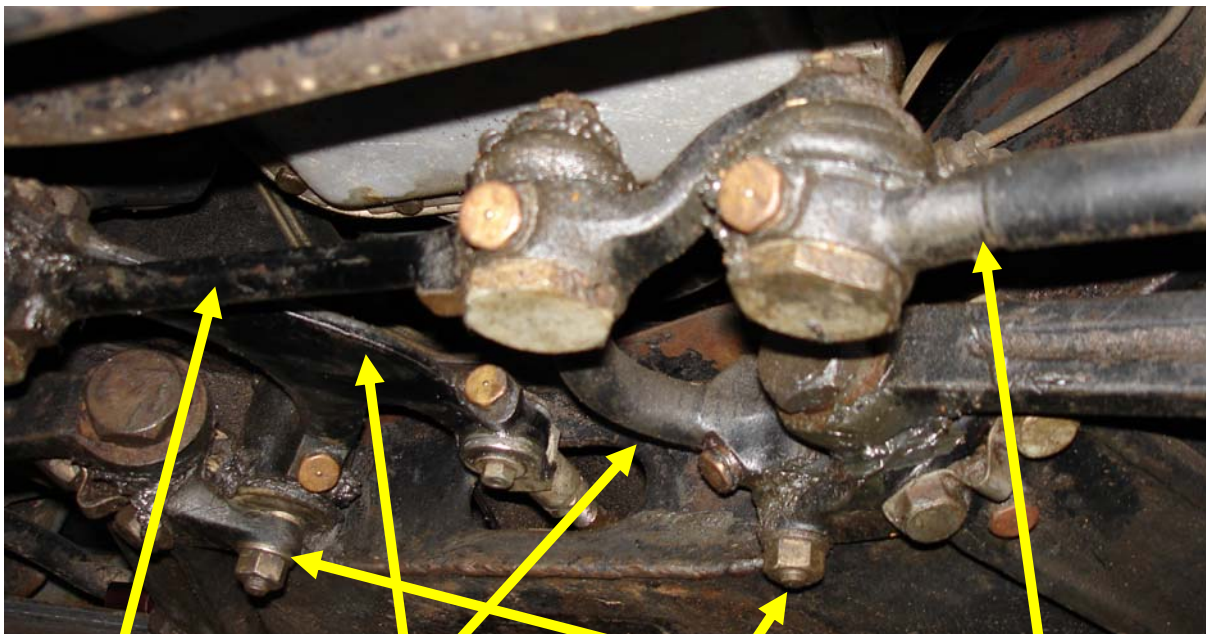
Yoke

Relay levers

Pivot pins

Right hand tie rod

I apologise for the graphics but let's face it they are not my forte! The two relay levers on the Cloud are quite different in shape but perform the same function. This is because the power steering ram, that strange protuberance that pokes out from the middle of the front cross member, actually pushes on the left hand relay lever. The linkage can be seen in the picture coming through the member. Given the extra load on the left hand lever by virtue of the power steering task, the pivot that it swings on is that much stronger. This rarely wears provided it is kept well lubricated.

By contrast the right hand lever is much lighter, runs on relatively small bronze bushes and is prone to wear.. The repair is simple. Remove the pivot pin by removing the nut and washer and tapping the 'bolt' upwards with a long drift. The 'bolt' or pivot pin will fall to the ground when it clears the top mount and the entire pivot lever can be pulled free from the cross member. Note the washers that pack the lever top and bottom as it is important that they be replaced as they were on reassembly.

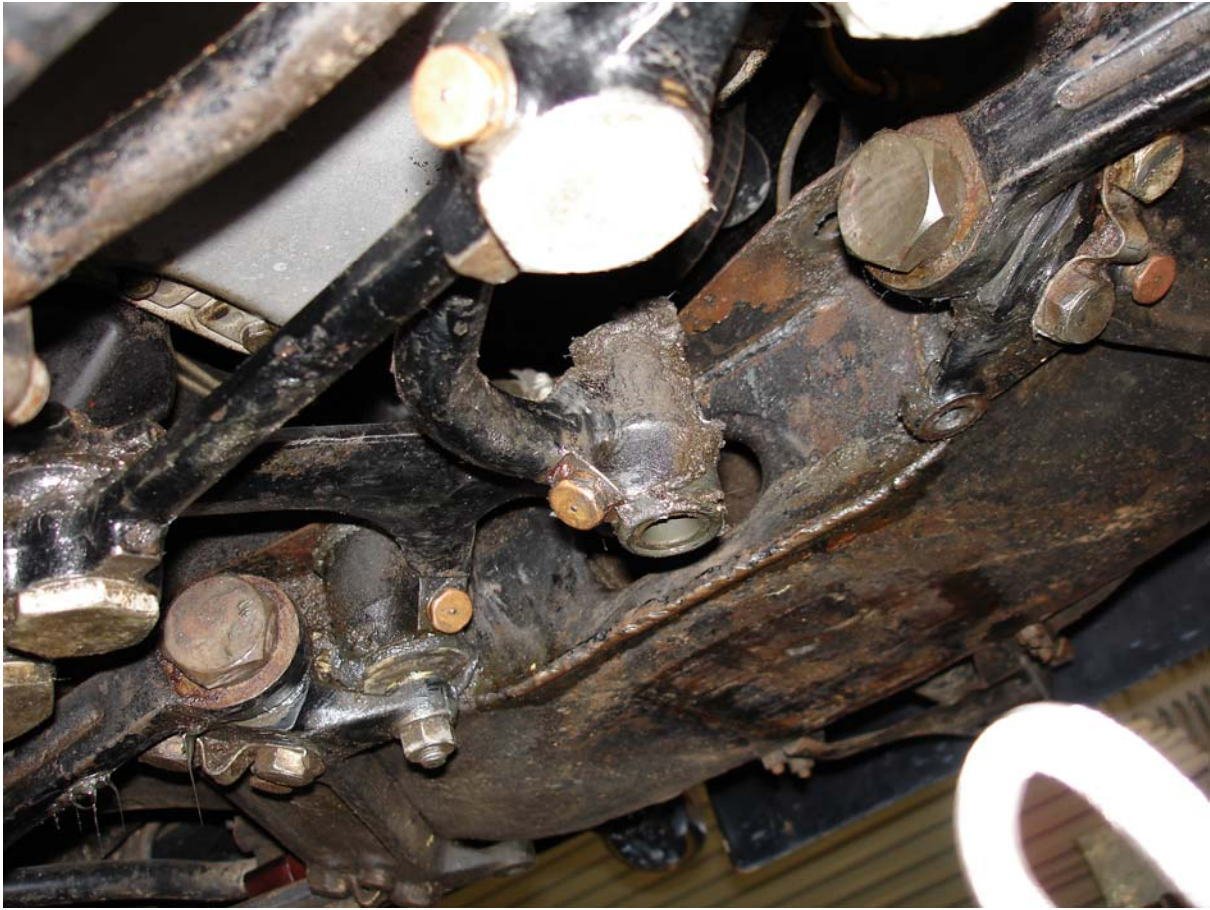
And here is the lever clear of the front axle. To disconnect it from the yoke usually requires a scissors type tie rod end splitter. There is sufficient room to work and once off, take all the bits to your friendly fitter and have him rebush the lever. The overall height of the bushes is important as the packing washers that were at the top and bottom were selected to give a tight fit. When fitting the lever it helps to cheat a little and lever the top flange on the cross member up a little to help line everything up. The bolt can then be dropped down from the top and tightening up the nut will provide the necessary nip.

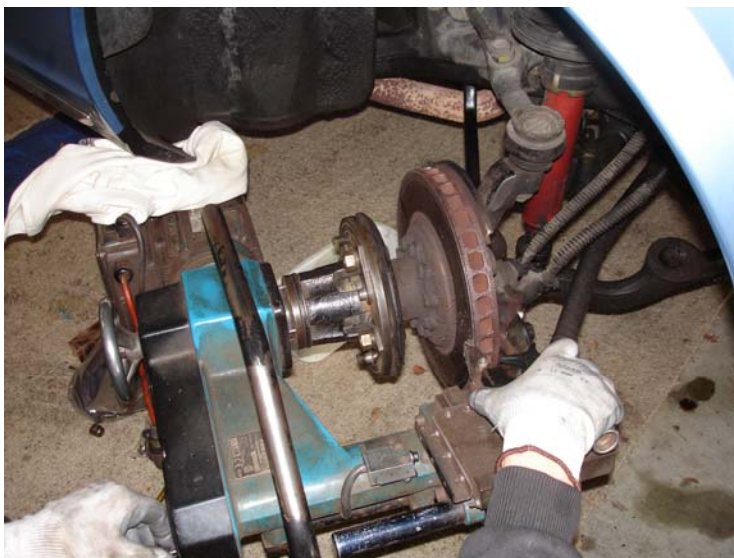
A called up my friendly local machinist who arrived with his equipment seen here mounted on one of the hubs of the Spur. I was required to remove at least one of

the calipers but I removed both. The grinding took 20 minutes and all was done. Apparently this is preferable to off car grinding as it guarantees concentricity with the front stub axle. Lastly keep an eye on the minimum thickness of the rotors which is stamped on the periphery of the rotor.
