# TEE-ONE TOPICS

Number 67

September 2007

## WORKING ON THE SU HIF7 CARBURETTORS

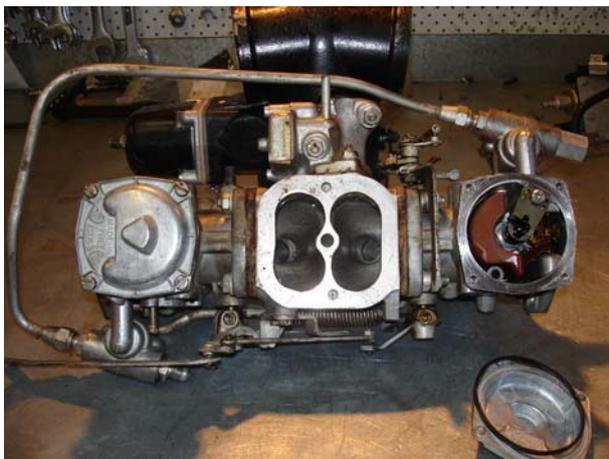
The whole induction assembly off and inverted and the air horns removed – not really necessary but allowed a bit of painting and cleaning. The filter units can be seen stuck on the side of the carburetors and joined by the recirculatory fuel pipe.

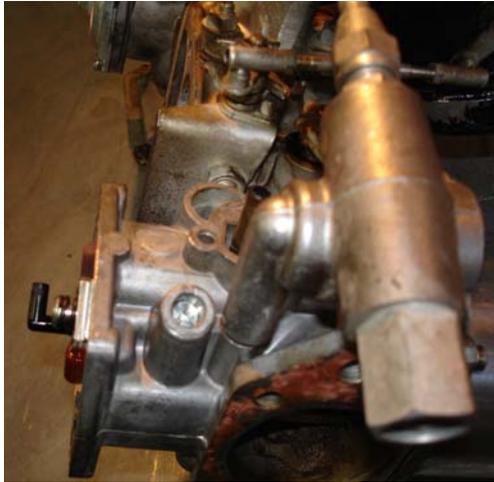
A side view. The little black proboscis at left actually draws up the fuel from the bottom of the fuel bowl. The mixture adjusting screw can be seen to the left of the filter holder mount.

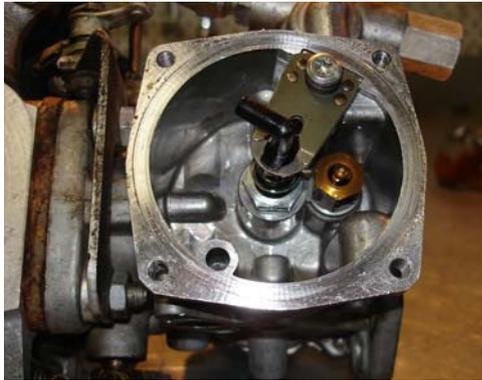
The 'internal float chamber' opened and the float itself removed. At right can be seen the needle valve. Spirits it should be noted use a large valve and not the usual small one. The change occurred very early in the series.

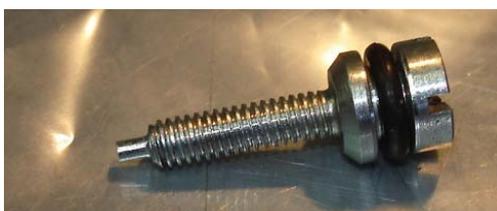
The mixture adjusting screw complete with 'O' ring. These carburettors have cunningly concealed mixture screws. They are nicely recessed and actually screw into the body of the fuel in the float chamber.

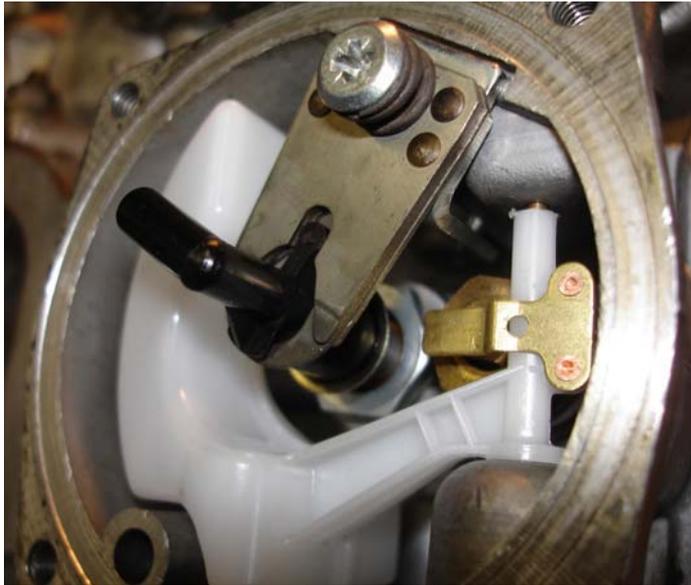
You guessed it, the second leak point. The 'O' ring goes hard and the first turn of the screw breaks any remaining seal and we have the leak.

New needle valve and seat screwed in and new float fitted. The latter are acetate and can leak.

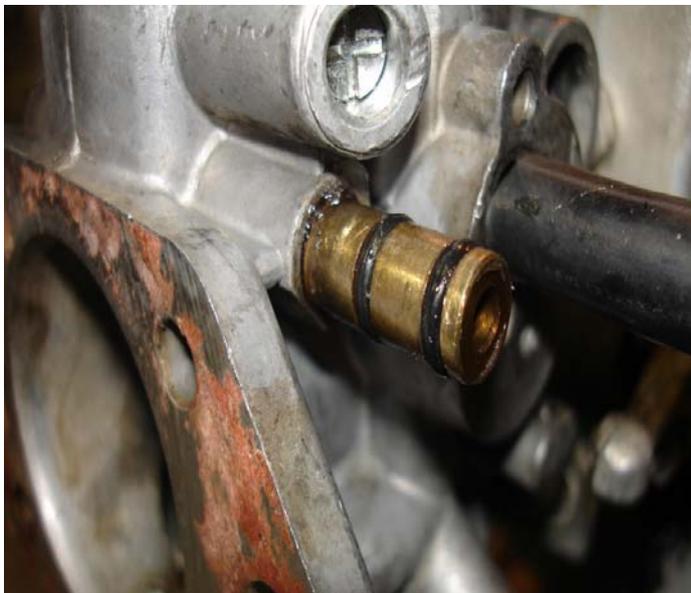
To get fuel into these carburettors there is a simple pipe poked into the body of the float chamber. The pipe is brass and has two circumferential grooves into which yet more 'O' rings are placed.

A separate device containing a paper filter and adapters to handle in and out pipes is pushed onto the brass pipe. The 'O' rings do the sealing. The location of this filter holder can be moved towards or away from the carburettors for some distance which allows brackets to be fastened to it to hold it in place. Again the 'O' rings get hard. Pulling the filter holder off and replacing it does nothing for the sealing properties and there you have the third leak point.

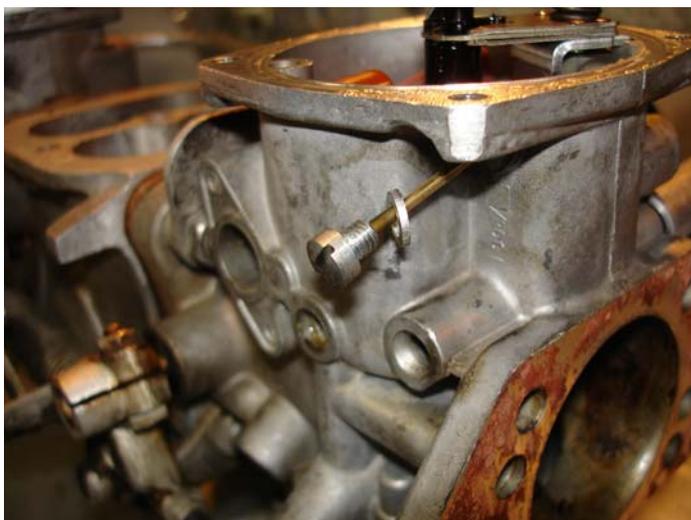
This sagging screw is the axle on which the float pivots. Most importantly the little 'washer' on the screw must be replaced. It is made of soft metal and seals the joint between the screw head and the body of the carburettor.

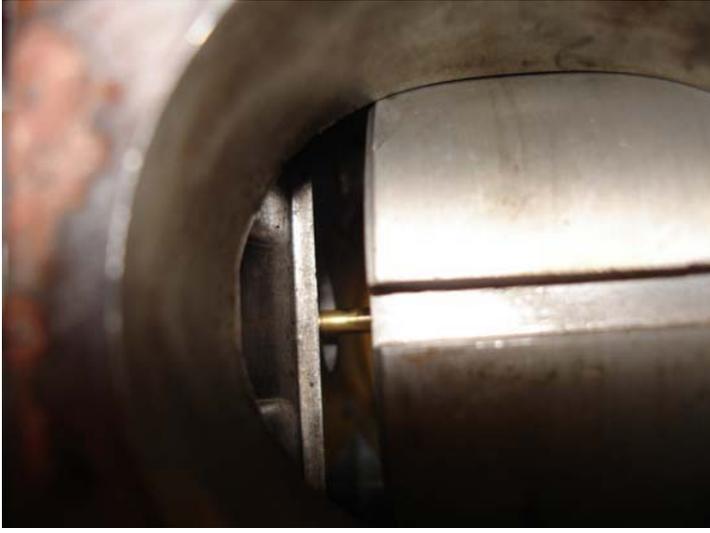
There is actually a misprint in the workshop manual. For the initial adjustment of the main jet screw the adjusting screw in until the end of the jet seen here just levels with the base of the carburettor. Then give the screw two more turns out lowering the jet. This will give you enough mixture to get the engine started.

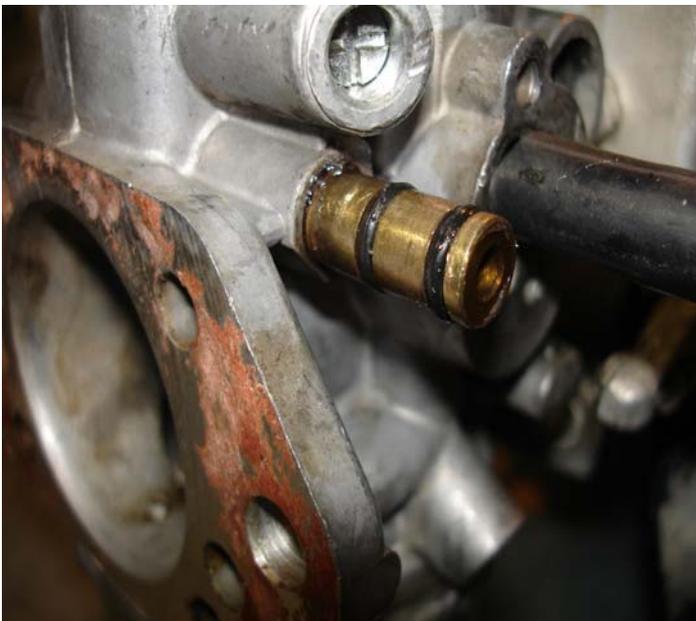
The brass transfer pipe with two new 'O' rings and a little Vaseline. The filter holder to be slid over it. This fitting is not particularly robust and should be treated with care. It is not a spare. If you break it off, extract the remains with an Ezyout and take them to your friendly fitter for a remanufacture. Note the mixture adjusting screw above it.

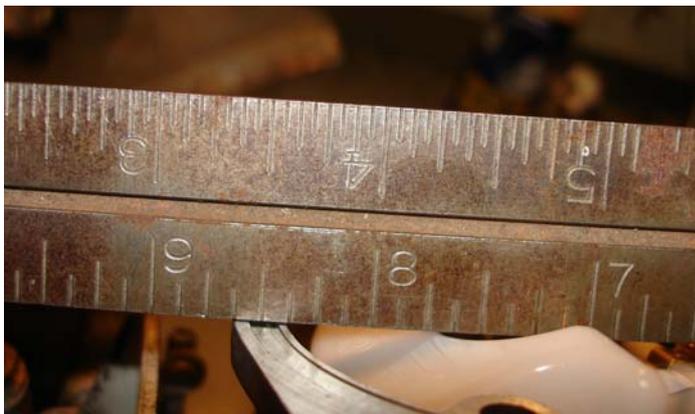
If you replace the floats the levels will have to be adjusted. The object is to have the lowest part of the float, seen here, just below the level of the rim of the float chamber.

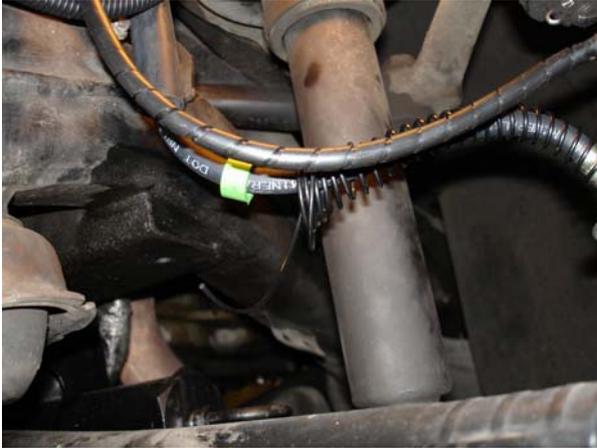
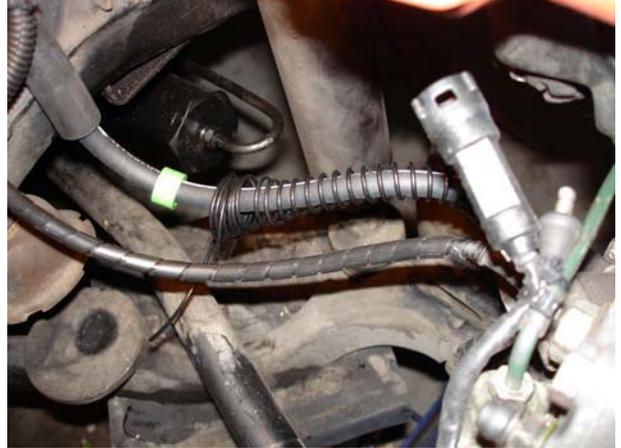
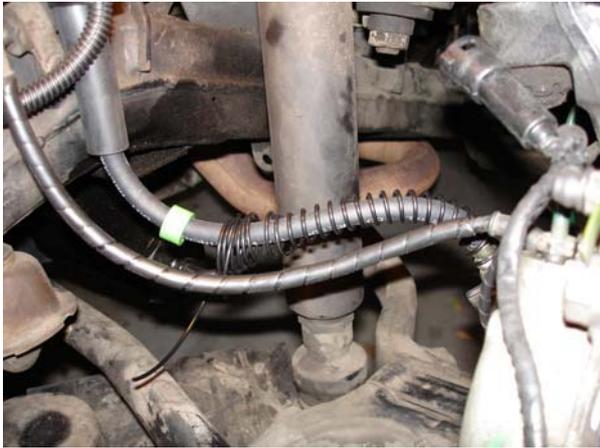
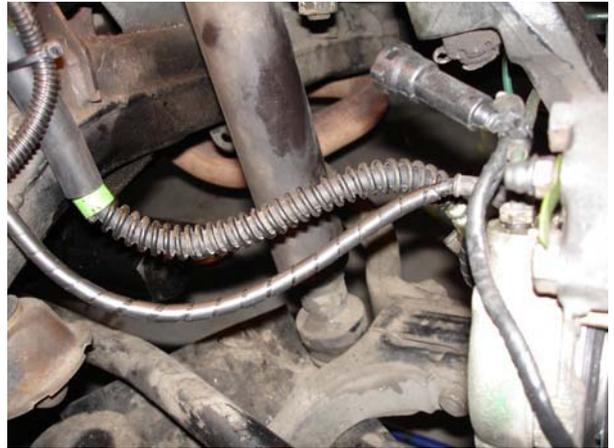
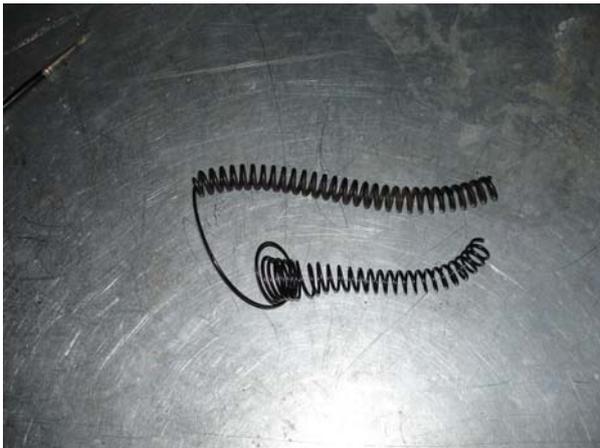
I have asked in many quarters for answers to the above problem. The old Factory for hopefully worthwhile reasons decided to provide some protection to the front hoses in the form of a plastic spring wound around the body of the hose and capped by a green ferrule. I have fitted many of these hoses but early last year the springs which had notably lightened up in material, started unwinding and eventually falling off. They of course do not come as a spare and my only recourse to

date has been to remove the old springs where they are of the heavier construction and wind them on the new hoses. Surely someone has had this problem apart from me. The left lower photo shows the two grades of spring and right lower photo the original spring fitted and remaining in place!

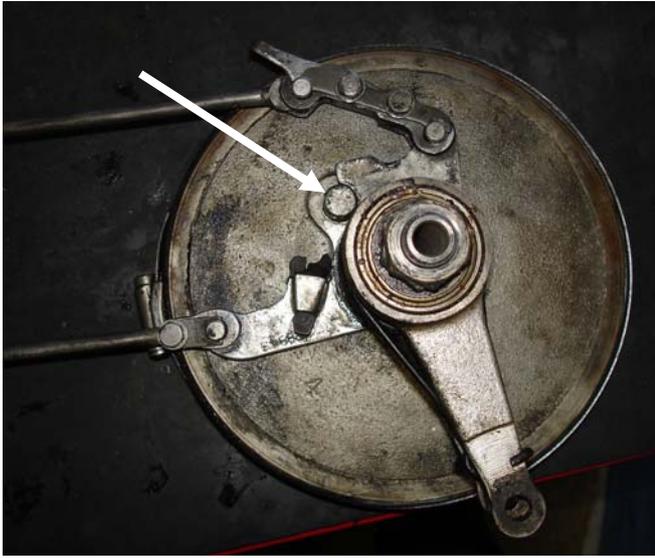
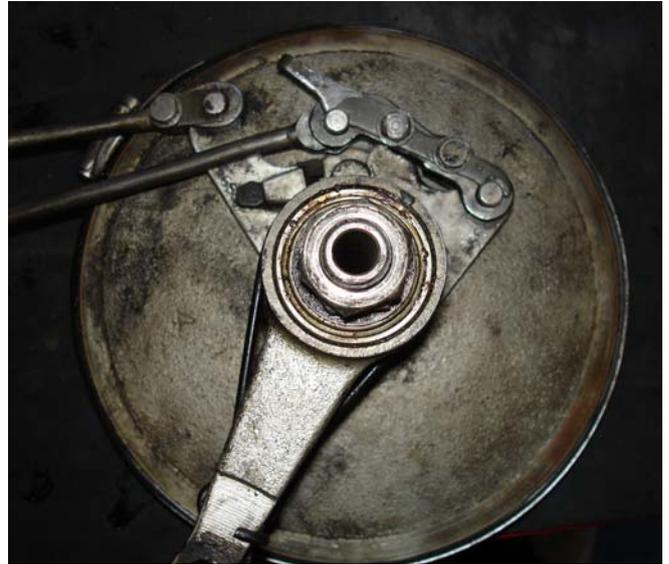
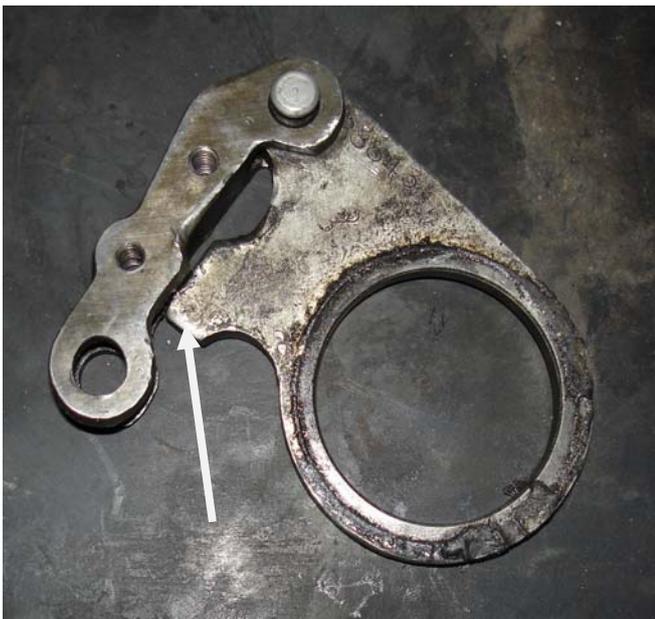
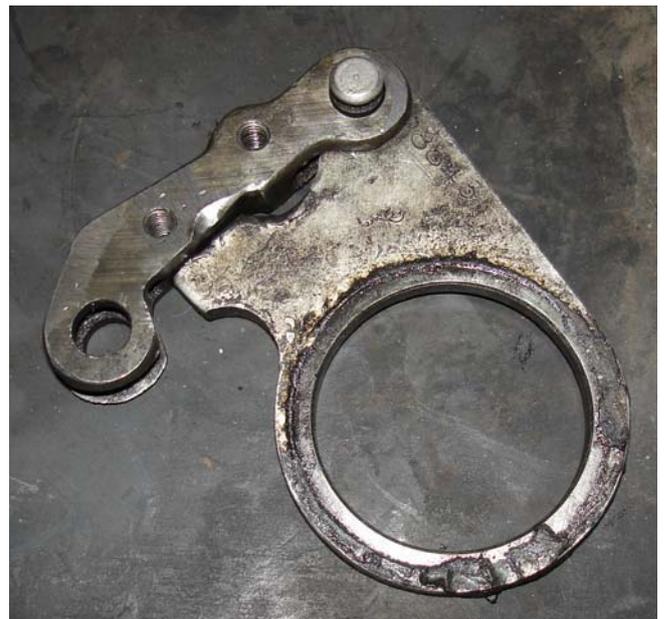
Well the oldies among you will recognise that extraordinary contraption that pulled the brakes on in the post55 cars. The disc that you see is the main working bit, co-axially mounted with the friction surface drive plate behind it. The two levers depending from the central shaft (you can only see the outer one here) are the ones that force the main plate you can see against the driving plate. The most important bit is the substantial peg seen top left. Here the servo is in full forward braking mode pulling the rods snaking off to the left that are connected to the trapeze that applies the master cylinders.

The picture at upper right shows the servo in extremis. This usually occurs when one or more master cylinders fail allowing the whole assembly to wind to the limit of travel of the master

cylinder pistons. By this time the rear mechanical brakes should be working hard to stop the car – as designed. The peculiar articulated linkage between the rod and the cam lever allows this rotation to occur without bending the brake rod. The linkage however can be fitted the wrong way around as can be seen in the left lower picture. Note the small area of contact between the toe of the cam and linkage (arrowed).

The right hand lower picture shows the correct installation of the linkage. The ‘tear’ mark on the linkage was caused by the linkage when incorrectly fitted, sliding off the cam when under full pressure!

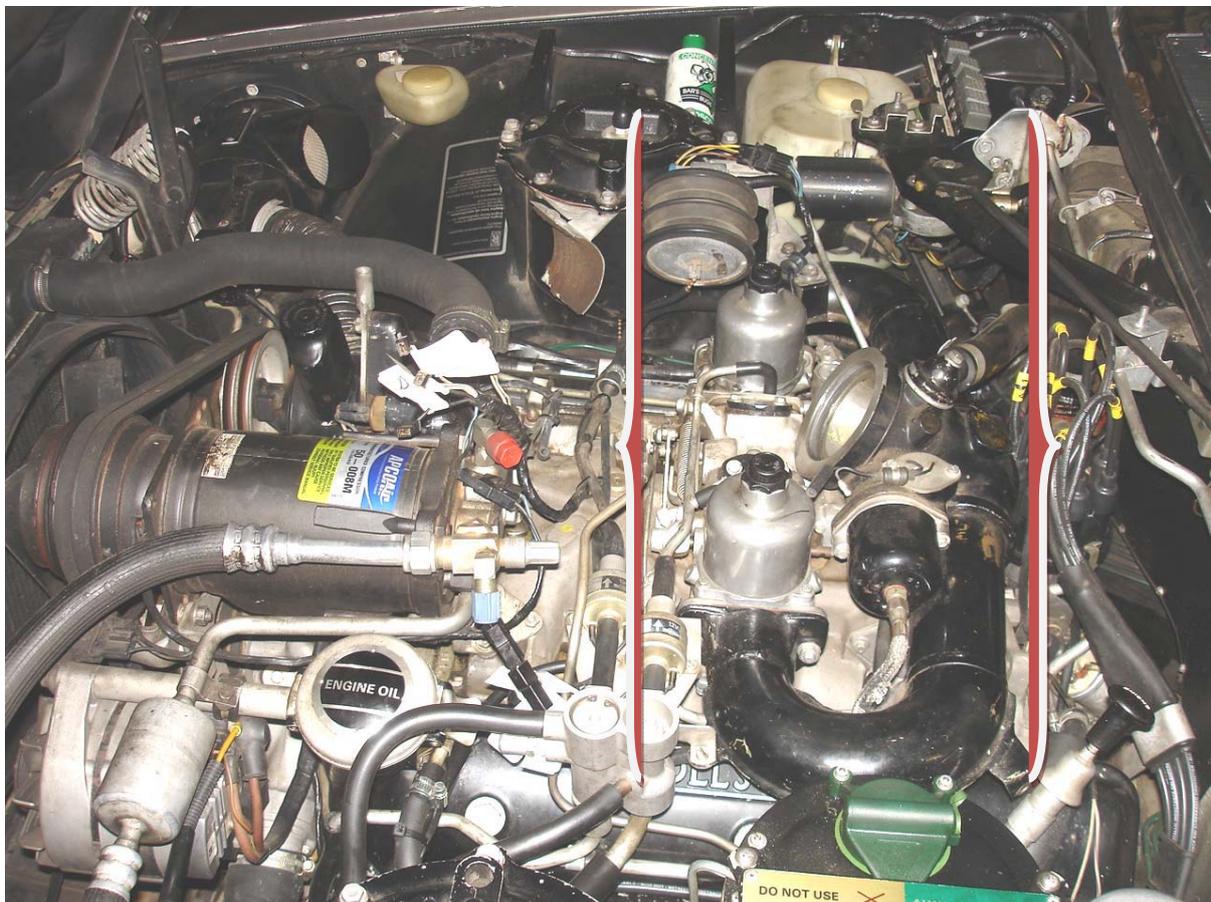
It's all a bit unnerving when first contemplating an invasion of the top of one our vee eights. As I said earlier the great feature of this induction assembly is that it is held on the engine by one bolt, right through the centre of the 'T' piece! The most likely need you will find to move the assembly will be to service the rear hydraulic pump. Undoing the magic centre bolt and lifting the assembly to clear the locating dowels under it will often allow the whole thing to be moved forward enough to get at the pump. This assumes of course that you have a serrated tube spanner to unscrew the pump. If you don't you are up for removing the whole assembly as well as the intake manifold which allows you to use a 'C' spanner on the pump.

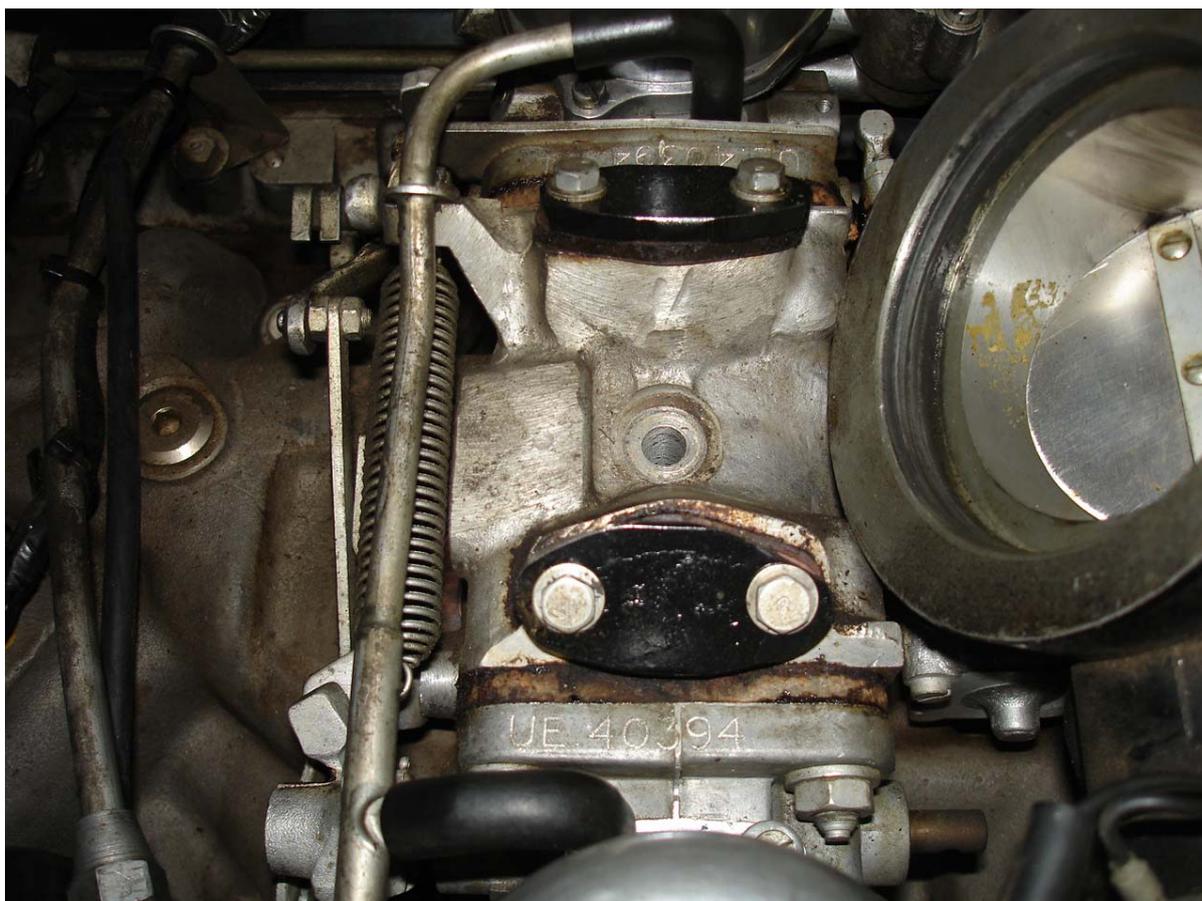
And here above the centre bolt has been removed. The metal line with black rubber tubes in the centre of the picture are vacuum take off lines for the anti-dieseling system on later engines. These pipes connect to the engine side of the throttle butterflies where the vacuum is the greatest when the engine is running. When the engine is switched off the anti-dieseling solenoid opens and connects this source of vacuum to the float chambers sucking the fuel back and stopping the engine.

The thick pipe to the left is the return pipe for the recirculating fuel system and is one of the disconnects if you are removing the whole assembly. Note the heavy insulating 'heat blocks' between the carburettors and the central 'T' piece. There is another one between the whole assembly and the intake manifold. These were not used until the Shadow II. Their function is simply to minimise the heat transfer from the engine block to the carburettors.

The Phantom VI along with its Shadow equivalent had nothing more than a thin paper gasket under the 'T' piece. Given the expectable long idling periods and slow running on hot days and two air conditioning systems pumping away the fuel in the carburettors was virtually boiling. When the engine was switched off, the carburettors got even hotter being deprived of their cooling air and the boiling fuel was blown out of the overflow which exits at the rear of the early engines, onto the ground. This explained a very long standing complaint about the smell of petrol from ceremonial cars!

The obvious modification can also be fitted to early Shadows as well as the Phantom. The latter heat block can be purchased, a longer centre bolt obtained from your local friendly bolt shop and longer dowels fitted in the intake manifold.

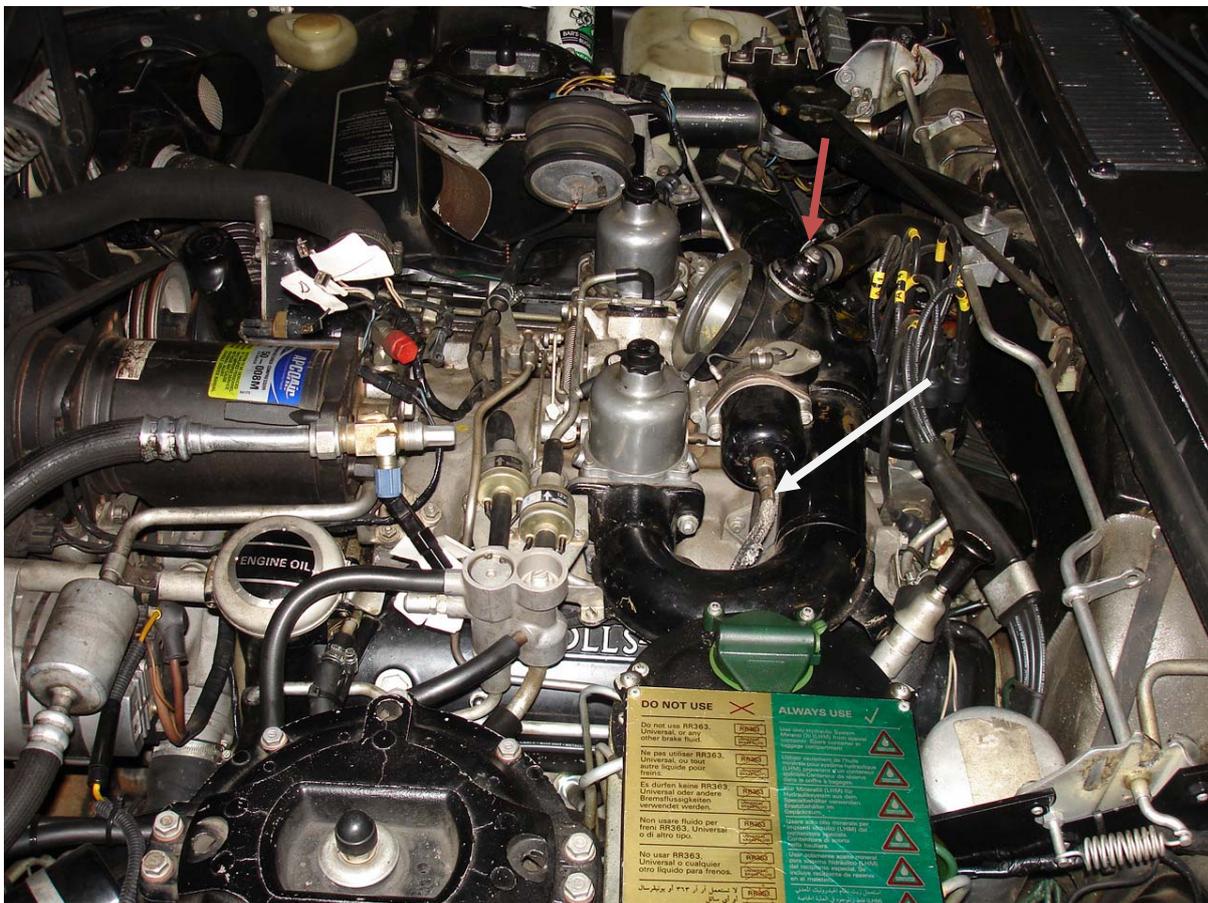
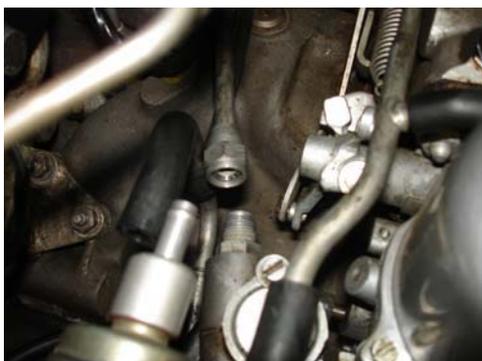
Note the tagging of the various wires connecting the solenoids to the engine looms. This really is step one. Use decent size labels and press the glued ends together firmly. The various pipes in the foreground on the fuel weakener device all pull off and virtually cannot be wrongly re-connected. Note that the chain to the speed control bellows had been unhooked. At the same time the small loom to the control solenoids needs to be unplugged. The stove pipe (white arrowed) is disconnected but can be left in place although invariably the insulation gets torn trying to thread the air horn around it. Ideally, albeit awkwardly, remove the pipe completely.

The red arrowed take off point for the engine breather is disconnected after removing one bolt and the pipe swung to the rear of the engine. These were fitted to all but the early 'S' series cars.

At left is the disconnected entry point for the fuel. The exit point under the 'A' bank induction horn has a restrictor to ensure that not only are the lines always full of fuel but that the pressure remains constant.

The pipe to the right is that connecting the carburettors to the anti-dieseling solenoid.

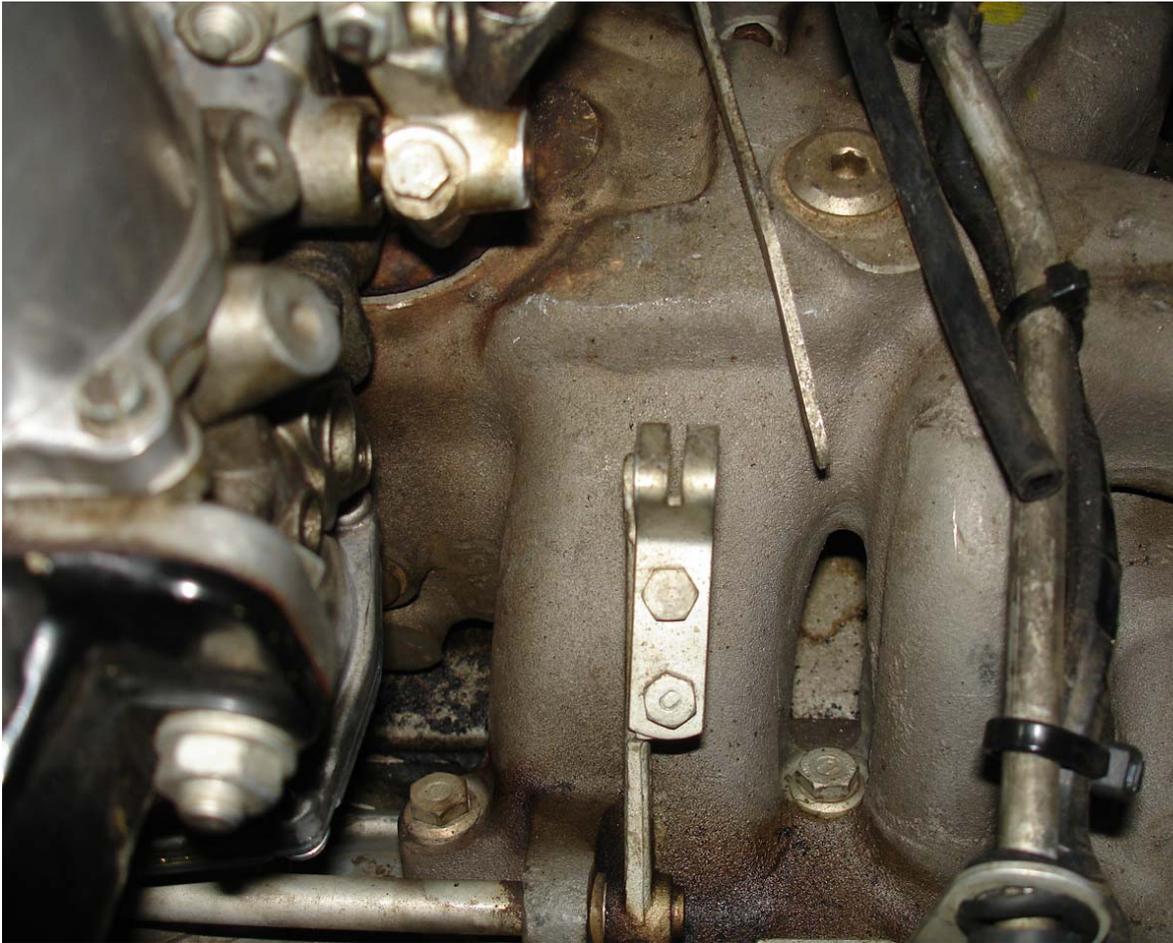
The central lever is directly operated by the accelerator. The forked attachment bolted to it receives the chain from the speed control bellows. At right the fuel delivery pipe. The angled lever connected to the carburettors lying on the intake manifold has been disconnected from the lever. The use of cable ties seen here is par for course for all the cars after the post55 series. Gone are the dinky little clips and conduits of yesteryear. Apart from mucking around cutting them off and reattaching them they seem to be very effective.

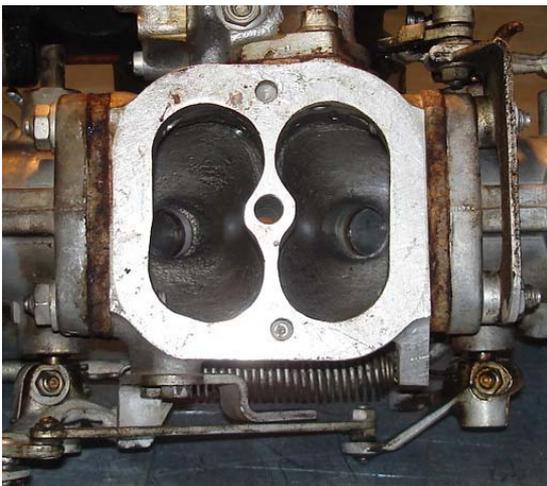
At left the underside of the 'T' piece. The centre hole accommodates the long fixing bolt. The two little holes top and bottom match dowels in the intake manifold to locate the assembly. Note that they are offset presumably to avoid putting the whole lot on back to front !???

If you are fitting a heat block to an early Shadow you will find that the dowels are NOT offset which simply means that you have to punch a hole in the heatblock to correspond! You will also need to make up longer dowels to

accommodate the block!

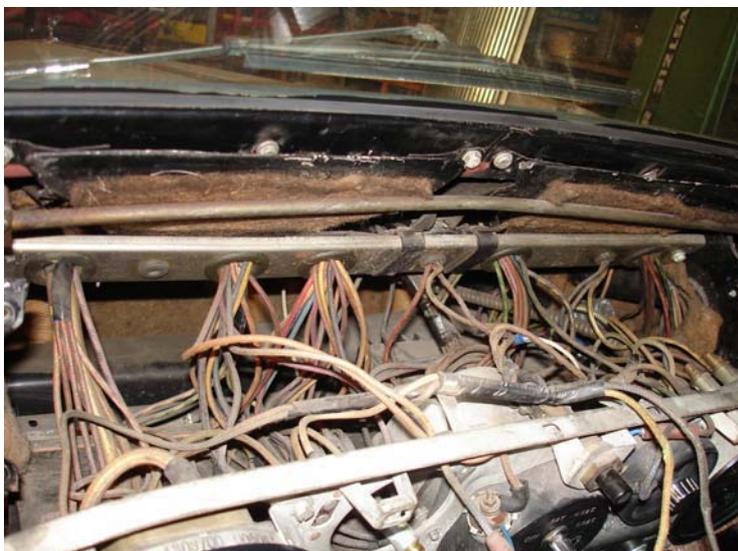
A friend with an S2 Bentley slightly older than my own asked me to help return the facia to his car which had been refurbished by his wife who apparently does

not subscribe to the bare footed image in kitchen presentation! I have gone one better with my S2 and removed all looms for remaking. I have yet to re-install them. I have had them remade because all the wires in the engine compartment once when heated, rapidly lose their outer covering and look awful.
