NOT FOR THE FAINT OF HEART

Last issue I bemused you with our efforts to extract the engine from a 1972 Silver Shadow. Since writing I have had a couple of mild remonstrance's from I suspect some of the old gang whose credo was along the lines of 'these cars should only be worked on by fully Factory trained operatives'. These people now realise that the supply of these legendry mechanics is drying up very quickly and that it is they that need to get their hands dirty, to read the books, ask the questions and share their experiences if our cars are to survive.

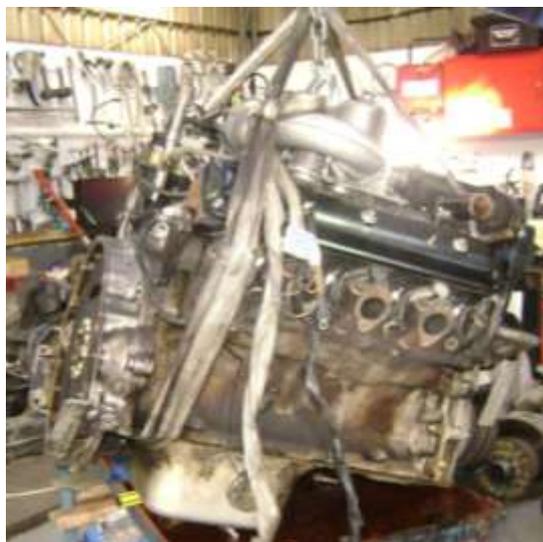
Well here is our engine minus exhaust manifolds which if you look down the side of your engine are pretty close to the body sides. The transmission has been removed which explains the tilt of what is left. Previously you have seen the torque converter mounting. One point to watch is when removing the transmission, ensure that the converter stays with it. It is not difficult to overlook this and have the unit pull out from the gearbox as well as away from the drive plate on the engine and then drop on the ground. Crying after such events is perfectly reasonable!

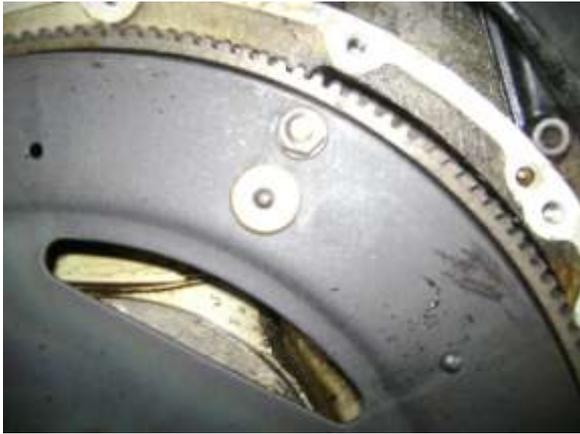
Times have a 'changed since the old days of enormous flywheels with shrunk on starter ring gears. Last issue showed this drive plate but here we can see the ring gear which is bolted to the rear of the plate – so much simpler. Of course ring gears now last forever because we now have pre-engaged starters that quietly thread the little starter pinion into the ring gear before belting it with Mr. Lucas' fury! Before, it was wind up and crash!!! The old ring gears would always wear off their teeth in three places on the old six cylinder

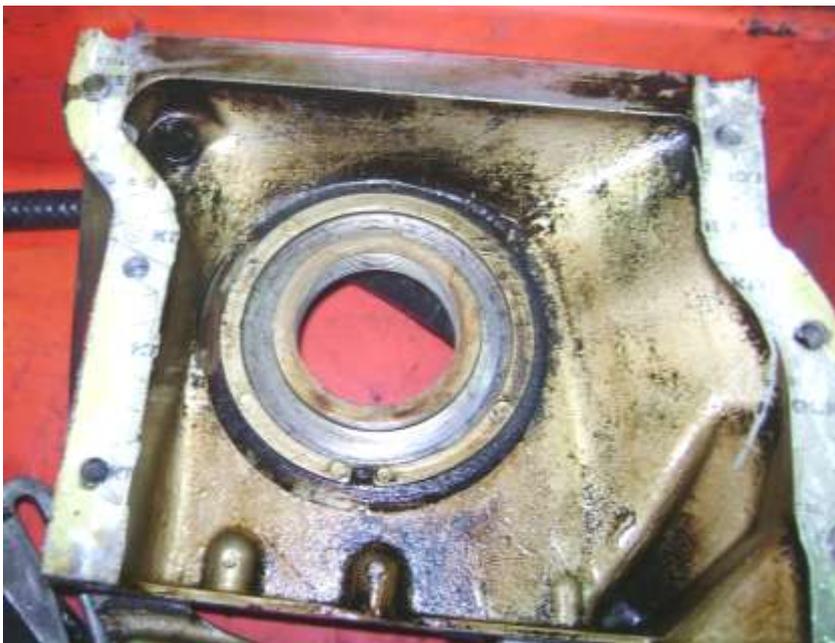
By now all the induction gear is off the top of the engine and the front crankshaft pulleys and bits have been removed. The lower half of the timing case has been removed and inverted for your inspection. In the top left hand dirty corner is a rubber plug. This ingenious bit pushes the oil pump delivery pipe into the gallery leading to the oil filter and then to the big time stuff. If you leave that plug out a lot of

oil pressure will be lost and any gauge will show a widely fluctuating pressure reading.

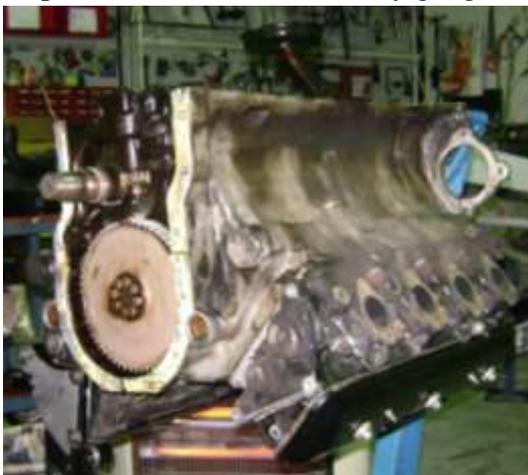
At left the engine still with its heads on, starter and exhaust manifolds removed. The front mounted oil pump can be seen above the camshaft gear although the driving gear for the pump has been removed from the camshaft.

The small oil pump gear which is bronze is driven by a steel worm gear. Later cars reversed the design fitting a bronze worm gear and a steel oil pump gear. Some brilliant people have actually changed the bronze pump gear for steel so that

you have steel driving steel which is a perfect recipe for destruction. The bronze pump gears are available after market.

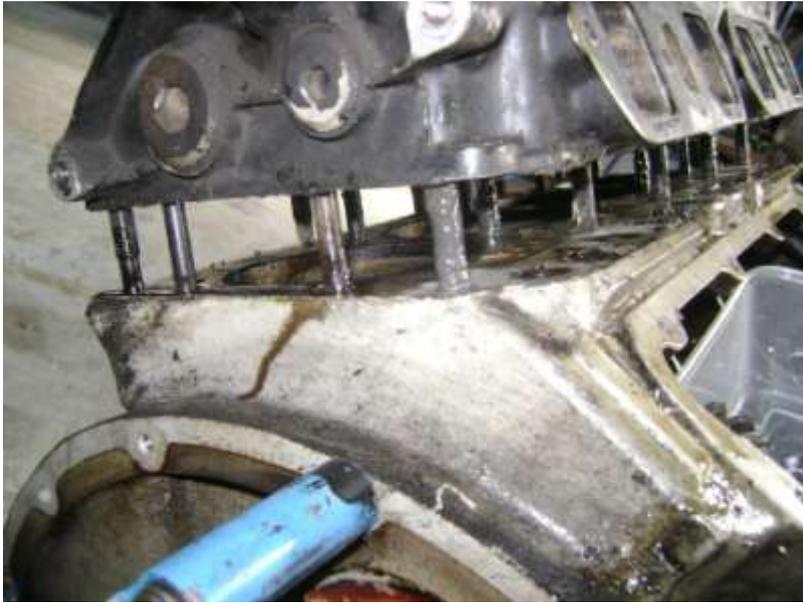
The heads can be a problem for removal fortunately this engine seems to have had a sedate life and been well maintained. The nuts and special washers all came off and a slight tug got them this far. Some years ago I tried the same approach with a very early Shadow. In the end we had the car suspended by the head and it would not budge and apparently never did? Discreet pullers have now been designed which apparently have overcome

the problem. The advice I have received has been to treat these units with great care. Do not fling them into the local fixit station for a quick head job because invariably they will shave it and there is very little to play with. Furthermore the head being shaved brings the rocker arm shaft closer to the cam shaft which can upset the lift performance of the cam followers. There is also the problem that the heads have to match the inlet manifolds – have I passed the message?

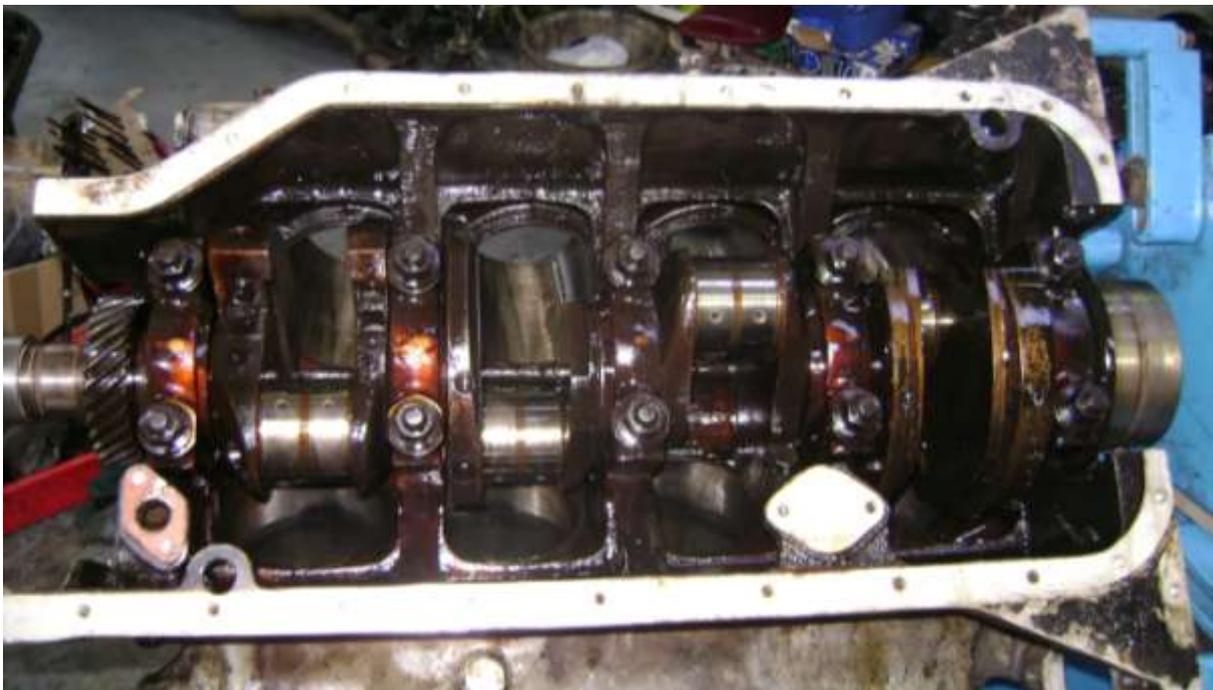
The heads are off, the oil pump removed from its mount at bottom left as has the pickup stirrup which is bolted to the crankcase on the lower side further along. I have been asked whether I will convert the sealing arrangements for the ends of the crankshaft to match the

later cars. The answer is no because it is a lot of very specialized work and very expensive. The throwers on the shaft work very effectively unless the main bearings are really very worn or the sump is over full!

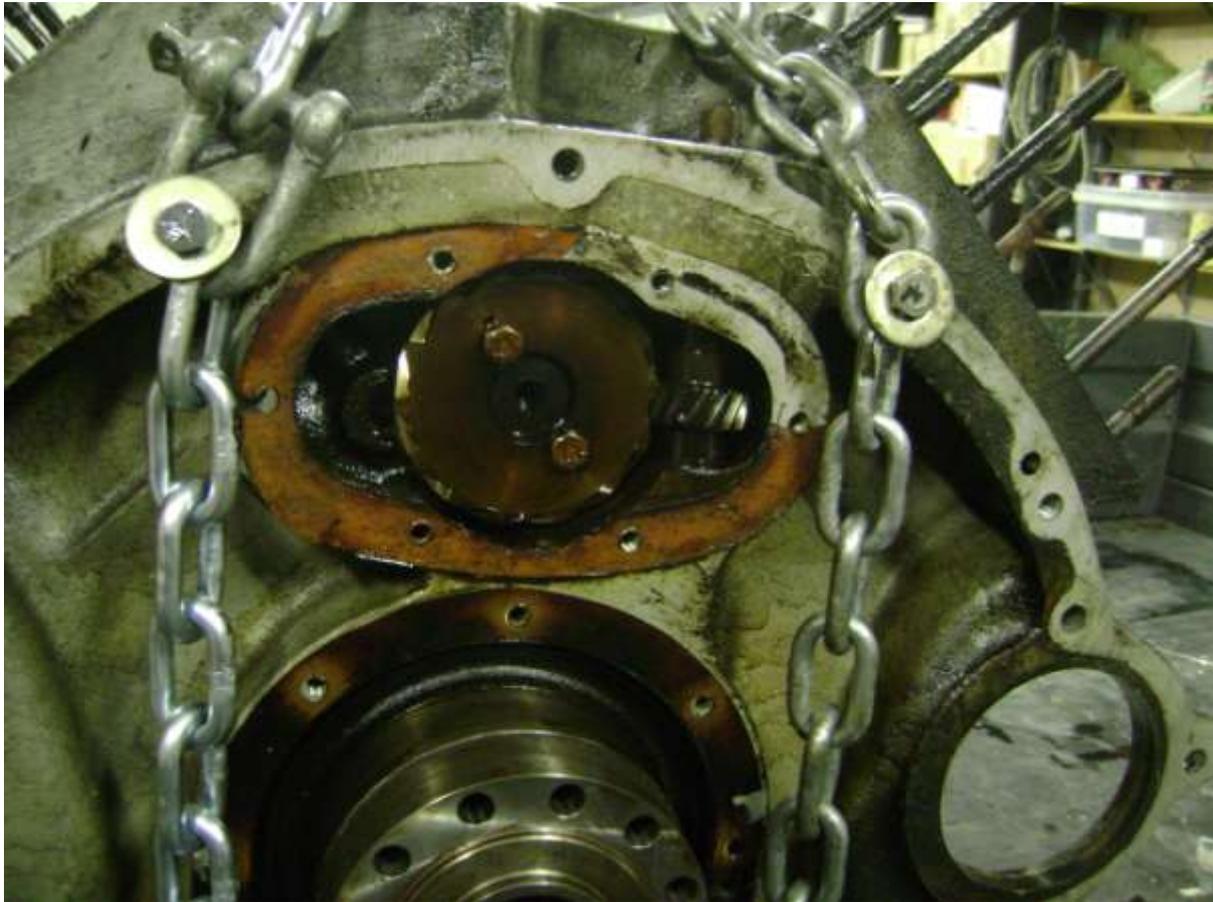
The cam shaft seemed to be the next logical bit to remove. An old hand pointed out that if I did not remove the bits at the back before I put the block on the engine stand I would be up for some keyhole surgery! This explains the block hanging in chains. The camshaft it held in position at the front end but before it can be removed the distributor drive gear at the rear has to be removed. And here is the latter! The helical gear to the right runs on a shaft that can be seen when the distributor is removed. Note that the rear bearing 'catcher' has been removed. Apparently experience suggests that these two joints be sealed with a good quality gasket cement and not use a gasket as the latter tend to weep.

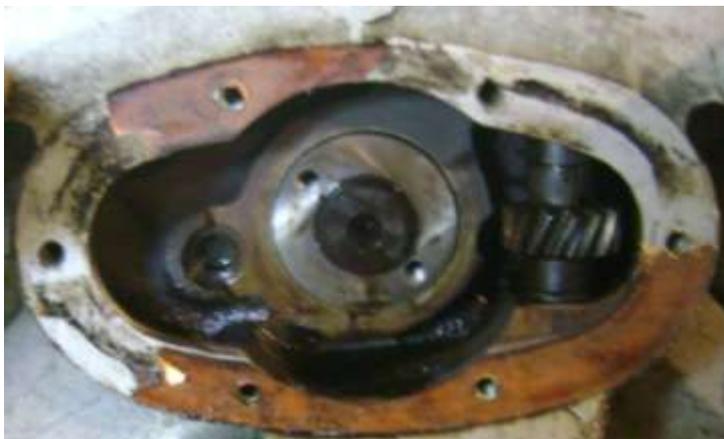
Here the distributor drive gear has been removed exposing the rearmost bearing of the cam shaft. Note that the shaft actually runs in the block and does not have separate bearings. To the left of the shaft is one of two Welch plugs blanking off the rear of the two main oil galleries that run the length of the engine. The other one is behind the distributor gear.

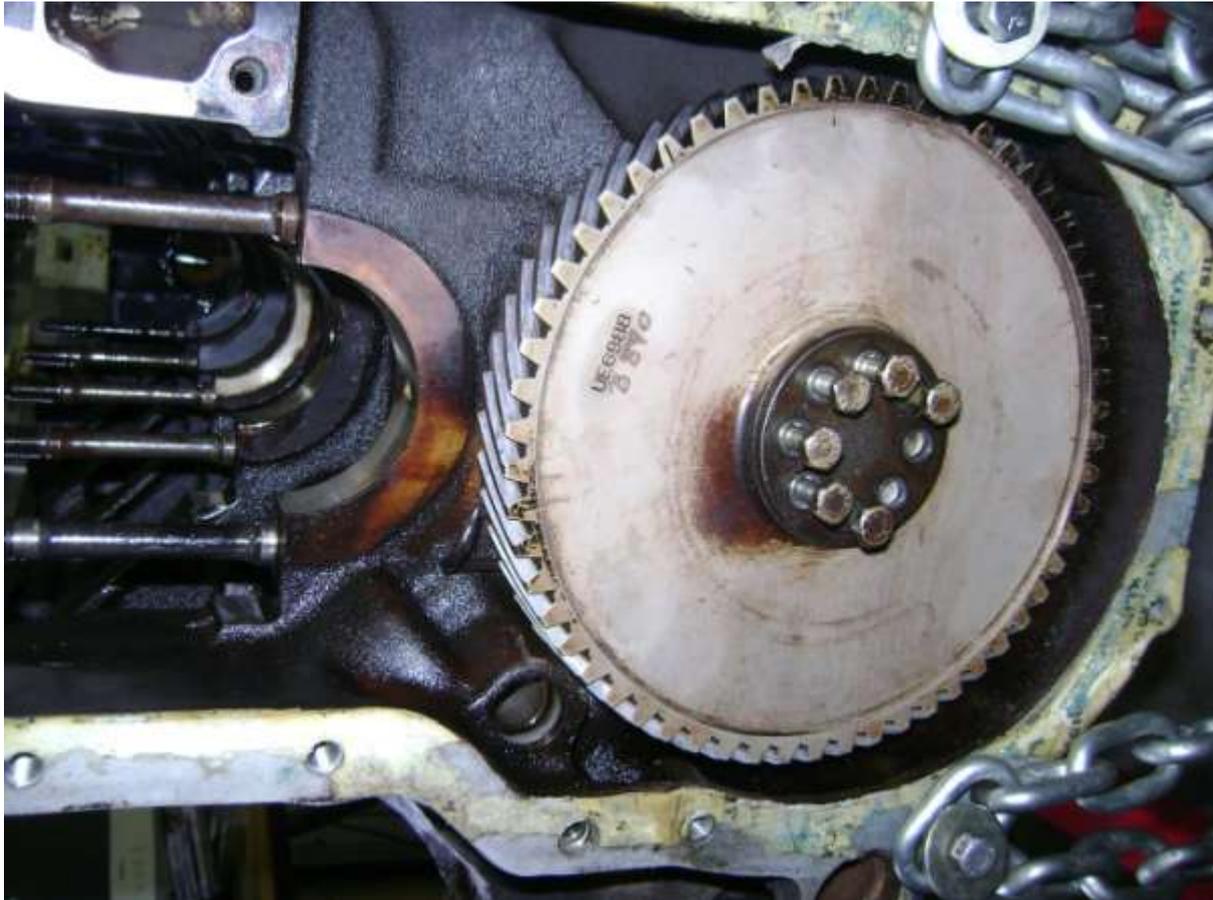
The crankshaft has been removed with the respective bearing shells and the eight bolts securing the camshaft gear are being removed. These do not have lock plates or washers under the heads. The hole near the gear on the lower side is the input point from the oil pump.

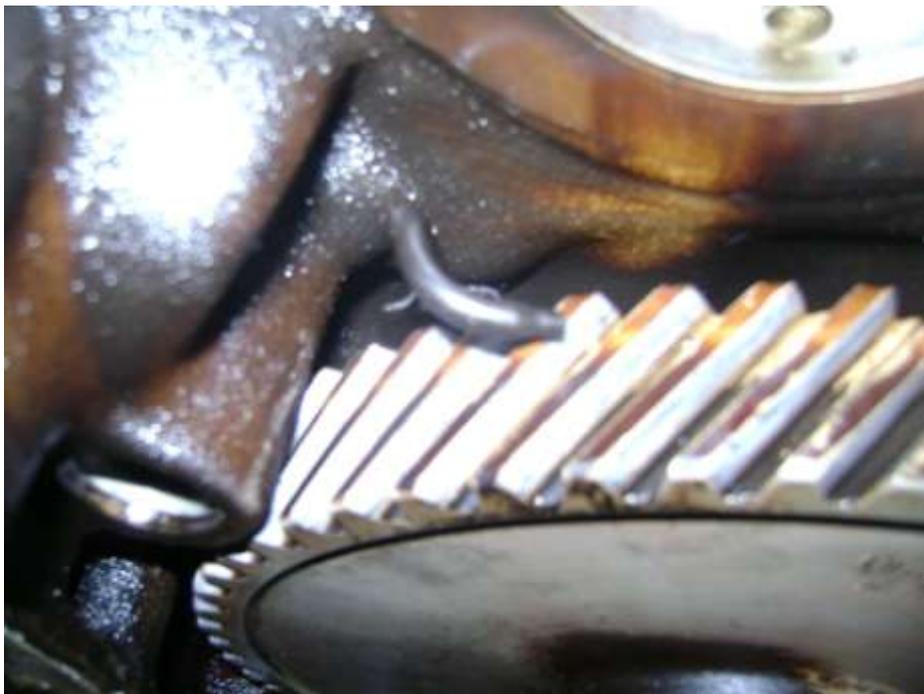
This neat little pipe is fed from the main oil gallery and squirts adequate oil onto the camshaft gear. Note again that the camshaft gear is aluminium driven by a steel gear on the crankshaft. The hole to the left is another view of the oil pump input to the block (the block here is upside down).

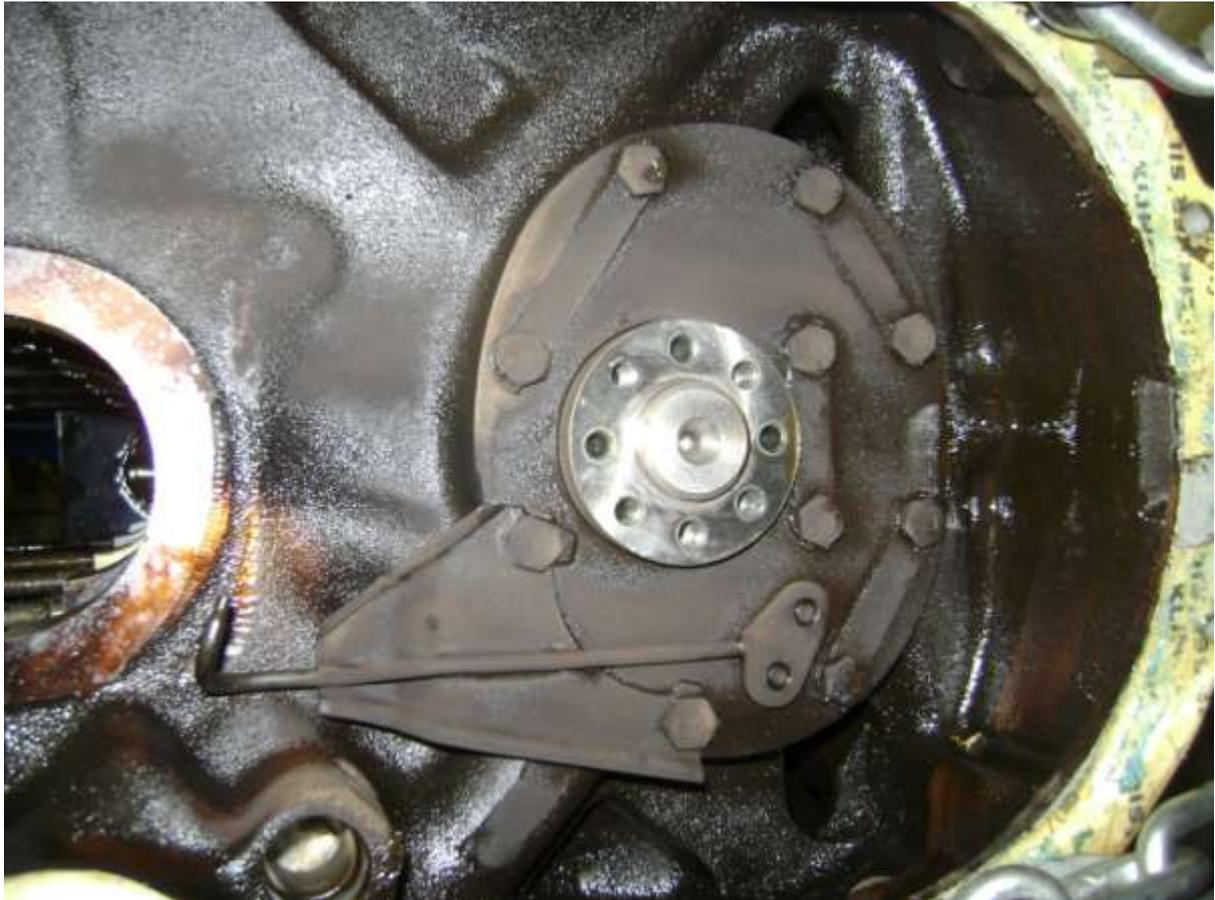
Here is the camshaft thrust plate and cover for the two main oil galleries. The small pipe jet for the camshaft gears is part of the assembly. Below, the camshaft gear has been removed and the camshaft is ready for extraction. The recess surrounding the gear ends in two holes. These are the ends of the main oil galleries that feed the main bearings and thence the big ends.

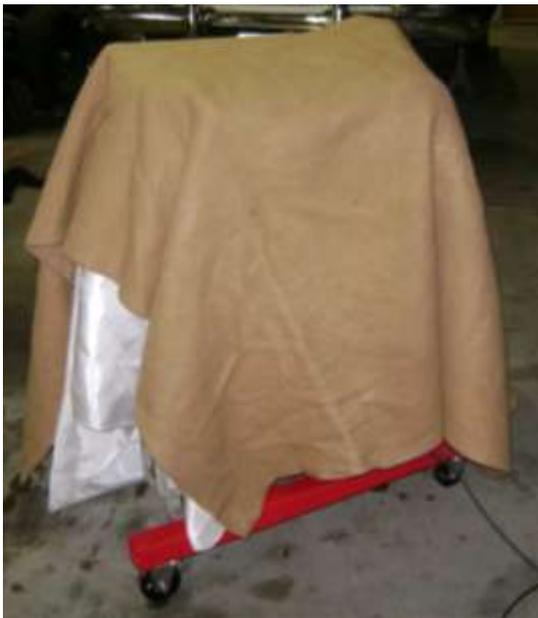
It is essential that the whole block is heated. Not having the prescribed hot air oven to raise a temperature of 150 degrees C, I settled for 80 degrees C by putting a 2,400 watt radiator under the block with a fire blanket and an old army blanket to keep the heat in. This took about 4 hours.

Apocryphal accounts of blocks cracking, liners jamming, pullers breaking, abound! Fortunately again this car has been well maintained and the task was not difficult. A very stout puller has to be made up some indication of the pressure required is illustrated by the extractor thread.

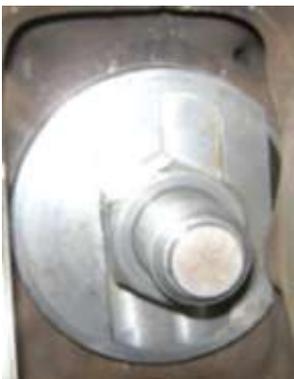
It is important that a liner is not pulled that is not supported by a block end and/or another liner! This is because the webs at the bottom of the liners are the weakest part of the casting, it is also the point where most of the detritus from the cooling system collects and sticks to the bottom of the liner. Pulling this past a seal may be just too much for the casting.

The base plate for the puller needs to have the side cut off to accommodate the main bearing webs. The maker of this puller thoughtfully milled a groove into the plate to hold the nut from turning.

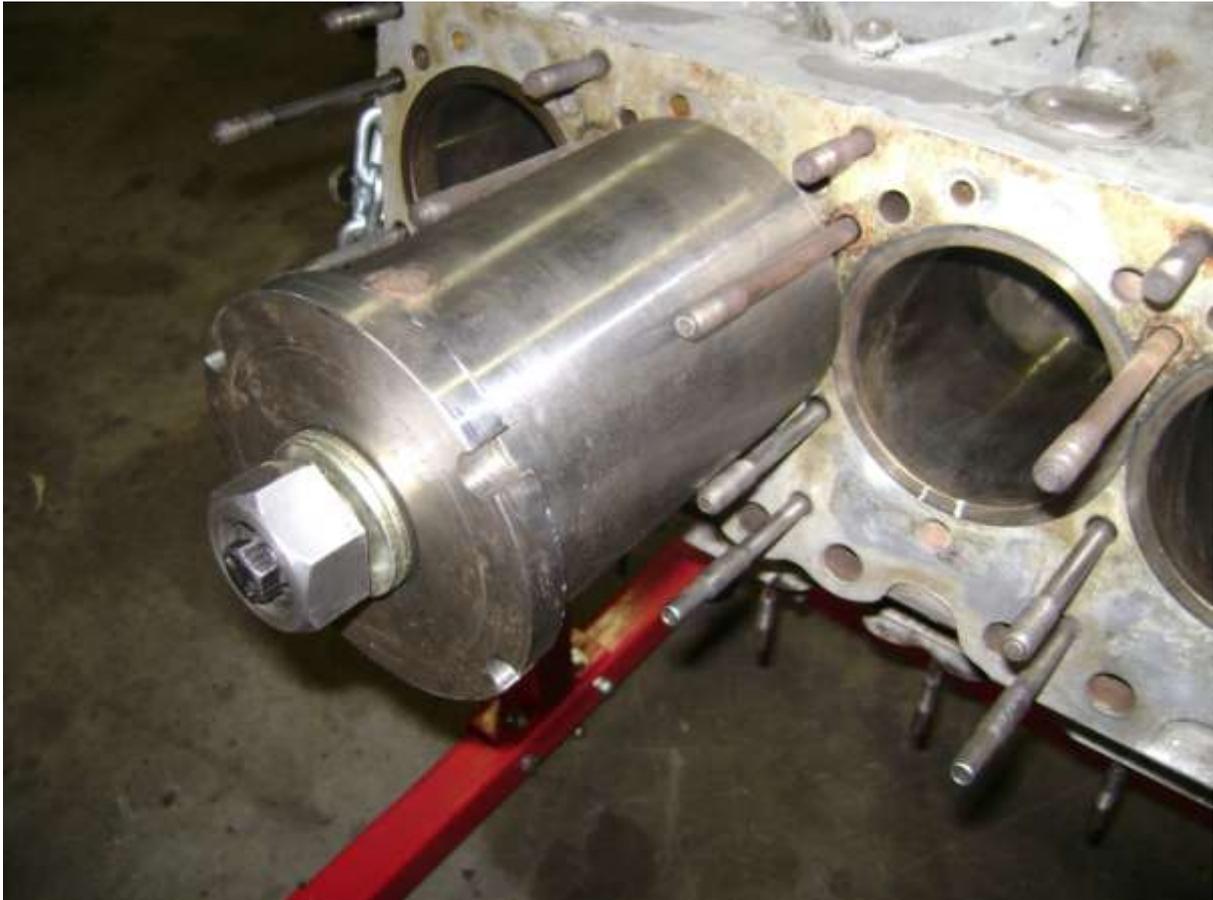
The puller pulling! Note that liners are inserted either side. This was a bit of an embuggerance in that while the block was hot I pulled numbers two and four on both sides and let the block cool. The liners were then cleaned up, the old seals removed and the bulk of the muck in the web area and the top of the block cleaned out. The liners when cleaned were stored in the deep freeze. The next day the block was re-heated and the frozen liners dropped into their cleaned places. They went in under their own weight! But within a minute were locked solid having expanded. With liners two and four in place the process could be repeated for the other four units. The white lines on the liner tops surround the etched number of the liner relative to the block. The etch is quite faint and the lines helped to find them. Below one of the liners as pulled, the spanner used to do the pulling and the clean block minus liner to show the seal grooves.

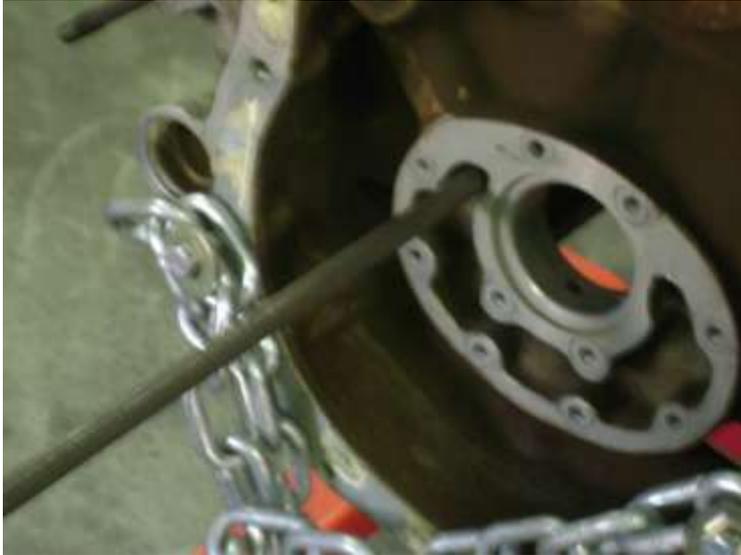
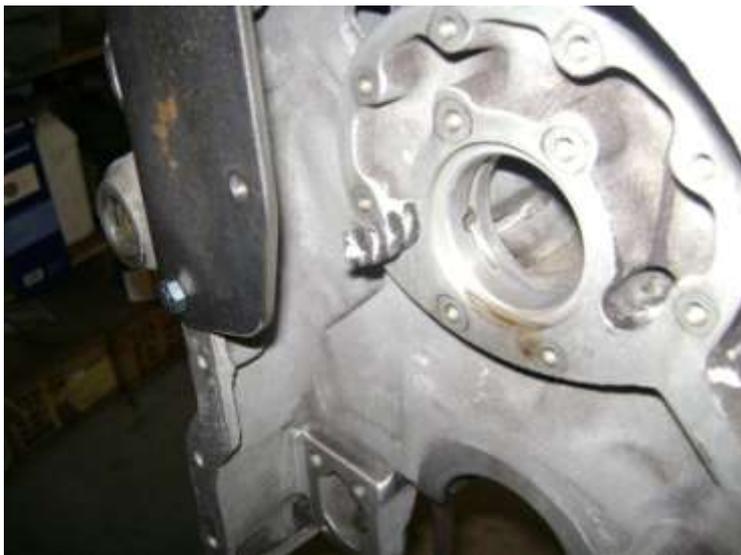
At left poking the Welch plugs out at the other end of the block with a steel rod. This enables the galleries to be thoroughly cleaned particularly after machining. The picture below is taken at the other end showing the brush as it emerged from what was purported to be a clean engine!

The original arrangement was some sort of screw in plug. On an occasion Mr. Welch had one of the screwed in types blow out and solved the immediate problem of keeping the coolant in the block by fitting a coin in the hole and belting it with a hammer! Below is the other end of the brush. Clearly more cleaning is required!

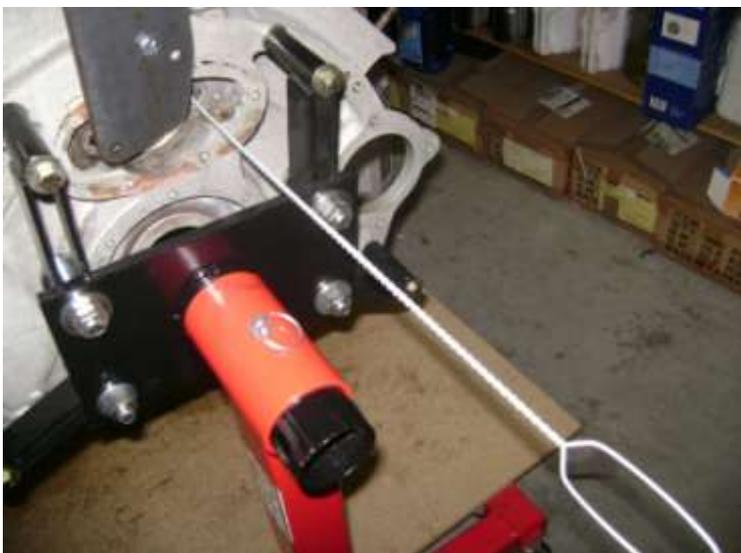
At left the handle end of the gallery brush. This is a particularly effective innovation, a specially made nylon brush half inch in

diameter. Here it was being pushed through the block after its first professional cleaning. One of the vexing tasks in this exercise has been getting the cylinder block clean! The deposits from the coolant and exhaust carbon etc are easily scraped but the basic frum that coated the inside was impervious to high pressure water, solvents and brushing. The only solvents that seemed to work were all purpose thinners and carburetor cleaner. The commercial baths used by engine cleaners seem to do a reasonable job although I had to have two goes at it. This was because the block as blocks go is much larger than most if not all other vee eights! The baths are not immersion instead they work like a dishwasher with pumped solvents and detergents raining down and squirting up from rotating sprays. In the end I fear I will have to go over the block carefully to see that the job has been done and probably apply some old-fashioned elbow grease!

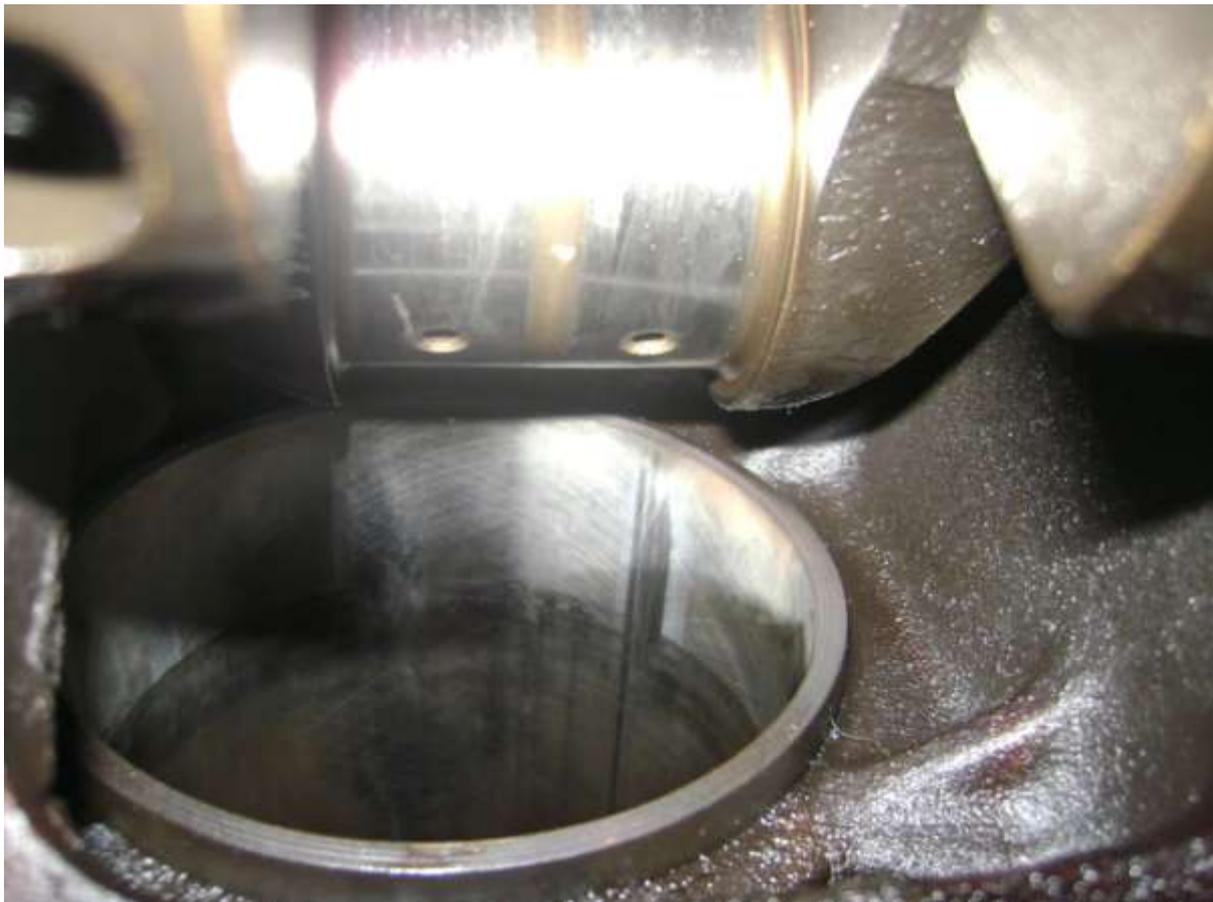
This is view of the bottom end of the liner where it pokes through the bottom of the block. The liner is actually slightly larger than the hole so grips it somewhat tightly and explains why the block needs to be heated to get the things out safely. When the engine is hot the fit must be not quite so tight because if the lower of the two seals at the bottom of the liner has had it, oil from the whirling crankshaft will find its way through the gap and leak out of the weep hole!

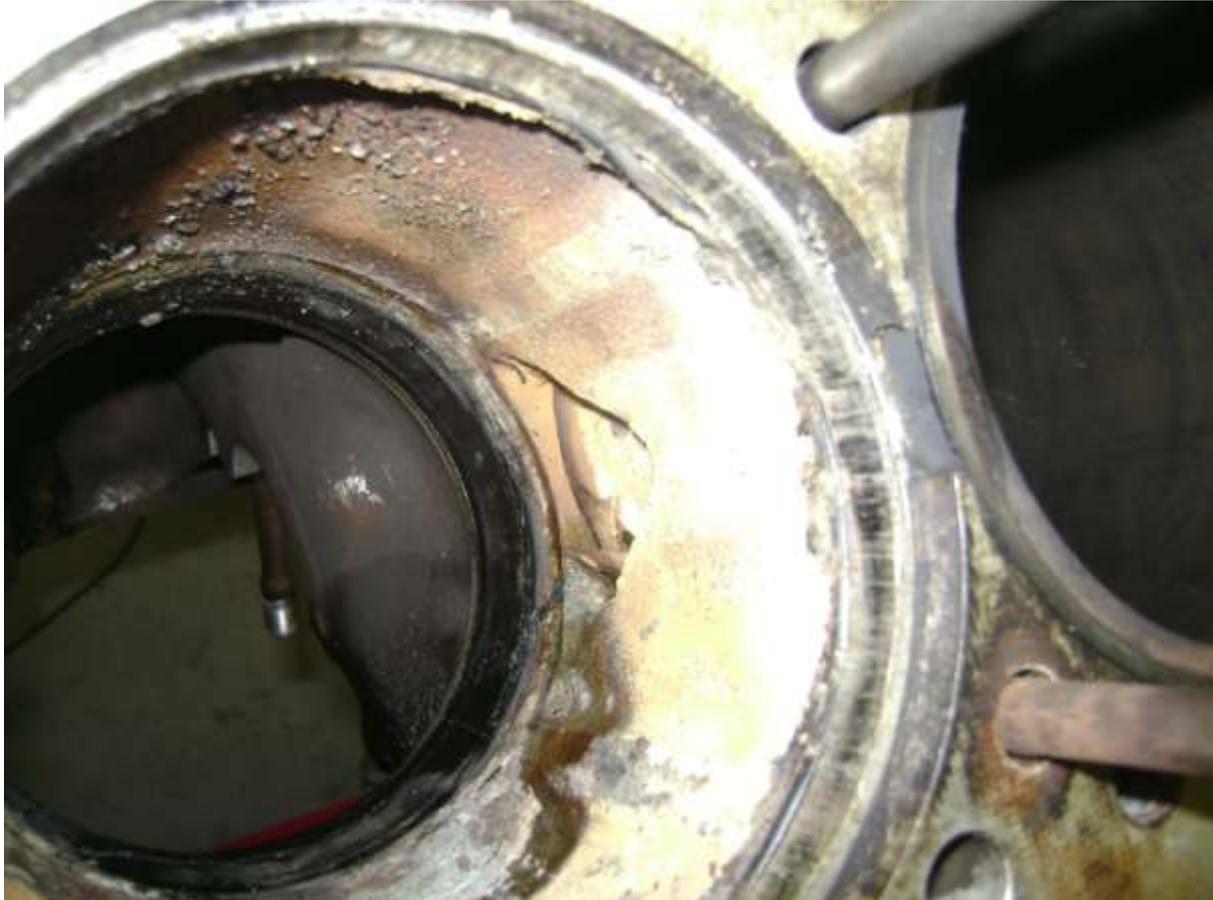
This is the view when you pull a liner. A bit of the top liner seal can be seen at about 4 o'clock. The dark area at the bottom is the crankcase between the two bottom seals. Both seals at the bottom are the same composition yet the lower one has to cope with hot oil and the upper one with hot coolant. The lower one usually gives out first and the weep holes weep. The triangular opening near the bottom on the right hand side is the passage for coolant to circulate between the cylinders. The lower half of the adjacent liner can be seen through the hole. Also can be seen a shard of corrosive deposit that has dropped down. This is the sort of item that constricts cooling.

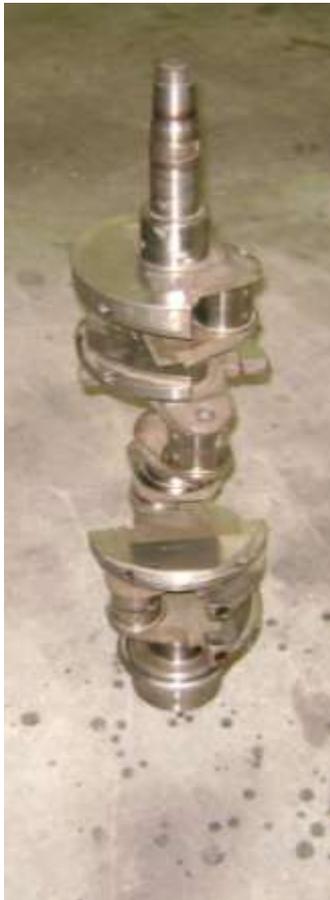
And at the left we have the heart of the engine, the crankshaft, which is all the average man can lift. The semi-circular throes are bolted on which is not usual practice. The early cars had integrally cast weights. The only but vital maintenance here assuming the journals and main bearing surfaces are not badly worn or damaged is to clean out the sludge traps. Despite the best of filters a mélange of very fine particles of carbon, metal and general muck circulates in the oil and the designers decided to use the centrifuge effect of the whirling crankshaft to extract the stuff. This accumulates in special chambers in the shaft which may be accessed through holes suitably plugged and sealed.

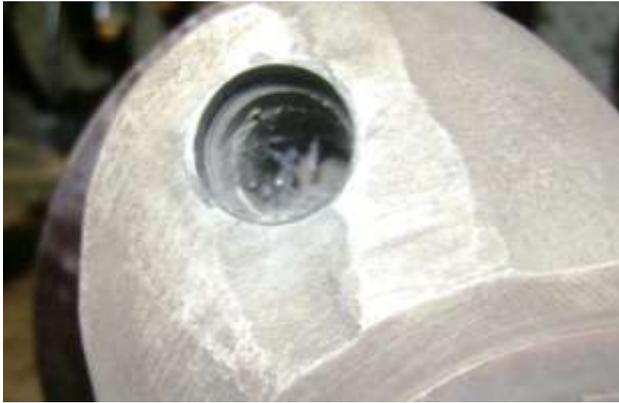
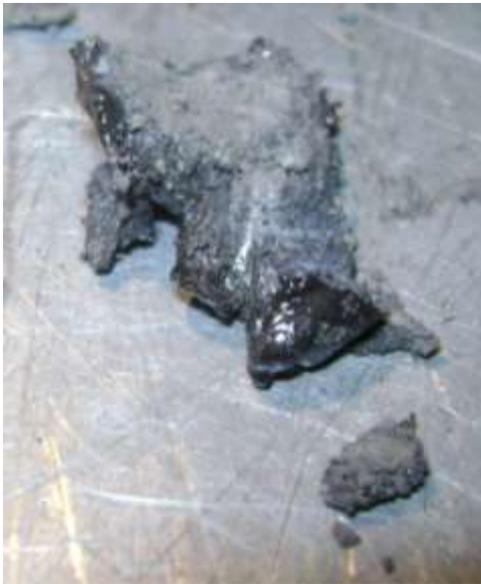
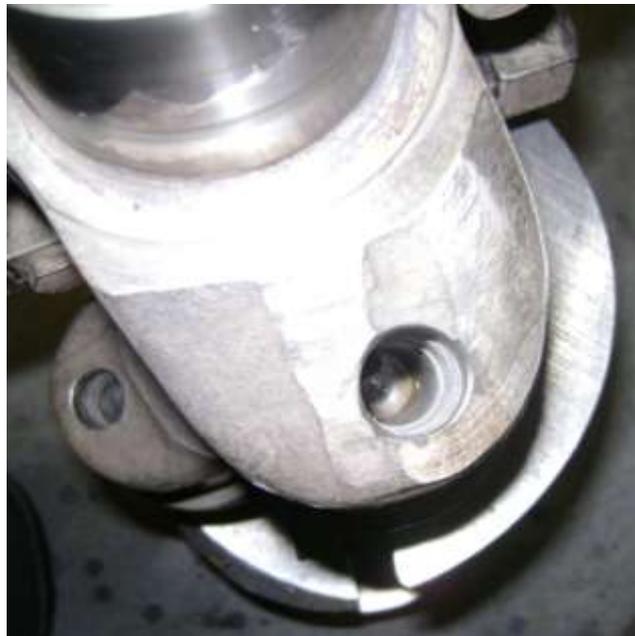
Here is a sludge trap opened which requires a pair of contracting needle nose circlip removers and a small bolt to act as a puller. At lower left this is typical of what you will find. The main pressure oil comes down from the main two galleries that run the length of the block then through drilling to the saddles that the main bearings sit in, through the bearing shells and through the holes drilled in the crankshaft journals. These go direct to the

sludge traps and the 'clean' oil then squirts out holes opposite to the sludge to lubricate the big end bearings.

The 'plugs for the traps have a simple 'O' ring around them to keep the seal. When replacing the seal it is a good idea to replace the circlips as well – after all they have been 'accumulating' for nearly 40 years!

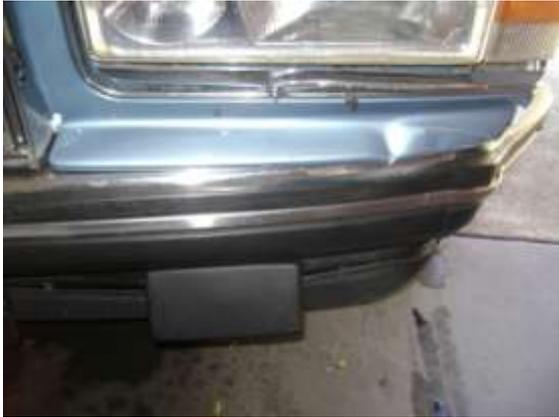
was a complete write off. There are variations of this scene. Fortunately our technical minders have now designed our car so that a relatively minor bang and you finish up with a neatly parceled car with the body intact and the entire mechanism neatly folded up underneath! The impact of the Spur was on the front left hand corner and the main load was taken by the bumper bar. These are fabricated in very thick aluminium in a box section shape covered in front with pretty rubber and strips of anodized metal and a polished stainless steel fillet on the top. The bumper went under the valance of the front mudguard collecting the surround of the electric fans which in turn punched a hole in the air conditioning condenser and that in turn punched a hole in the radiator. The fog light, grille, headlight and parker

were untouched except that the impact loosened the guts of the headlight!
