# POWER ASSISTED STEERING

## Rolls-Royce Silver Cloud II

David Chaundy

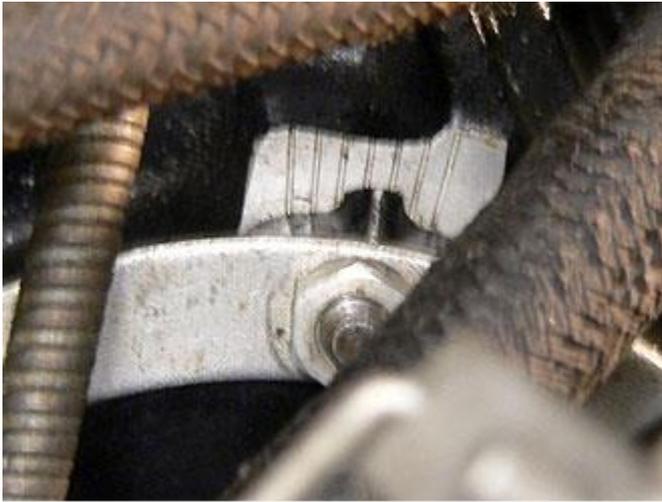
Picture 3. Uppermost steering box adjustment

I slackened the nuts on the top cover, and the bolts on the lower rocking shaft bearing housing. A pointer is cast into the top cover (see picture 3) and second pointer is present on the lower rocking shaft bearing housing (see picture 4). Engraved on the steering box casing is a set of incremented settings for the top cover. A similar array of setting increments are present on the lower mounting arm adjacent to the pointer on the lower rocking shaft bearing housing. To make the increments more visible I rubbed chalk into them (see

To reduce the backlash between the cam roller and worm gear. I turned both top and bottom covers by exactly the same amount clockwise half an increment at a time then re-tightened the securing nuts and bolts before re-checking the backlash between the cam roller and worm gear by once again noting the spring balance reading whilst the mechanism turned through the tight spot. The process takes several attempts to get the setting correct. It is worth trying to adjust the mesh of the cam roller and worm gear before the system is filled with fluid. It is vital all the nuts and bolts are tight before any attempt is made to check the poundage readings. I should point out that to disturb an unrestored steering box to adjust these settings without being sure of the poundage settings on the internal bearings is not a good idea. If nothing else disturbing the covers will cause leaks, because the “O” rings will nearly always tear when the covers are moved.

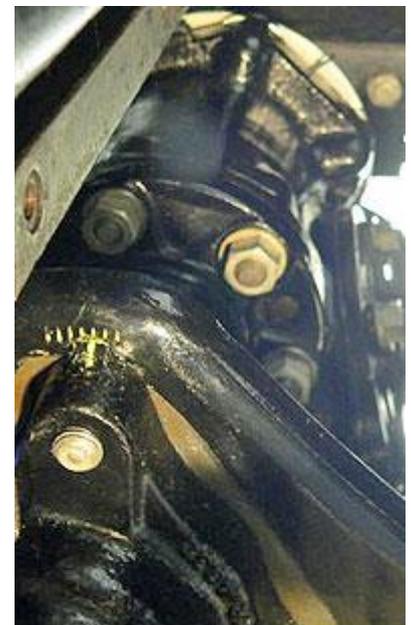
Picture 4. Vernier adjustment on steering box 1

picture 4).

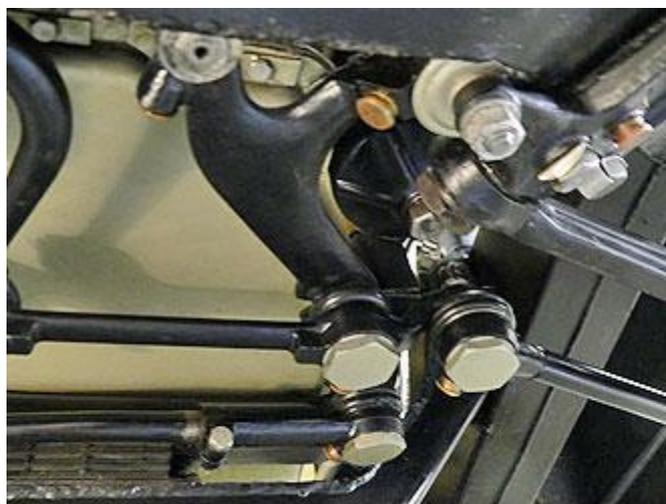
View of steering mech from underneath
