REPLACING AND MODIFYING REAR WHEEL BEARINGS ON ALL S TYPE CARS

N. W. Geeson

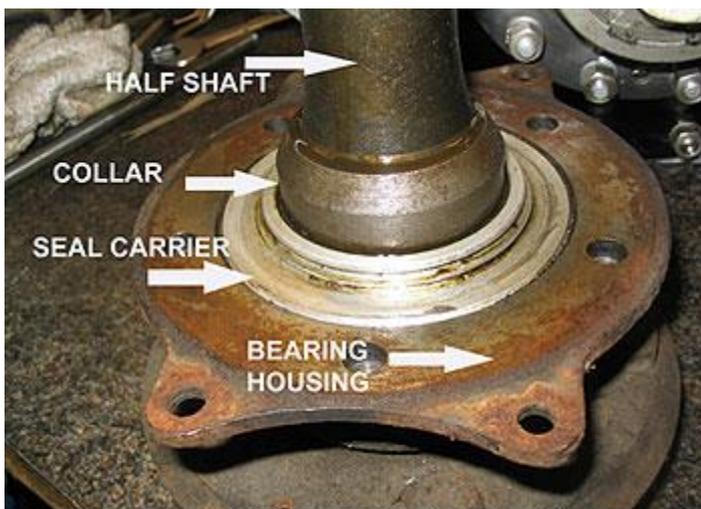
Fig 1. An old half shaft and bearing assembly after withdrawal from the axle tube

The various workshop manuals describe the removal of the half shaft assemblies, which are removed complete with bearings and bearing housings. Fig 1 shows a very old unit to illustrate what the assembly looks like after its removal from the axle.

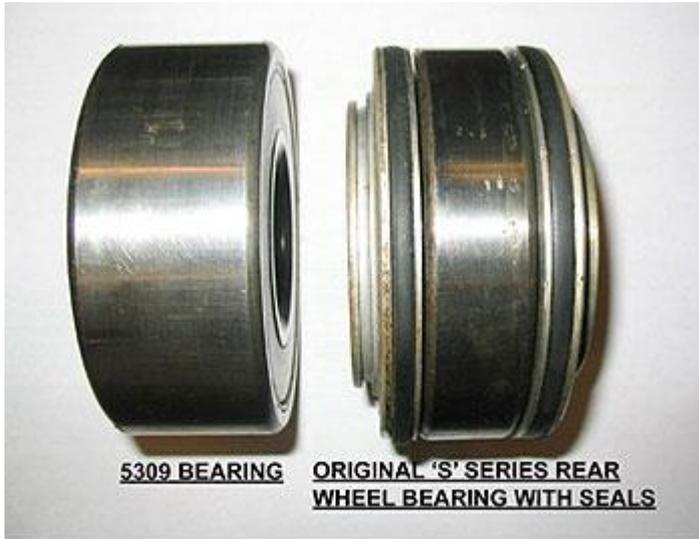
Fig 2. A new 5309 and an original S type bearing including oil seals

This is a F.A.G 3309B 2RSR or 5309 bearing. Fig 2, Fig 3 and Fig 4 show comparisons of the original and new bearings in various states of dress. Note in Fig 2 how the two original side oil seals and carriers make up the width of the old assembly to fit in the wheel bearing housing.

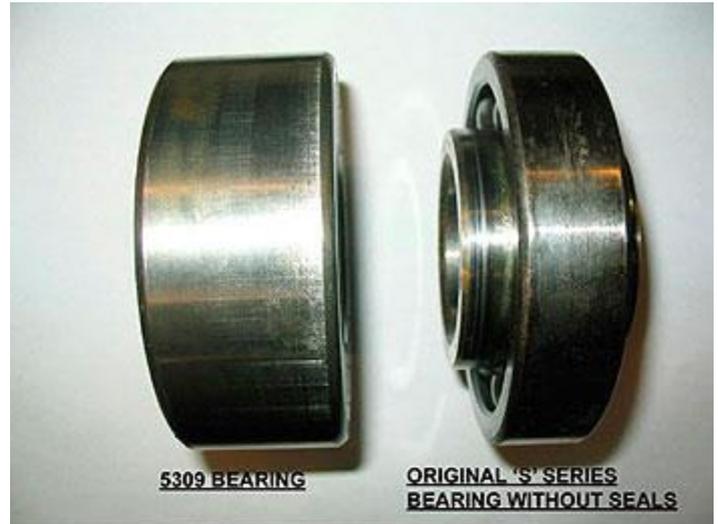
Fig 3. A new 5309 and an original S type bearing without oil seals

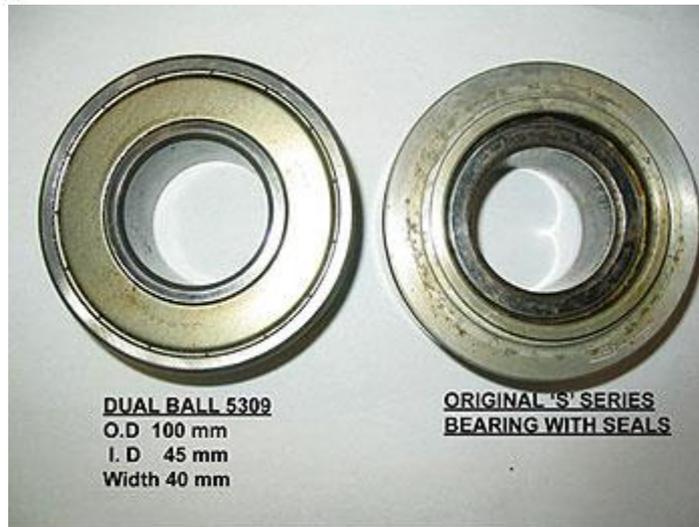
Fig 4. Side view of a 5309 and an original S type bearing including oil seals

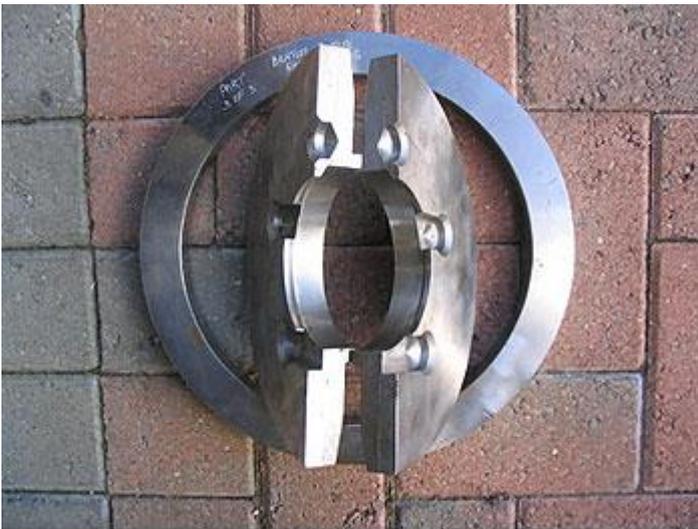
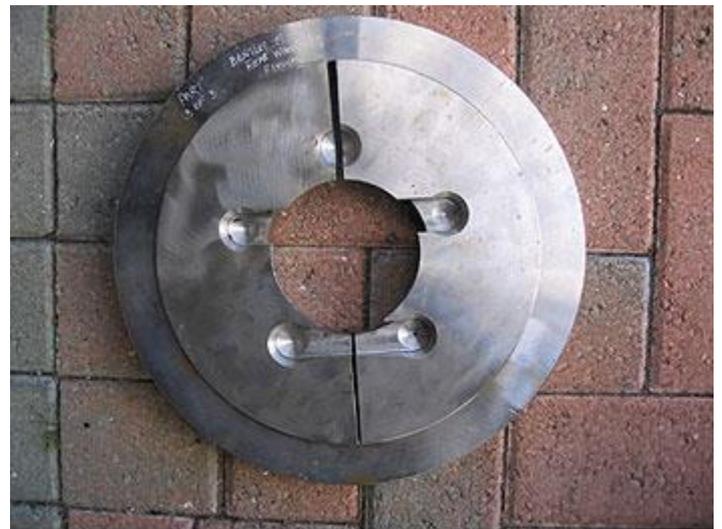
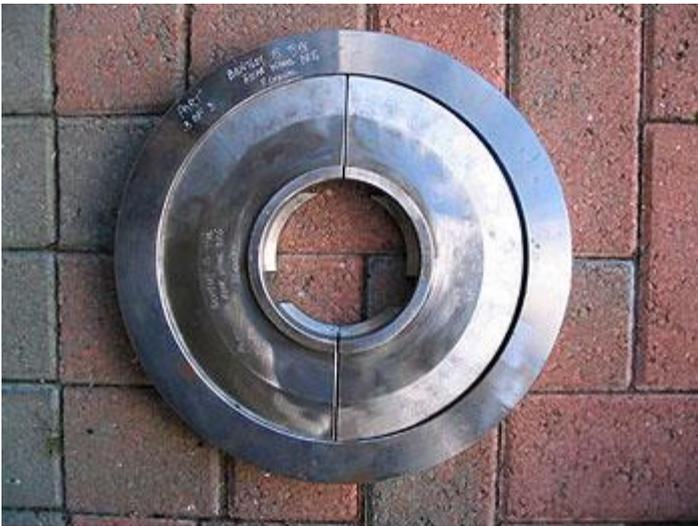
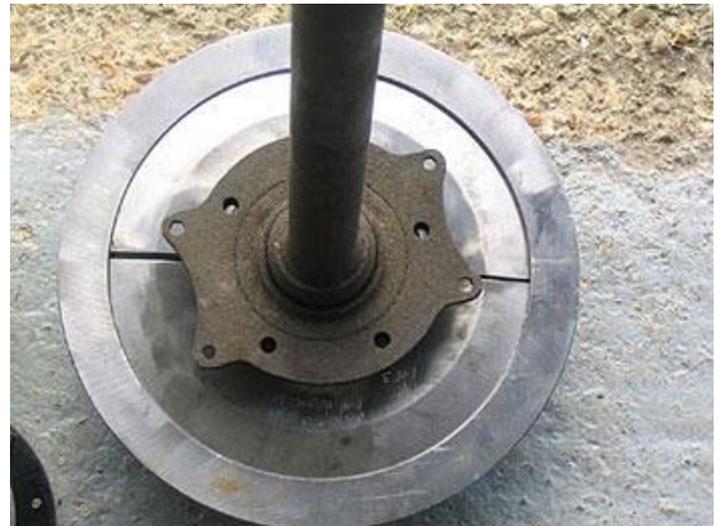
Fig 5. Hub support tool showing the split joint

Fig 6. Hub support tool showing the outer side

Fig 7. Hub support tool showing inner side

Fig 8. Hub support tool assembled onto an old half shaft, note the outer ring

Due to the high loads that the component parts will experience it is vital that the bearing housing is supported well to avoid damage. It is of no use changing the bearings or even an axle assembly if the bearing housing has been warped during the procedure. Fig 5, Fig 6, Fig 7 and Fig 8 show details of the tool, which I use to hold the housing. This is a very heavy tool because it is used continually. Fig 8 shows the tool on a half shaft with the encircling ring in position this stops the tool sliding off the housing when under load. Normally a tool could be made which would support the housing directly under the threaded bosses of the housing, as long as the situation is monitored.

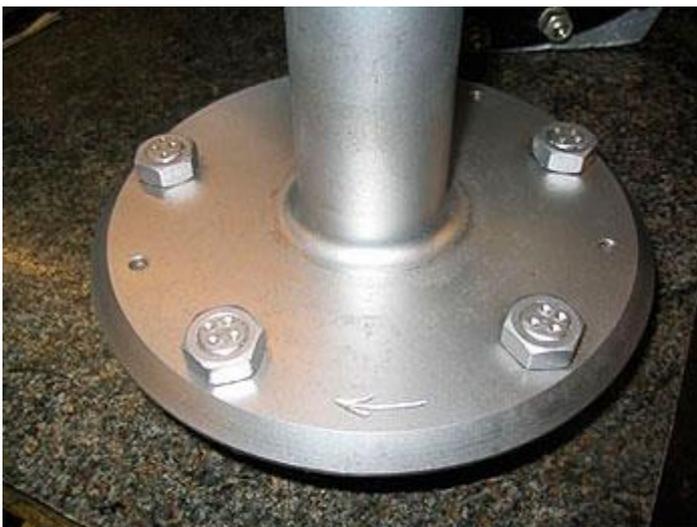
Fig 9. The axle side of an S type half shaft before assembly

Once the shaft has been pressed off the bearing it is necessary to recover the bell shaped spacer from the flange end of the shaft. Fig 9 shows the bare shaft cleaned up ready for rebuilding, whilst Fig 10 shows the spacer fitted and the shaft then is ready to fit the bearing and housing assembly. This spacer positions the bearing the correct distance from the end of the shaft, and in doing so, sets the final running clearance between the brake back plate and the edge of the brake drum. Fig 11 shows the comparison between the S type half shaft spacers and those of the earlier cars. It is easy to trim down an earlier spacer if required. Even in the event of needing to grind a bearing housing below the normal dimensions an early spacer could be used suitably turned down to achieve the 2.60 inch setting again as mentioned below.

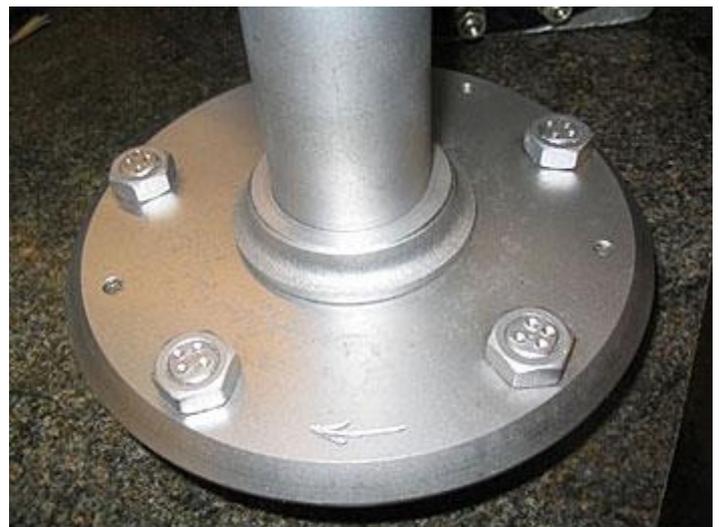
Fig 10. The half shaft with the spacer fitted, ready to accept the bearing assembly

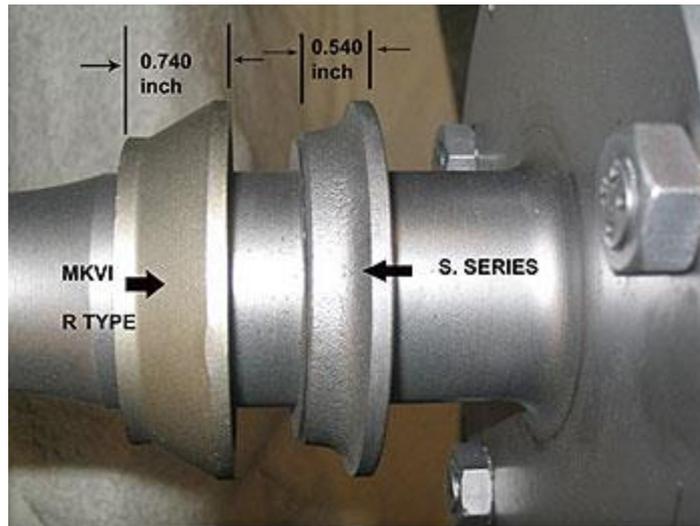
Fig 11. Comparing spacers of the S type and earlier cars

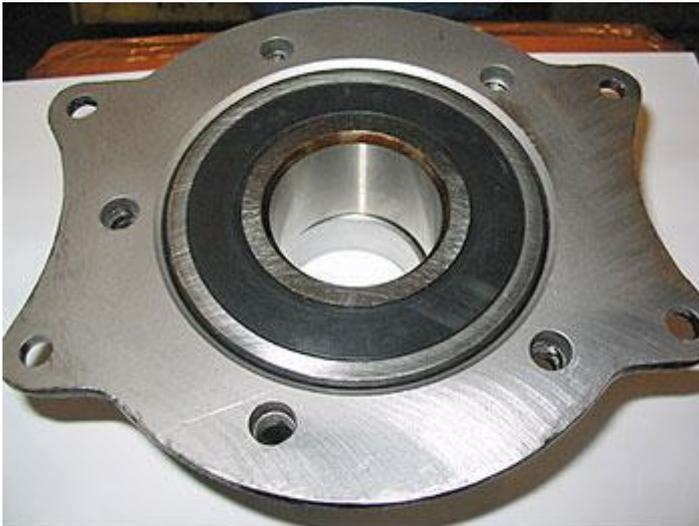
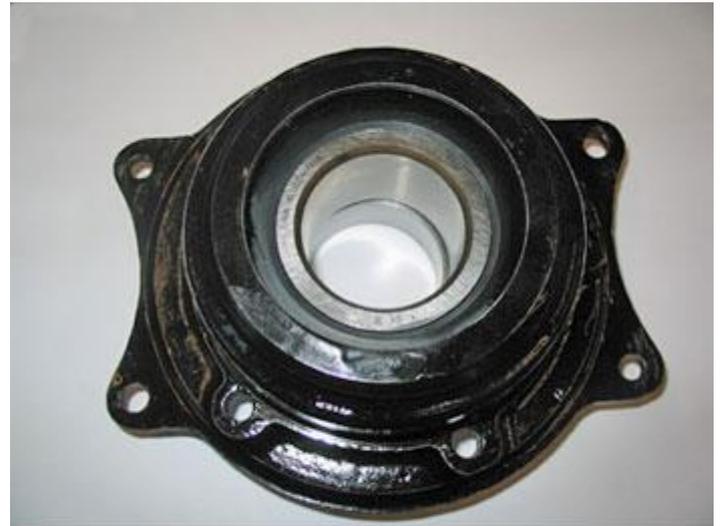
Fig 12. The bearing housing after pressing in a 3309 2RS bearing

Fig 13. The opposite side of the bearing housing fitted with a 3309 2RS bearing

Having prepared the bearing housing it is possible now to press the bearing into the housing, taking care to only exert pressure on the OUTER bearing track. Make sure that the original bell shaped spacer has been positioned on the half shaft beforehand and it is orientated correctly with its large diameter against the flange of the half shaft. The shaft can then be pressed through the centre of the bearing and its housing. Fig 12 and Fig 13 show a bearing after it has been pressed into the housing.

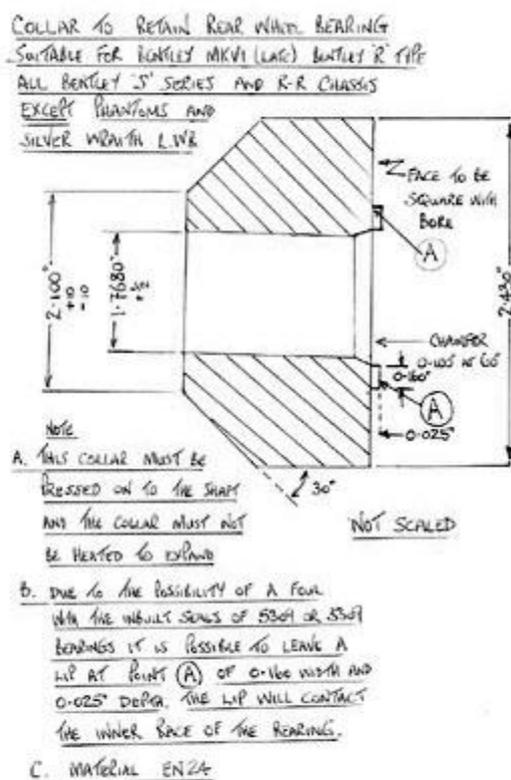
Fig 14. A sketch of the GB 4956 wheel bearing retaining collar

the region of 3 to 5 tons to allow the bearing to seat. Following this operation a new bearing retaining collar part number GB 4956, see Fig 14, must be pressed onto the shaft, and then a minimum pressure of 15 tons and preferably 20 tons applied.

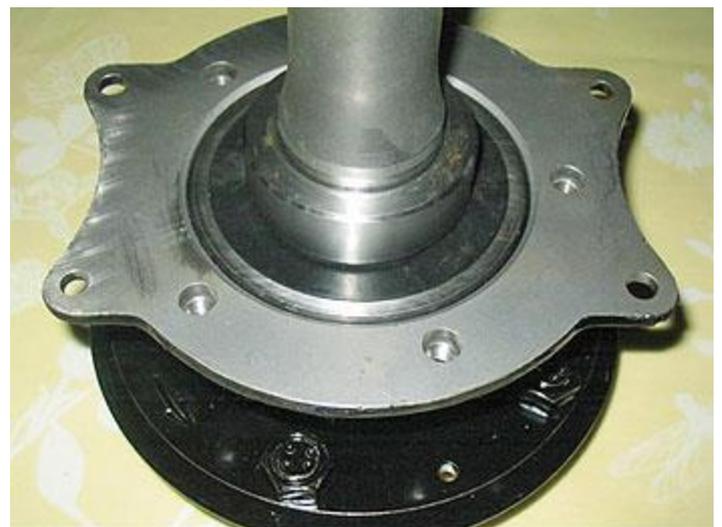
Fig 15. The complete assembly, ready to fit back on an S type car

In order to visualise both the bearing and the collar pressing operations, the half shaft flange end, that is the end where the wheel studs are positioned, is upwards and takes the force of the hydraulic pressing ram, whilst both bearing and /or collar are in contact with a piece of tubular steel, which is supported by the cross beams of the press bed. The aforementioned piece of tubular steel needs to be made wide enough to be wide supported by the cross beams of the press bed and thick enough to stand a 20 ton load. In addition it needs a raised section or up stand of approx. 0.250 inch, some 2.150 inch (54.61 mm) outside diameter and the whole block needs boring through the centre 1.80 inch (45.72 mm), which makes it a tube. Visually this looks like a large steel ring with a smaller ring placed on the top. The up stand or smaller ring is sized so that it contacts the INNER bearing track or GB 4956 collar, depending on which operation is being performed. When the bearing is being supported the bored hole allows the tool to pass over the 1.772 inch (45 mm) half shaft diameter where the retaining collar is to be fitted. After the bearing and retaining collar are fitted, see Fig 15, the half shaft assembly can be replaced.
