STARTING HANDLE ALIGNMENT AND THE COVER FLAP

N. W. Geeson

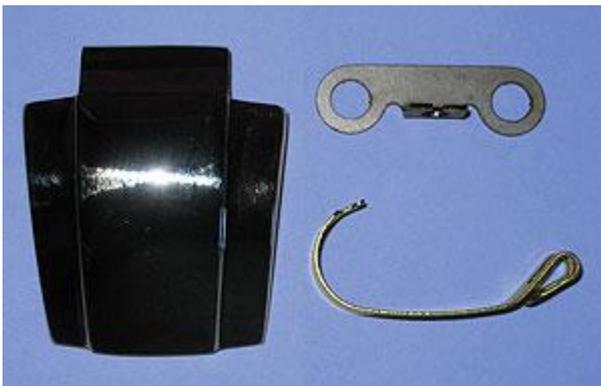
Fig. A. Illustrates on the left the new flap, top right the toggle retainer, and lower right the toggle spring

The main components which make up this assembly are illustrated in Fig A, B and C, however reference to Fig F will show the relative positions of all the parts when the flap is both open and closed. Close inspection will show that the long blade spring works with a toggle action, in short during the operation of the flap the assembly swings “over centre” or toggles.

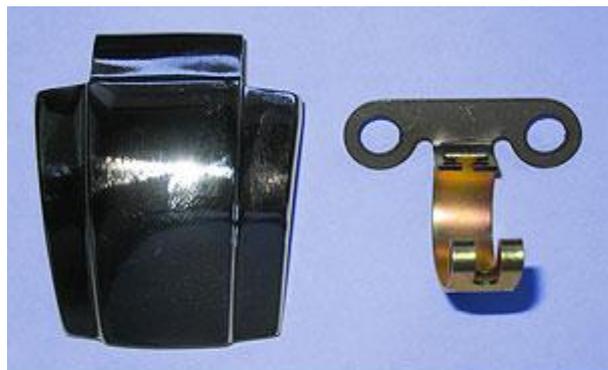
Fig B. Right shows the toggle retainer and toggle spring assembled.

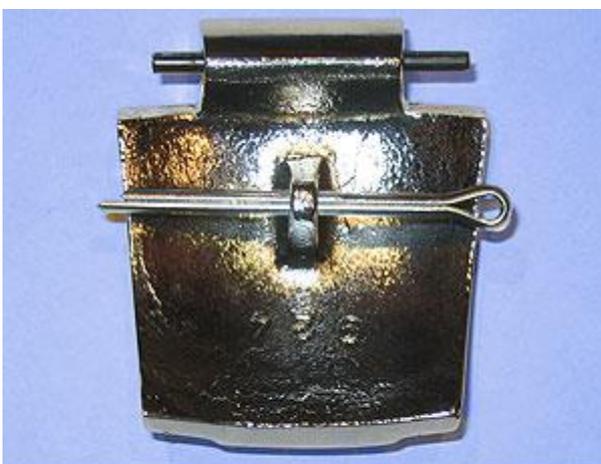
Fig C. Shows the two pins needed to attached the flap to the bodywork and toggle mechanism.

Examination of Fig C will show a hinge pin fitted through the pivot bore of the flap. The pin size needs choosing so that the flap itself will pivot on the pin and the pivoting action will not take place in the centre driving lamp mounting. The pin shown in Fig C is a “roll” pin or spring pin of a ‘U’ shaped section, the flap is a good but swing fit on the pin. Prising out the centre of the U sectioned pin widens the exposed ends of the pin so that the pin ends are a firm fit in the driving lamp mount. When eventually fitted the flaps have a tendency to fall and an unsightly gap appears between the flap and lamp mounting, any further failure of the retaining system will result in the flap becoming detached. If however the flap pin ends are a tight fit and the flap is pushed firmly into engagement with the mounting, followed by the application of some epoxy glue to the end pin fitting as shown in Fig G, the flap will never detach even if the retainer fails. In addition the owner will be rewarded by the excellent fit and closure line shown in Fig D. Once the anchor or toggle retainer has been fitted as described in the previous paragraph the flap pivot pin must be fitted as explained above, and held tightly in position whilst the epoxy glue sets hard.

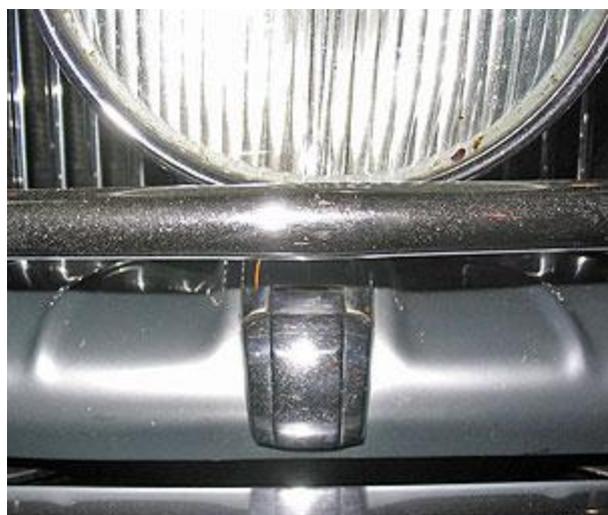
Fig D. Shows the flap in the closed position fitted to R type B87UL

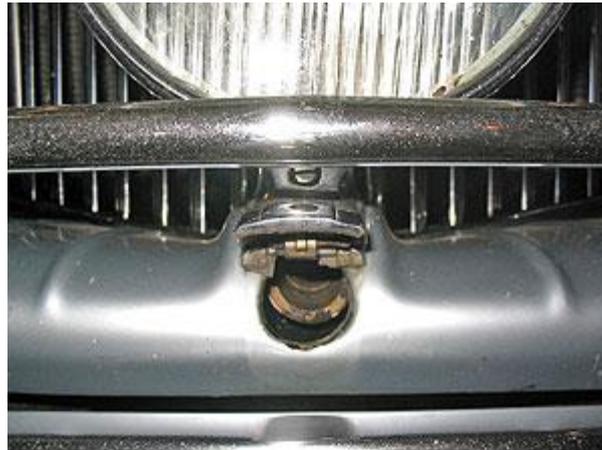
Fig E. shows the flap in the open position and also illustrates the modified starting handle guide with bronze bushing on R type B87UL.

This flattening of the spring needs carrying out carefully and with patience. When the adjustment is correct the flap can closed and opened smoothly and because the spring blade will toggle over centre the weight of the flap will supported when in the open position as in Fig. E and Fig. G. One final finishing touch is required, a small rubber buffer, made from say an old tyre inner tube, should be glued to the underside of the flap edge. This ensures that the flap does not toggle over onto the paintwork of the front apron causing paint chipping and subsequent rusting, or rattling when the car is driven.

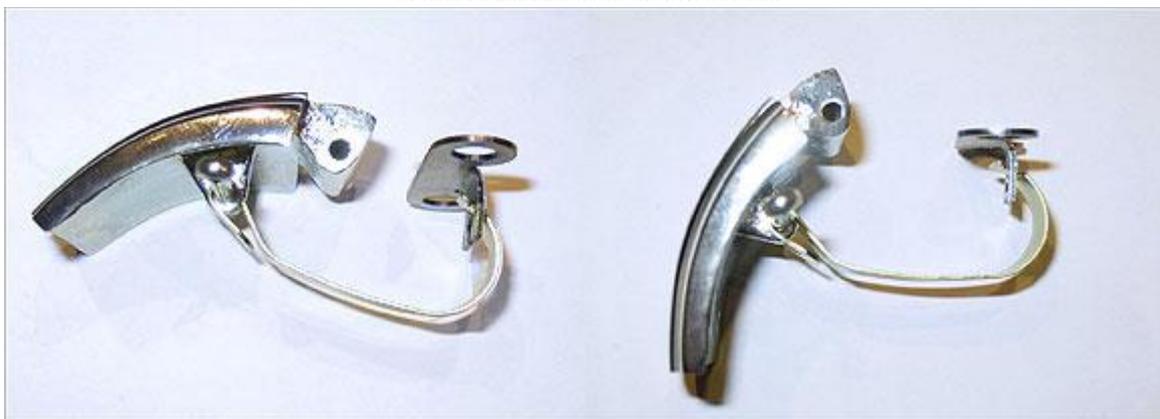
Fig F. Illustrates the assembly off the car. Left in the open position, and right in the closed position.

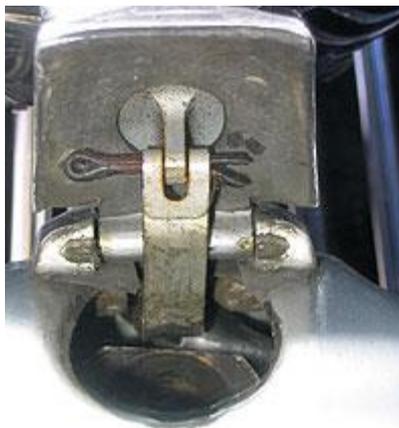
Fig G. shows the open flap, the image having been taken from slightly below the level of the flap. Also shown is the sheathed electrical harness to the centre driving lamp and the cut off top section of the modified starting handle guide together with the flap pin retention method.

trapped in service it is necessary to cut off the top of the offending steel tube but leave the top of the bush largely intact. Fig G shows the cut off section in question and the cable passing over the bronze bush.
