FRONT WHEEL STUD MODIFICATION

N. W. Geeson

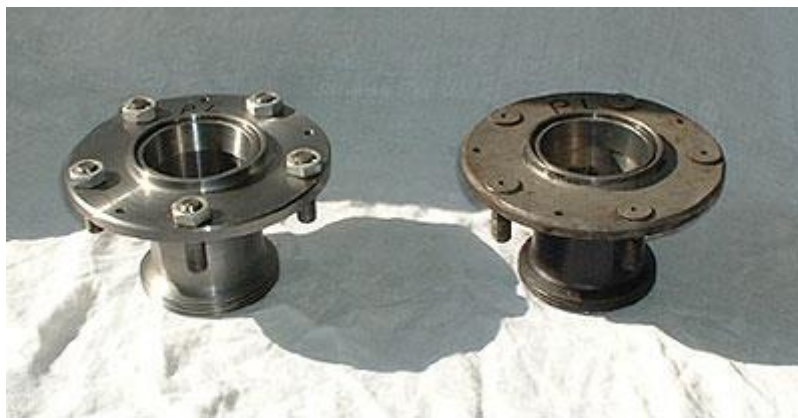
It is believed that the intermediate studs were only fitted to front hubs with the tapered wheel bearing arrangement. However the images show the two types, on the INNER view the studs with backing nuts can clearly be seen on the left, in the OUTER view the hub on the right is fitted with the backing nuts.

Front wheel stud inner view

These intermediate type rivet head studs are extremely dangerous, they bend and in most cases prevent the road wheel from being removed. Whilst most of these studs have been changed a few vehicles, which have been stored for some years, still have these studs fitted.

It is a matter of some importance that no vehicle is used with the rivet type front wheel studs.

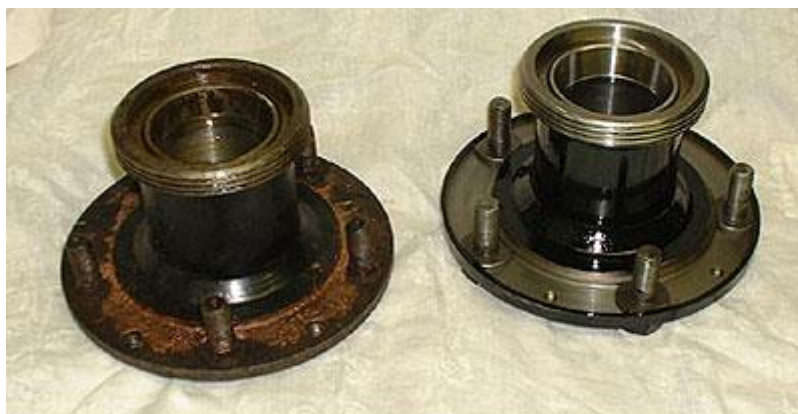
A close look at the left hand hub in the OUTER view will show that the hub is machined differently around the stud pitch area on this hub, which has the rivet type studs.

Front wheel stud outer view
