The ramblings of an amateur enthusiast to be shared with others who own, drive, mind or repair Rolls-Royce and Bentley cars, or those who simply love them.

## A NEW START

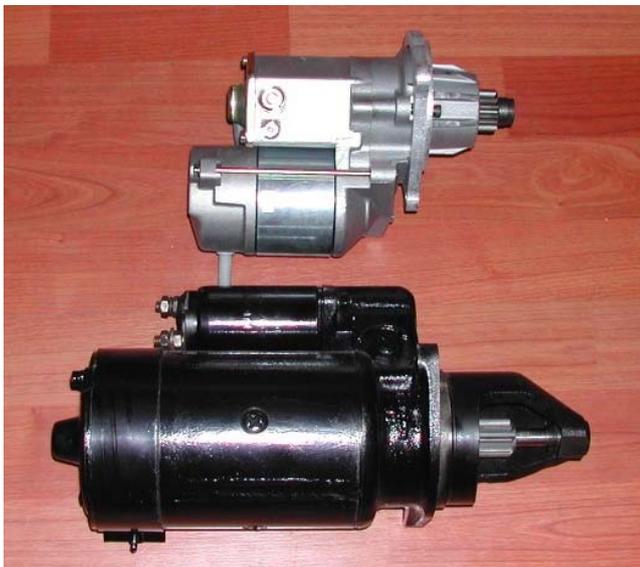
The American firm British Starters [www.BritishStarters.com](http://www.BritishStarters.com) who have been producing Nippondenso-based units for Silver Shadows and Spirits has now produced a version for earlier vee eight cars with four speed gearboxes. For those who came in late the Factory adopted Nippondenso starters for their cars in 1987 and as far as I am aware had no problem with them to the end of production. For what it is worth my various auto electrical gurus all think that it is the best starter on the market today.

The picture shows the startling difference between the genuine article and the newer fitting which greatly facilitates later removal (you still usually have to pull the exhaust to get the old one out) and of course a significant

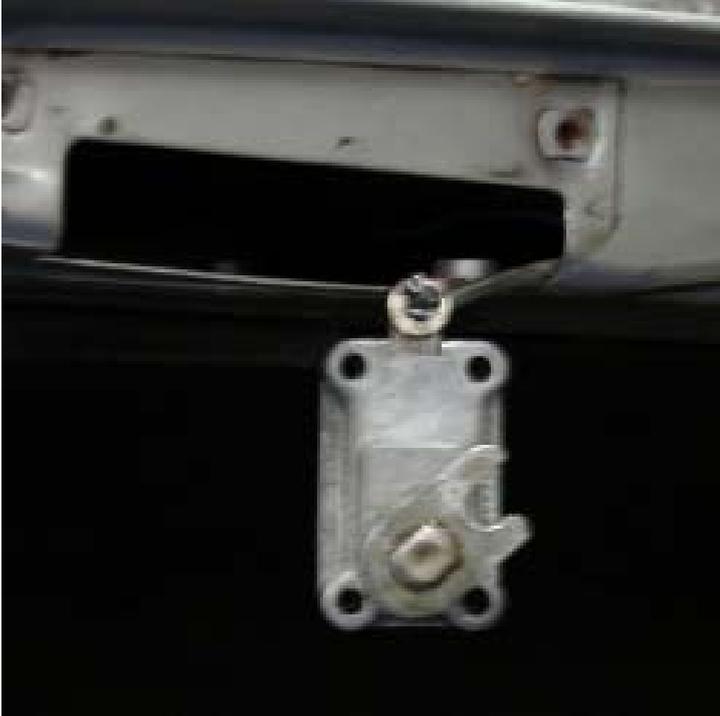
The sharper eyed among you will immediately recognize the depending boot lock of a Silver Cloud I, II or

III. The crab claw seen at the bottom of the lock was spring loaded such that when it struck the peg like casting on the bottom of the boot aperture it would clutch it like there was no tomorrow. The ONLY way it would release the peg was to have the release plunger seen at the top of the lock pulled.!

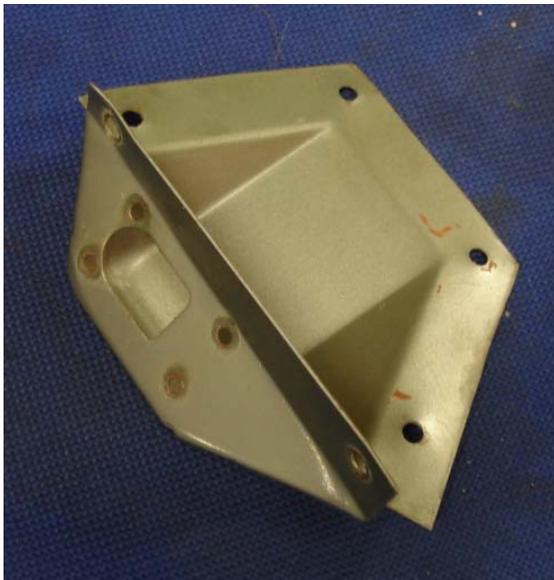
At left is the mounting plate for the lock which is the bit you see most when you lift the lid. Note that all the rod/plunger joints have no means of lubrication other than from your fair hand . Not really rocket science I suggest!

Look closer my friends and observe the lock hanging on the rod. The rod is connected to the central lock plunger at one end and the other end is attached to the plunger. This fits inside the lock, a bit of which you can see at the end. When the boot is closed and locked the crab claw snicks around until in this picture it is pointing straight up, clutching the boot peg.

The lock as you are viewing it here normally lies horizontal to that shown so that the rod pulling the plunger does so in roughly a straight line. Pulling the plunger releases the crab

claw and the boot opens.

Unlike later cars the Cloud and derivatives have two locks to hold the lid shut so the above operation is duplicated. If you look closer you will notice that the rod is simply poked through the lock plunger and secured with a split pin. But an even closer look will reveal that there is a washer between the pin and the plunger. This particular car for whatever reason had been reassembled without the washer and the opening and closing of the lock had worn the pin to a mere figment of its former self. Soon the pin would have fallen out, what was left of it, one good pot hole and the rod would have bounced out of the plunger and all the pressing of the button would not have released that lock! As someone once said 'but for a hapneth of tar

the ship went down'. Not a bad idea to check and in any case lots of oil into the locks and joints would be a great treat. Do NOT however lubricate the keylock itself. That is a job for a locksmith.

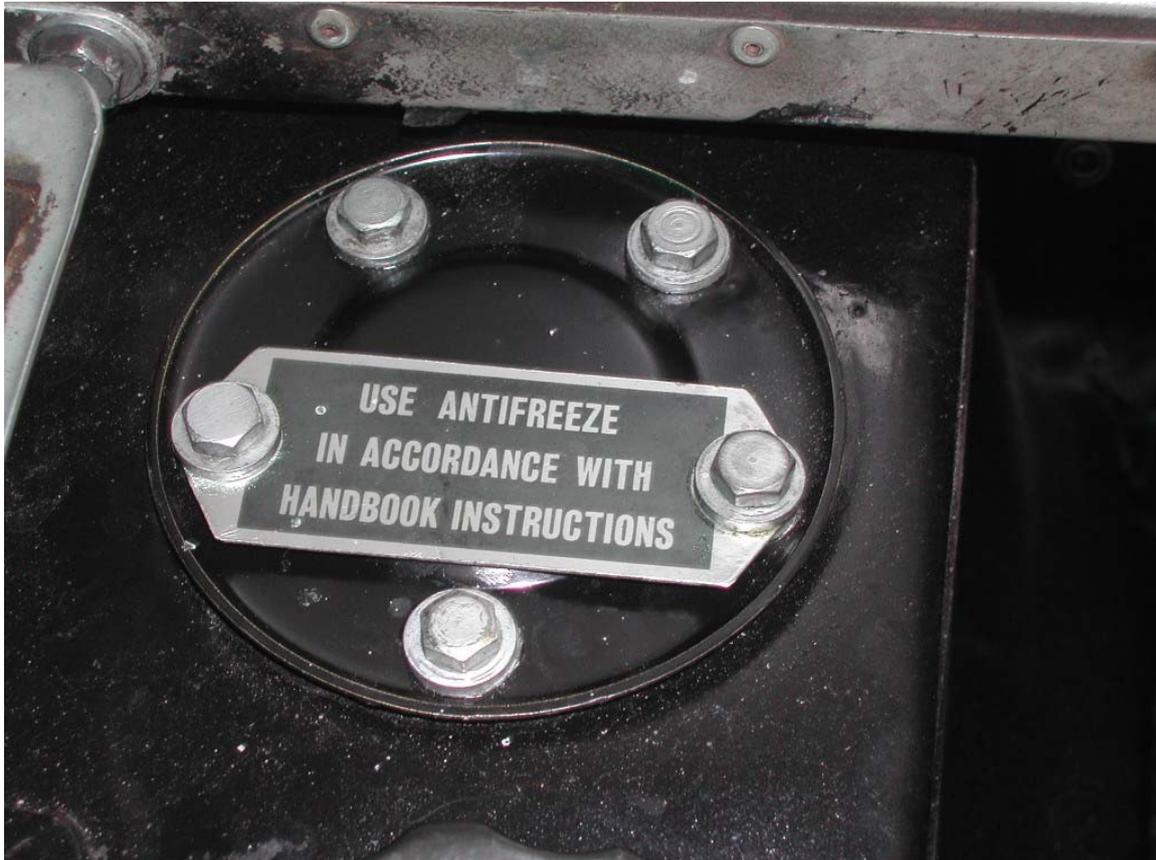
While few of us are into the perfect engine compartment class, this is an area that one can really make a little effort and get a lot of results. Under this bolted lid is the steam valve. In this particular case it belongs to a Cloud III but the same fitting appears on the header tank of every Cloud and Shadow. The function of the valve is to allow the pressure in the space above the coolant in the header tank to rise to a predetermined level which thanks to Mr Boyle and his law of thermodynamics raises the temperature at which the coolant will boil.

The valve also allows the system to blow off excess coolant if you have managed to overfill the system. By now you will have realized that the whole thing relies on things being water tight and steam tight. The assembly is quite simple with a valve housing sitting on a rubber seal and the cap seen above sealed to the header tank with a conventional gasket. If the valve is faulty and blows off too early the engine will lose coolant. If the above plate is not sealed properly it will have the same effect and make a mess as well.

Removing the plate is not always straight forward. The five small bolts have a 2BA thread which if poorly fitted will, if handled carelessly, seize and snap off. The first step therefore is much soaking in WD40 or similar and frequent gentle tries at removal. The threaded holes into which these bolts screw are blind. If

you can get a quarter of a turn, leave it there and soak it and screw it back in and repeat the process. If you manage to break a bolt your only recourse is to drill the broken bit out, rethread the hole and start again. If you are not confident in this department look up the yellow pages and find a thread repair/broken bolt expert and he will come to you and solve your problem.

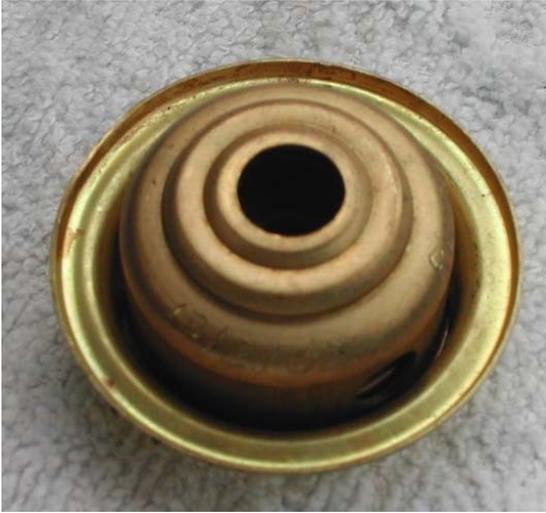
The steam valve seen here is not designed to be opened but the more adept among you will be able to prise the two bits of the body apart to find out why the thing has jammed open. It is usually a failed spring. If you do go down that route and fit another spring be very cautious and err on the lighter side in choosing a spring lest you set off a small Hiroshima under the nether end of the Lady!!

Extracting the steam valve is simple. The rubber seal thereunder probably is perished and needs to be replaced. If there is any doubt about the valve replace it as well. Note that Shadows had two different sized (in diameter) valves. The smaller diameter was the one the Factory finally settled on. If your early car has the larger valve you will need to get your fitter man to make up an annulus to drop in the hole and secure it with a good super glue. The valve pushing down on the new seal in the annulus will hold all together.

Glue the gasket for the cover in place and refit it with preferably new 2BA bolts. Note that the two holding the label on the cover are longer than the others having spacers under them to keep the label above the dome of the cover. If these have been lost make some up. Lastly so that the next poor bloke who pulls the thing off can do so without trauma, replace the bolts using an anti-corrosive paste!

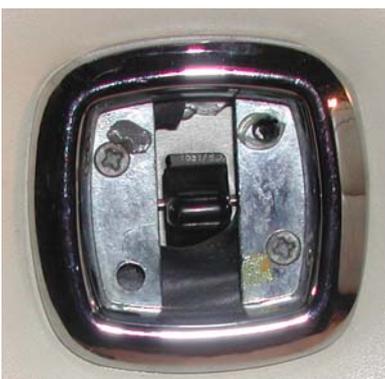
know that you have to ease the plate out evenly or break off the legs on the back of the escutcheon plate. These actually plug into very small plastic sleeves that fall out and are so easily replaced. Here you seen the mounting

plate with two gaping holes sans plastic inserts and at the top left one of two bits of blue tac used to hold the escutcheon plate in place!

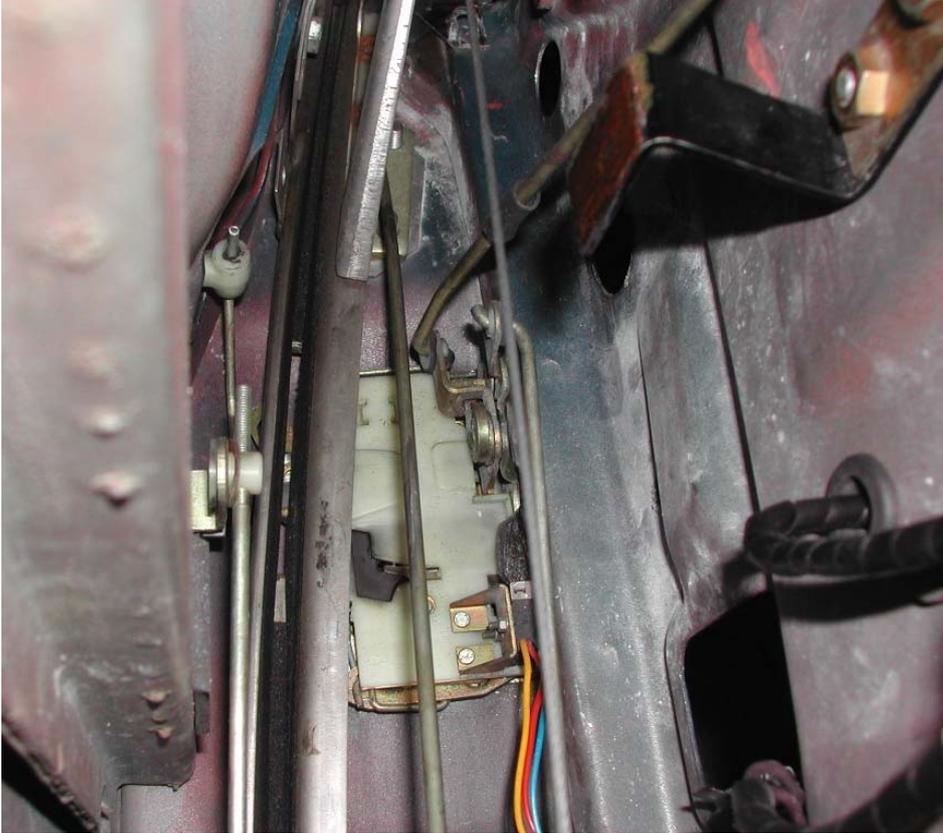
One of the delightful little fittings our cars had for many many years were switches neatly planted in the door pillar. These worked well until they dried out the button jammed or was bent or common grunge worked its way into the switches innards. When the SZ cars were put together they were incorporated in the actual lock assembly inside the door. And here thanks to flash lights and digital cameras and a door de-lined is a picture of the switch which is at the top end of the dangling wires.

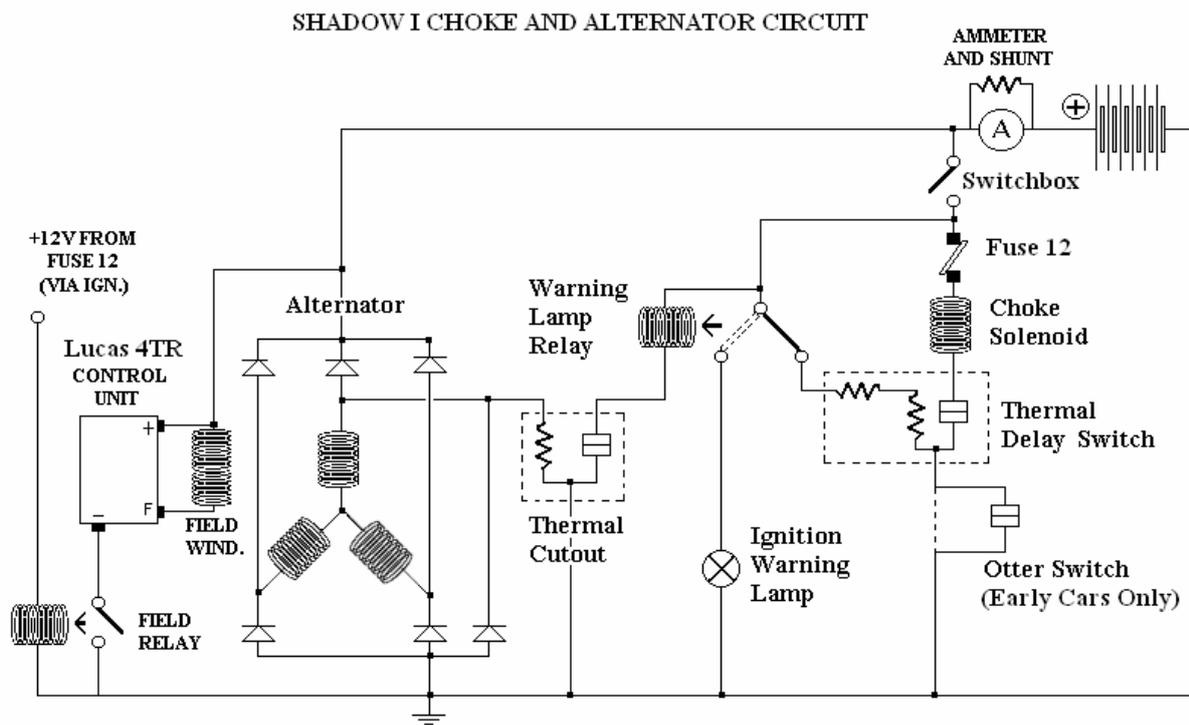
### Operation of the Choke Solenoid

**John Kilkenny** kindly extracted the circuitry for the later choke control systems used on the Shadow, which I reproduce below together with an explanation of his penmanship.

- The purpose of the Choke Solenoid is to hold the choke butterfly valve almost closed on startup to ensure a rich fuel mixture. If this was not done the suction of the engine would pull the butterfly open and weaken the mixture, making starting difficult in low temperatures.
- Referring to the diagram ; when the ignition switch is turned on, the Ignition Warning Lamp is lit due to the Warning Lamp Relay being energised.
- The Choke Solenoid is energised via the Thermal Delay Switch and the Otter Switch (provided that the ambient temperature is low enough to make the Otter Switch contacts).

- When the ignition key is turned further to start the engine, current from an internal alternator winding operates the Thermal Cutout which drops out the Warning Lamp Relay and extinguishes the Ignition Warning Lamp.

- The other contact set in the Warning Lamp Relay allows current to the heater coil of the Thermal Delay initiating the delay time..
- At the end of the delay time the Choke Solenoid is de-energised.

- The Choke Butterfly Valve will then gradually open as warm air enters the Choke Stove Assembly.
- The circuit remains in this state until the warmth of the engine opens the Otter Switch contacts, removing current to the Thermal Delay coil.

- This will close the Thermal Delay contacts but the Choke Solenoid will not be energised due to the open Otter Switch which prevents energising of the Choke Solenoid until the Otter Switch cools and resets.

- On later cars no Otter Switch is fitted and the Thermal Delay Switch goes directly to Earth.
- This means that current continues to flow through the heater coil, maintaining the Choke Solenoid de-energised.

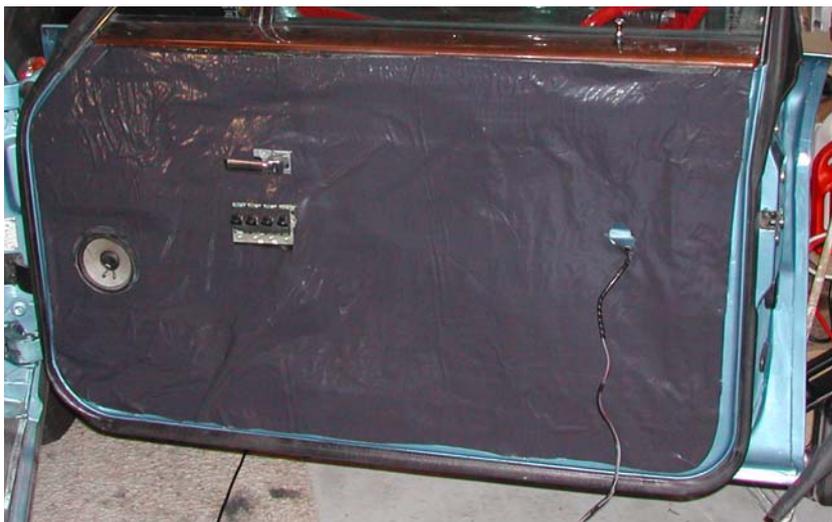
the vapour barrier seen here, is torn and crumpled like yesterday's lunch wrap. This is quite vital to stop the inevitable damp that gets into the interior of the door from rotting the wooden backing and perhaps even the leather of your door liner. Make up a new one in builders' plastic which will be better than the original and use spray on adhesive (only one coat on one side so that you can get it off again!).

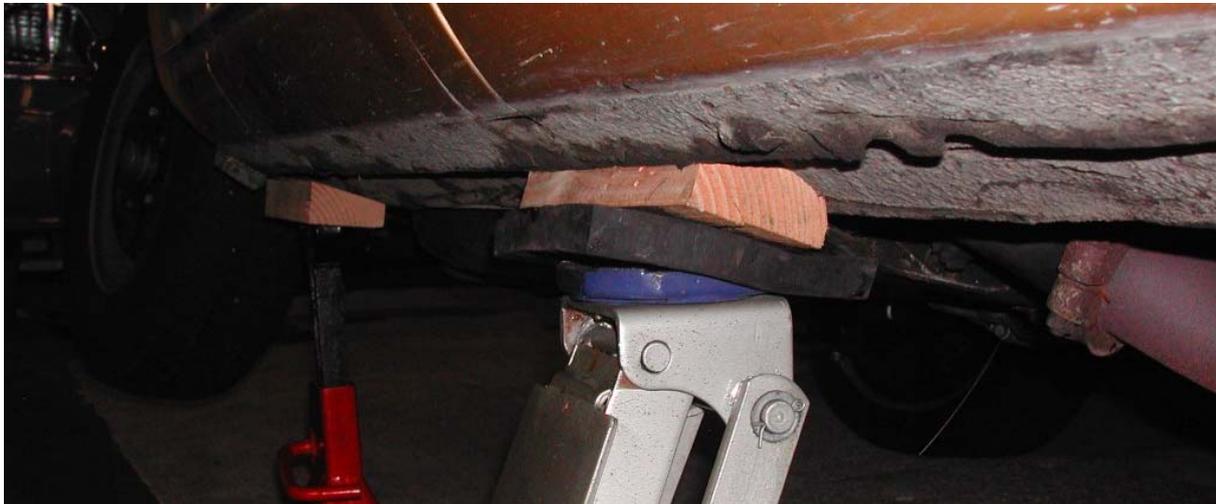
Using the conventional car jack is perfectly satisfactory although a large trolley jack should give you a higher lift. Of course whichever method you use, place stands under both ends of the car before getting in there. We don't want to prematurely reduce our readership do we?

Note the shaped wooden blocks used to support the car by the sills. These are essential to avoid serious damage to the car. If you use a trolley jack get yourself a 6" square of 1" thick industrial rubber to put on the head of the jack. This will stop damage and prevent slipping.

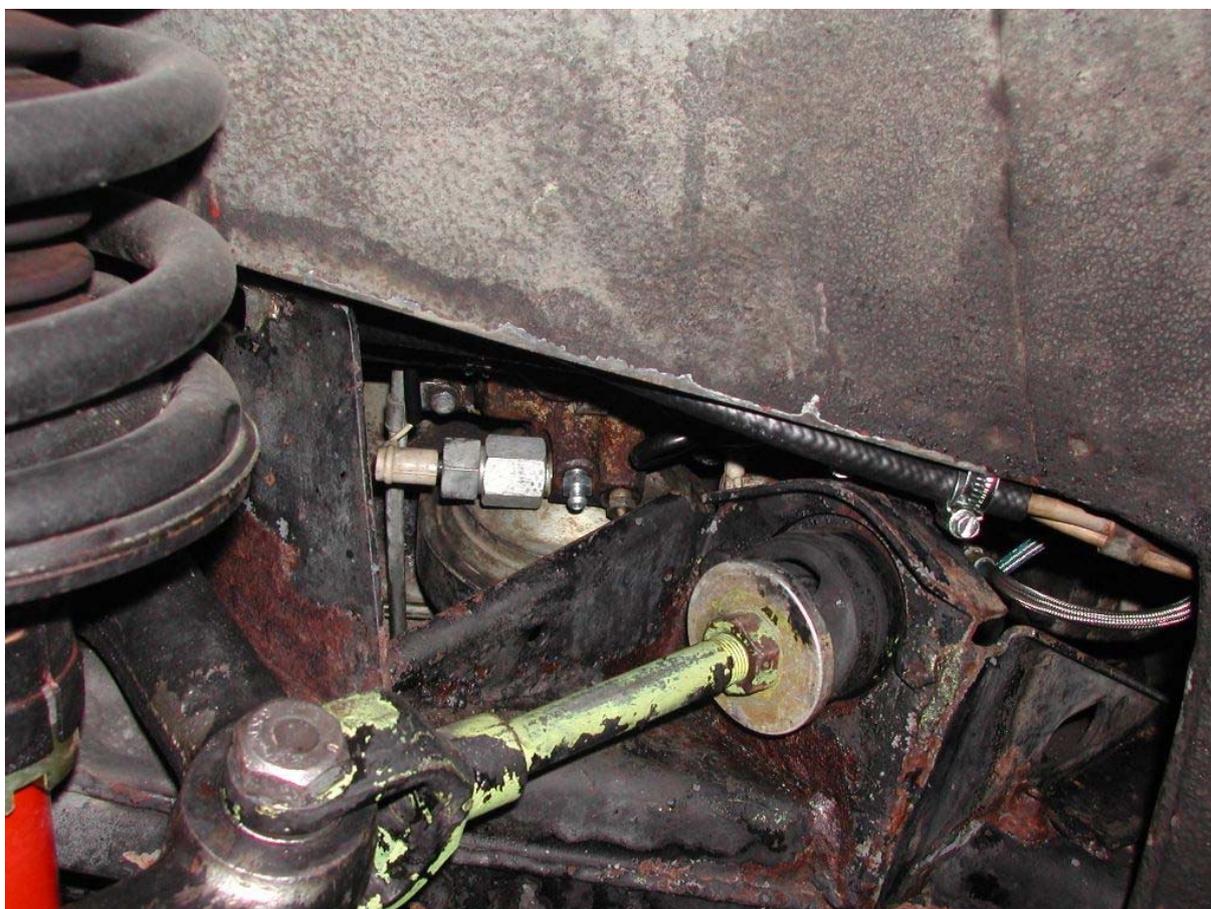
Here is a bird's eye view of the front or number 1 system accumulator on a Shadow I. The bleed nipple can be seen centrally with the pressure switch to its immediately left and the actual accumulator beneath it. The hose running along under the valance is one of the low pressure return lines carrying fluid back to the reservoir after the accumulator is fully charged.. The braided line to the right is the flexible high pressure line from the accumulator to the body of the car and thence to the brake actuation box under the driver's seat.

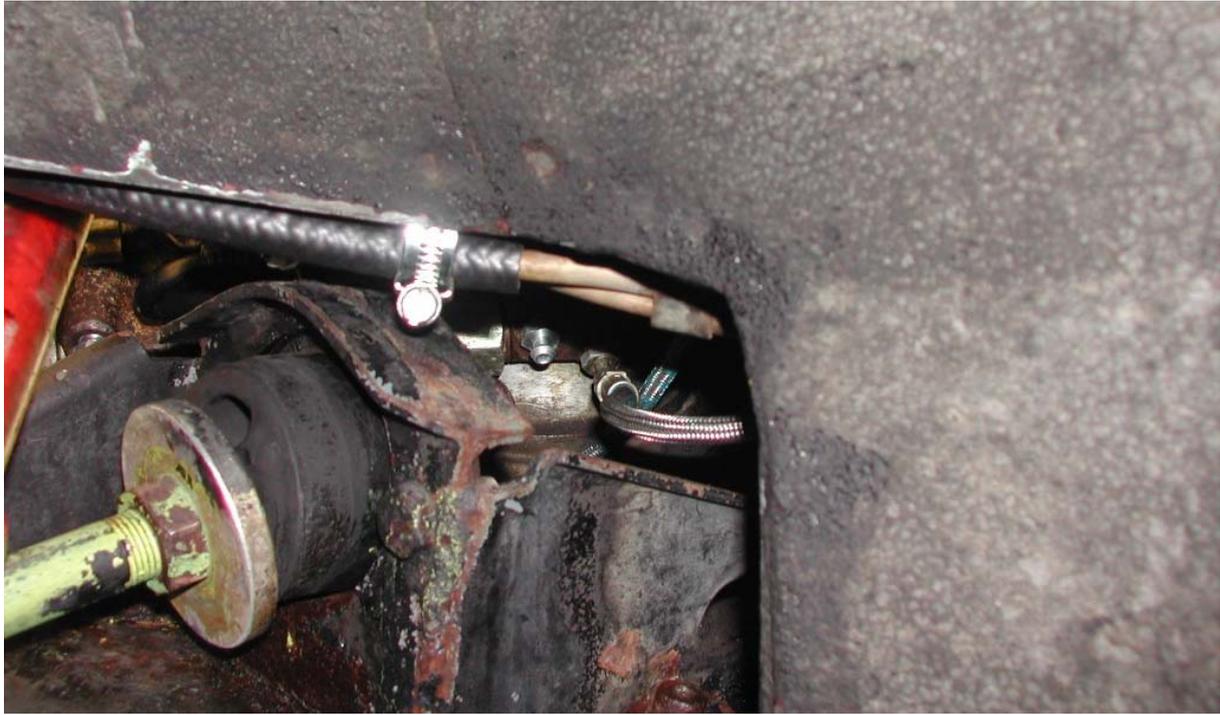
The rear or number 2 accumulator and its bleed nipple. The rear accumulator cannot be removed without first removing the front unit.

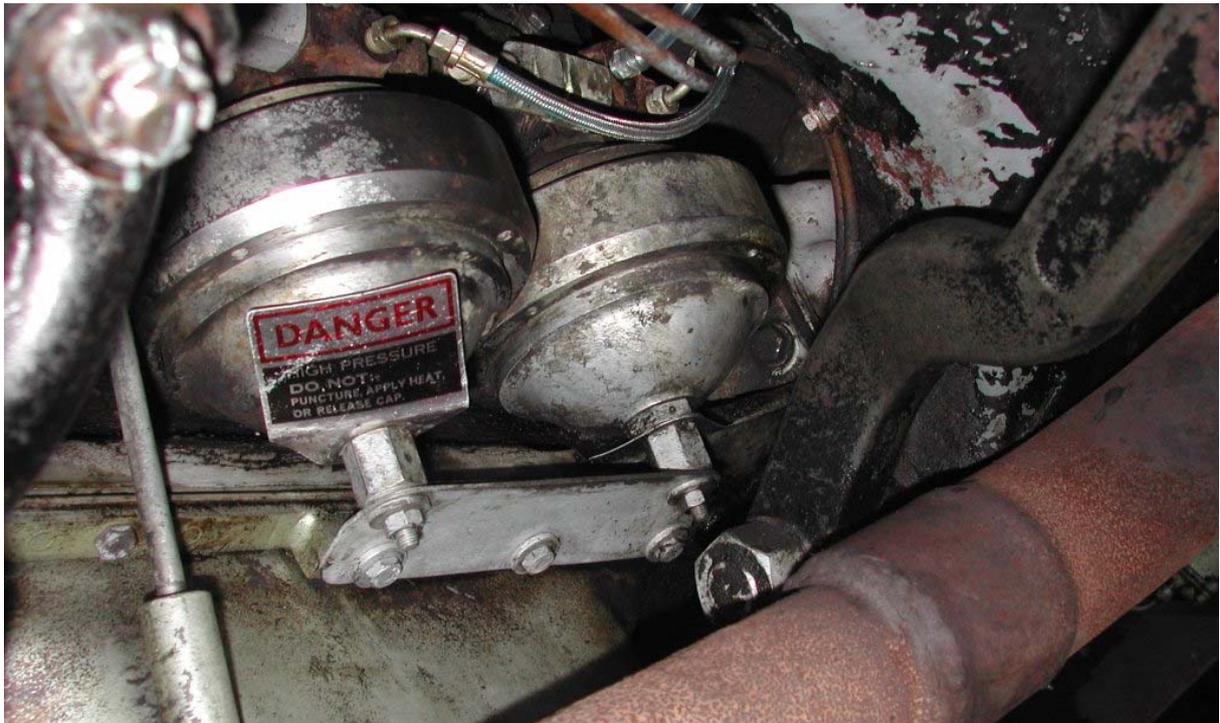
A worm's eye view of the two accumulators. These screw into the control valves which are bolted to the engine block. The plate between the charging caps and the sump is sometimes left off which does little for the structure given their weight. The heavy rings around the units hold the two halves together and are unscrewed by a special spanner using the holes seen in the lower side of the ring. The sloping pipe to the left is the dip stick tube and whilst going through cervical dislocation with the accumulators you may as well remove the tube and fit a new 'O' ring where it goes into the sump adapter.

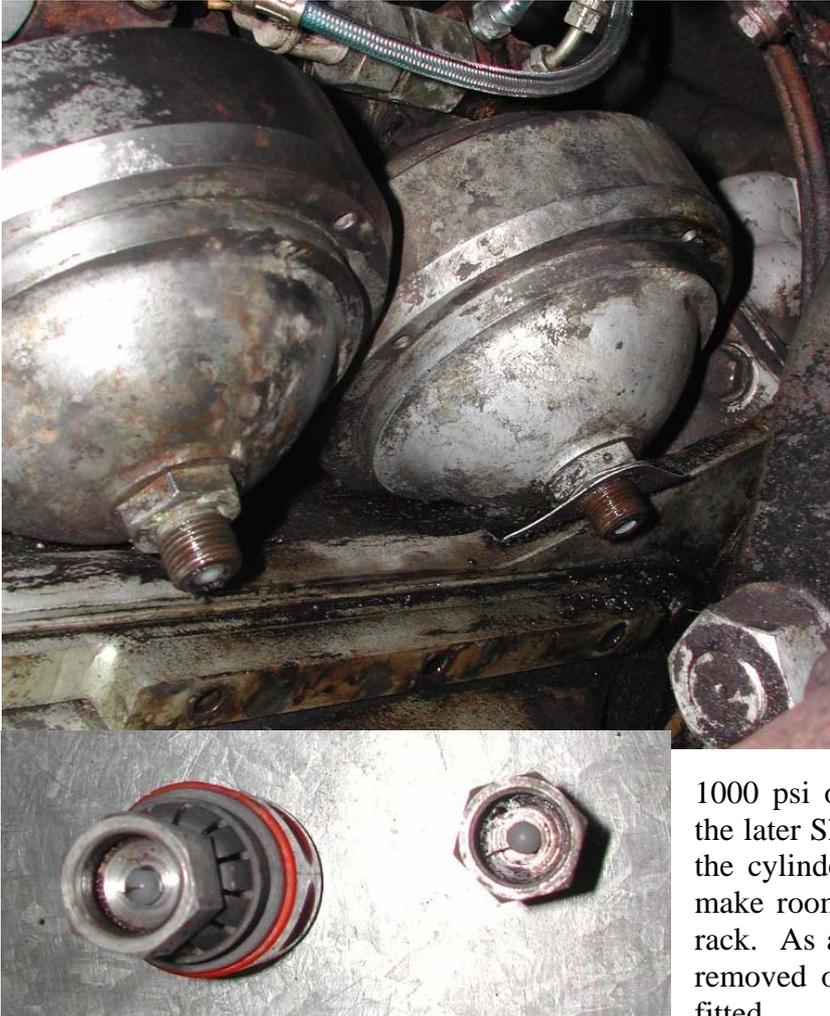
Below the lower support plate has been removed along with the charging caps. Note that the front accumulator has a nylon sealing ball still jammed in it which has to be prised out. It is at this stage that a perforated diaphragm will be apparent evidenced by oil coming out of the charging hole.

Before fitting the charging hose the warning plate and anti-rattle wave washer are cleaned and threaded back onto the valve body. This is to minimize the time between shutting the gas off, unscrewing the hose and refitting the charging caps.. Below are the charging caps fitted with new nylon sealing balls ready to be quickly refitted when charging is complete. Lastly at the bottom is the accumulator being charged with

1000 psi of nitrogen. The accumulators on the later Shadow IIs were sharply angled into the cylinder block and placed either side to make room for the then new power steering rack. As a result either the cap could not be removed or the charging hose could not be fitted.

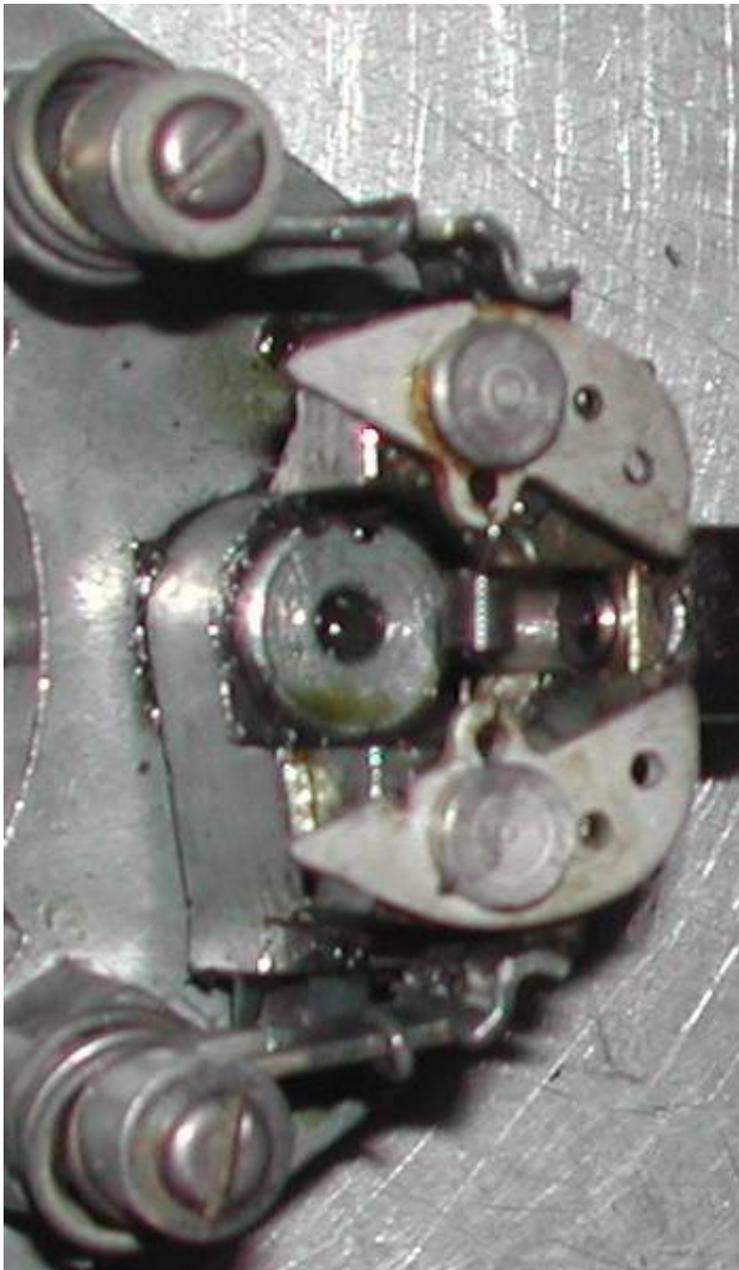
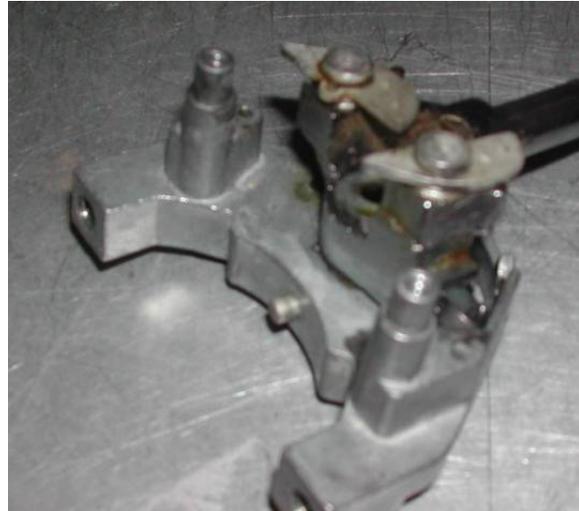
switches of this kind rely on a peg mounted on the steering column shaft or the back of the wheel to knock the switch mechanism back to the datum position when the steering wheel self centres. These switches appear to have been made with a poor selection of materials, the primary one being the large round pivot seen in the photo above. This has to take the various loads imposed on it through the switch lever and apparently wears prematurely. The result is that the 'cancelling peg' on the back of the steering wheel often pushes the whole lever and attached bits away from it rather than knocking it around to the mid way position.

Actually I lie in this case. The 'peg' in these switches was designed to push against one of the two half moon cams seen either side of the central pin at left. These cams in turn bear against spring loaded levers (arrowed) lifting them away from locating grooves and allowing the assembly to return to the central position. It is the mechanism to return the lever to the central position that is the other problem with switch operation.

Seen on the lower side of the switch and in the inset is a grooved abutment. Running in the groove is a spring loaded roller which sits in an aperture in the lever base. The groove is 'V' shaped and the sprung roller naturally returns to the bottom of the vee. Unfortunately the material that the base and therefore the abutment is made of is relatively soft and also wears quickly. This tends to inhibit the roller and the lever has difficulty finding the datum position. The solution appears to be to somehow face the roller track with shim steel to restore operation. As to the central pivot that is a relatively simple rebushing exercise for your local machinist.

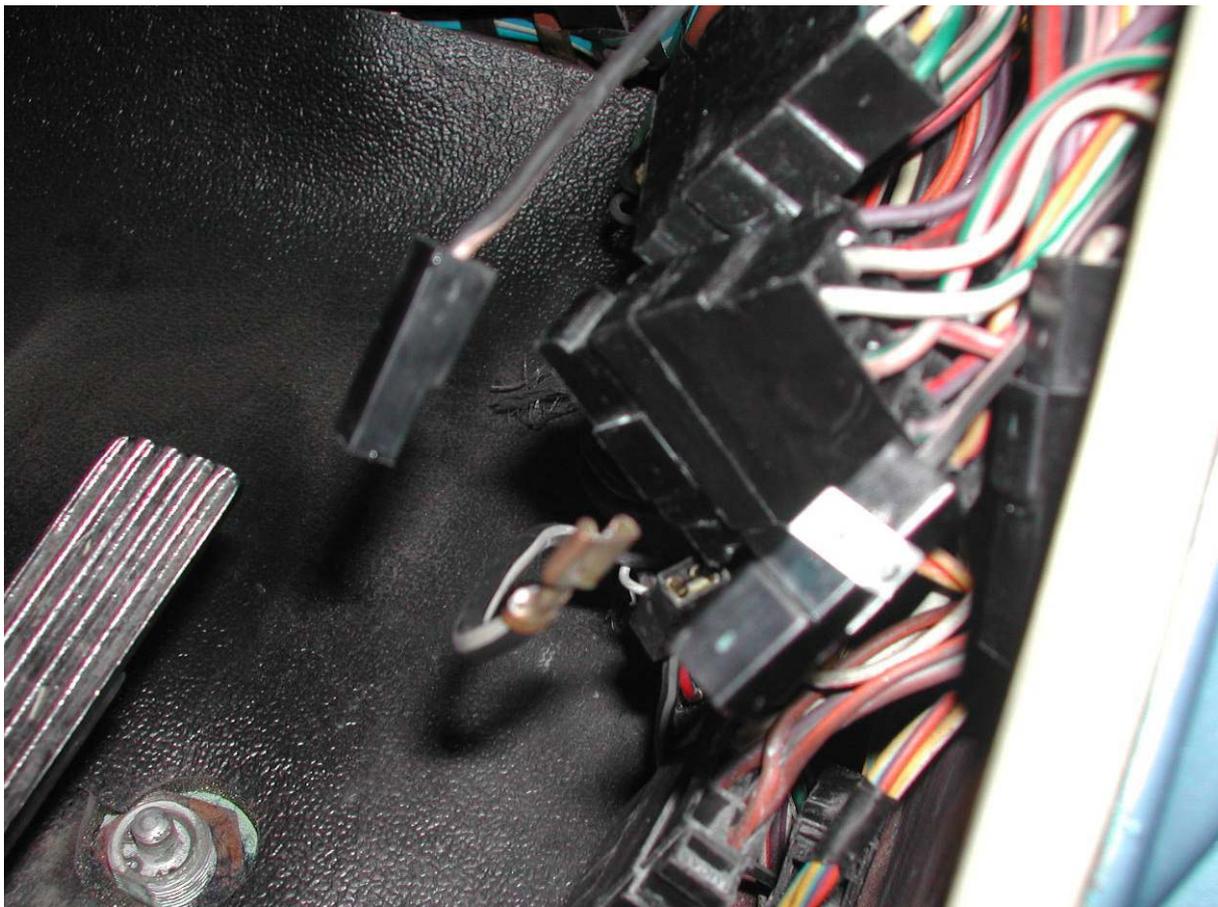
This mess normally resides behind the right hand kick panel of my Spur. Conspicuous is the myriad of plugs each with up to 7 terminals. Apparently humidity and electrolytic action at the contact points in these plugs causes local insulation and you have a broken circuit. The Factory recommended of all things liberal doses of WD40 to clean and remove the verdis gris.

The plugs are very accessible and easily parted and you might like to get a little more drastic with a popsicle and a strip of fine emery paper to thoroughly clean the terminals. The object of the plugs was to simplify the looms and facilitate their fitting. On pre'87 cars the plugging at the actual bulkhead is extensive and needs watching. Later cars threaded the looms straight through and sealed them.

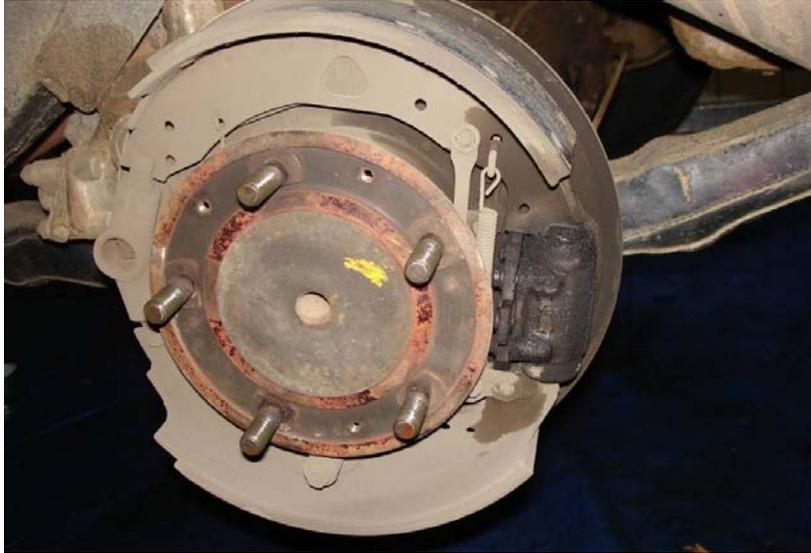
We spend so much time these days worrying about the problems of our high pressure Shadows et al. But the good old simple brake shoes and drums are not without their problems. This is the right rear brake on an S series car that has a significant leak in the wheel cylinder department. This will involve dismantling and fitting new cylinder seals and even possibly re-sleeving the cylinder itself if

it is scored or pitted.

These brakes on a concours standard car had front linings worn almost to the rivets - a condition that can only be ascertained by removing the wheels and drums, unlike their successors where a torch and an old bag can have you under the car to check the wear on your disc pads.

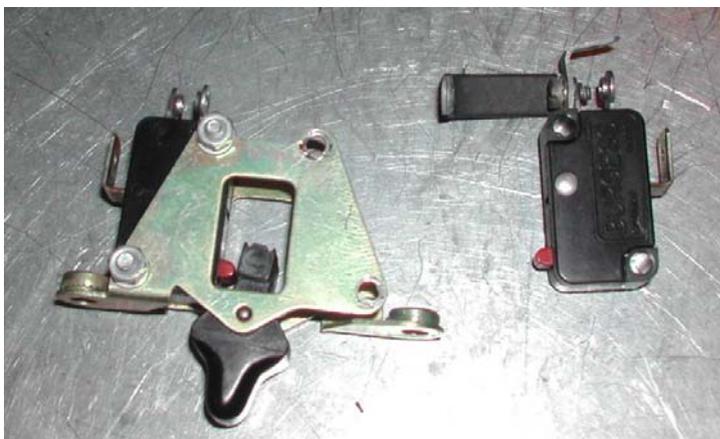
For those that haven't seen them these little assemblies nestle in the doors of your Spirits Spurs et al. Known as Burgess switches the little red button is the one that has to be pressed to make or break contact and run the little motors. In the driver's door four of these are packed in very closely connected up with little bus bars. The keen eyed among you will spot at the top of the switch two protruding terminals

each is fitted with a terminal screw. The screws actually screw towards each other. If the screws are too long they will touch. If they touch they will short out the window circuit and trip the circuit breaker. No window up or down! We have now seen this happen twice. In both situations the switches were a new series with metric threads. For information – be aware!!
