The ramblings of an amateur enthusiast to be shared with others who own, drive, mind or repair Rolls-Royce and Bentley cars, or those who simply love them.

SAVILLE ROW SUITS AND DIRTY UNDERWEAR

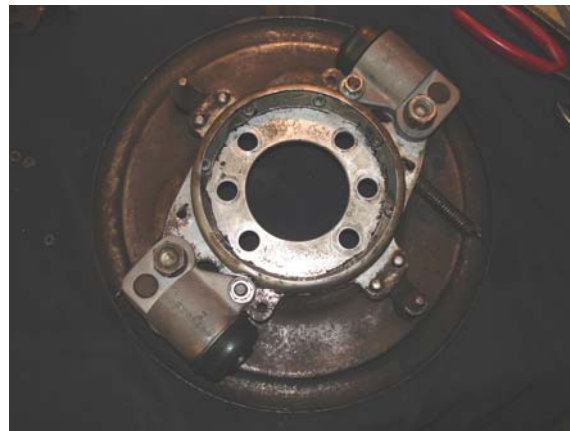
The gloomy picture at the right is the complete front brake assembly removed. This is a necessity to get the wheel cylinders off to re-sleeve. Given the neglect this car had had in this department removal stripping and cleaning was probably essential. At left is the muck in the bottom of one of the 'jam jars'. An interesting story heard from the antipodes:- apparently some bright gentleman was touring in his Cloud at 100 mph for a considerable time in an ambient temperature of over 40 degrees C. It was apparently too much for one of the jars which cracked with the heat and dropped its contents all over the red hot exhaust manifold starting a terminal fire!!

The tops of the reservoirs were removed, the brake fluid sucked out and lo, there in the bottom was a nice little pool of rusty water. The master cylinders were the final straw. They each had about half a teaspoon of silt in them so much so that the lower or smaller of the two master cylinders was jamming and the piston could not return far enough in the cylinder to replenish its fluid holdings. In short the car had about 55% of its normal braking power.

All cylinders were bored out and sleeved in stainless steel and the whole lot rebuilt with new seals and boots. Flexible hoses were replaced and new linings bonded to the brake shoes. These cars have a complex braking system but following the book the amateur mechanic should fare well with care in the exercise. And he should be able to drive the car anywhere regardless of its looks confident that it will stop as intended by the Factory!

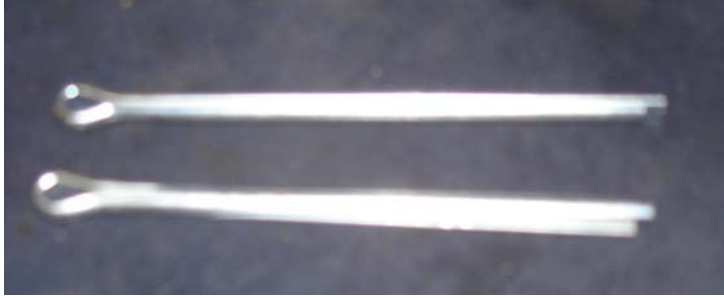
But one area in all conventional Rolls-Royce hubbed cars does demand split pinner of the highest order and that is the item used to hold the large nut securing the front wheel bearings to the stub axle. All post-war cars have a spring loaded contact riveted to the inside of the front wheel bearing hub cover. The contact rides on the centre of the stub axle. The last thing it needs are the stout legs of a 5 mm diameter split pin to be rotating about its contacts. The solution is the 'twisted' pin. And I note that there appears to be some query as to whether this is an approved method.

The above drawing from our Mark VI manual should settle that argument. Item '3' is the split pin duly wrapped around the nut! Note the sprung contact '2' which would be quickly wiped out if the pin was fitted the 'right' way as illustrated above.

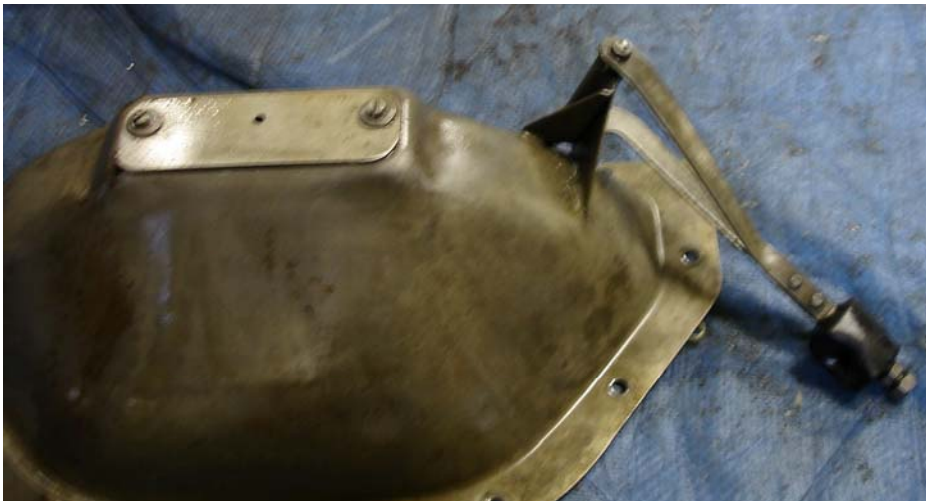
At left is the most simple component. It is the cover for the flywheel. The bracket swiveling off of it supports the whole mechanism.

the body was mounted on rubber as was the engine, the steering column and as far as possible the control mechanisms for the transmission. Hence the bolt seen through the pivot on the cover above had two small top hat rubber grommets fitted as insulators. Invariably these are missing, immediately giving rise to transmitted noise and looseness in the gear change mechanism. They are still available.

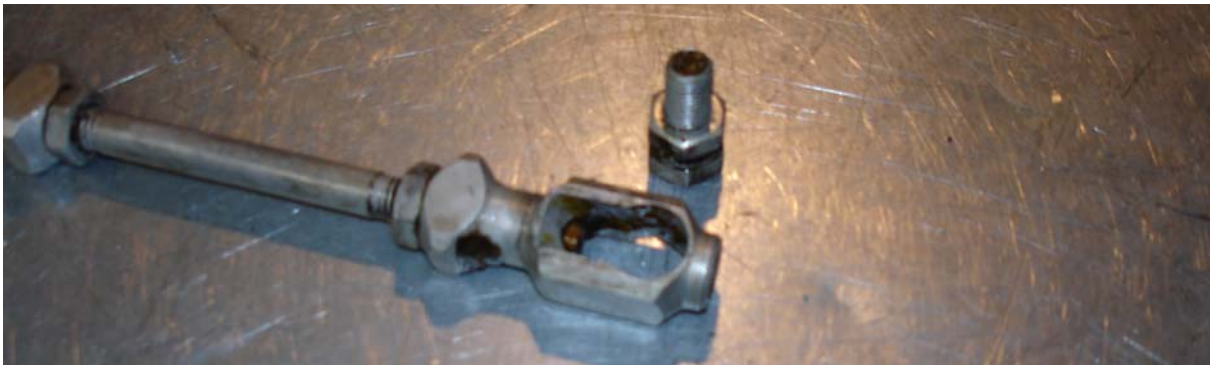
Above is one of the linkages with its adjusting nut. What is not shown is the ball joint that the end of the linkage grips. Look closely and note the hardened button at the bottom of the joint. The base of the bolt is similarly shaped, both are designed to accommodate the ball joint. The adjustment needs to remove all internal movement and with the slightest nip. The whole assembly is packed with high melting point grease and covered with a rubber boot. If the latter is damaged in any way replace it

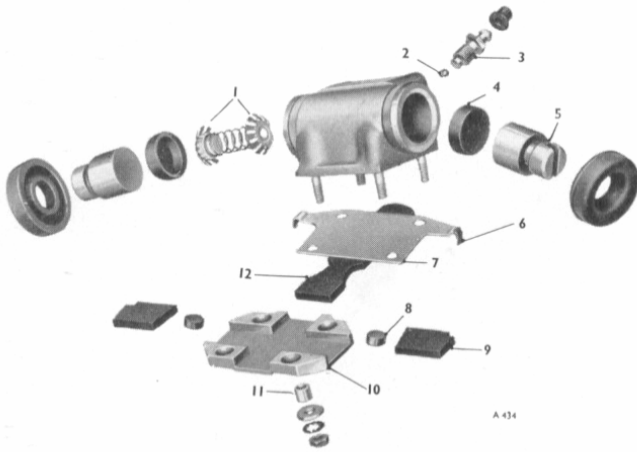
Fig. G28 Expander unit — exploded view

And here it is exploded! It is a combined mechanical and hydraulic expander used on the rear wheels of the Cloud series of cars. Some owners may not realise that most of the braking needed on any car is on the front wheels since most of the weight is there. But there is still some effort required at the back wheels which is why the braking bits there are much smaller. But this installed system goes one step further and uses the mechanism for the handbrake immediately before the hydraulics start doing their thing.

Item 12 is a very strong bit of metal with the end that you can't see, because it is under item 6, is connected to the brake rods from the mechanical servo on the side of the gearbox and at the

Pulling this same bit of metal forces the plungers (9) outwards applying the brakes. At the same time the hydraulic plungers (5) are also pushing on the toe of the brake shoe.

This is all very well when it is put together with some high melting point grease. The four nuts you see in this picture sit on spacers which keeps the whole assembly reasonably loose and avoiding early gumming up. Overall it is a bit primitive but effective. If there is no evidence of leaking in the hydraulics, consider a couple of cans of brake cleaner available at your local friendly car bit place, put a tray under the hub and get stuck about the whole assembly with the good fluid. This will also clean the brake dust out. Using a small screw driver when the assembly is dry you can replace the lubricant by poking a bit into the faces between the handbrake plunger and the cams. While you are there check the

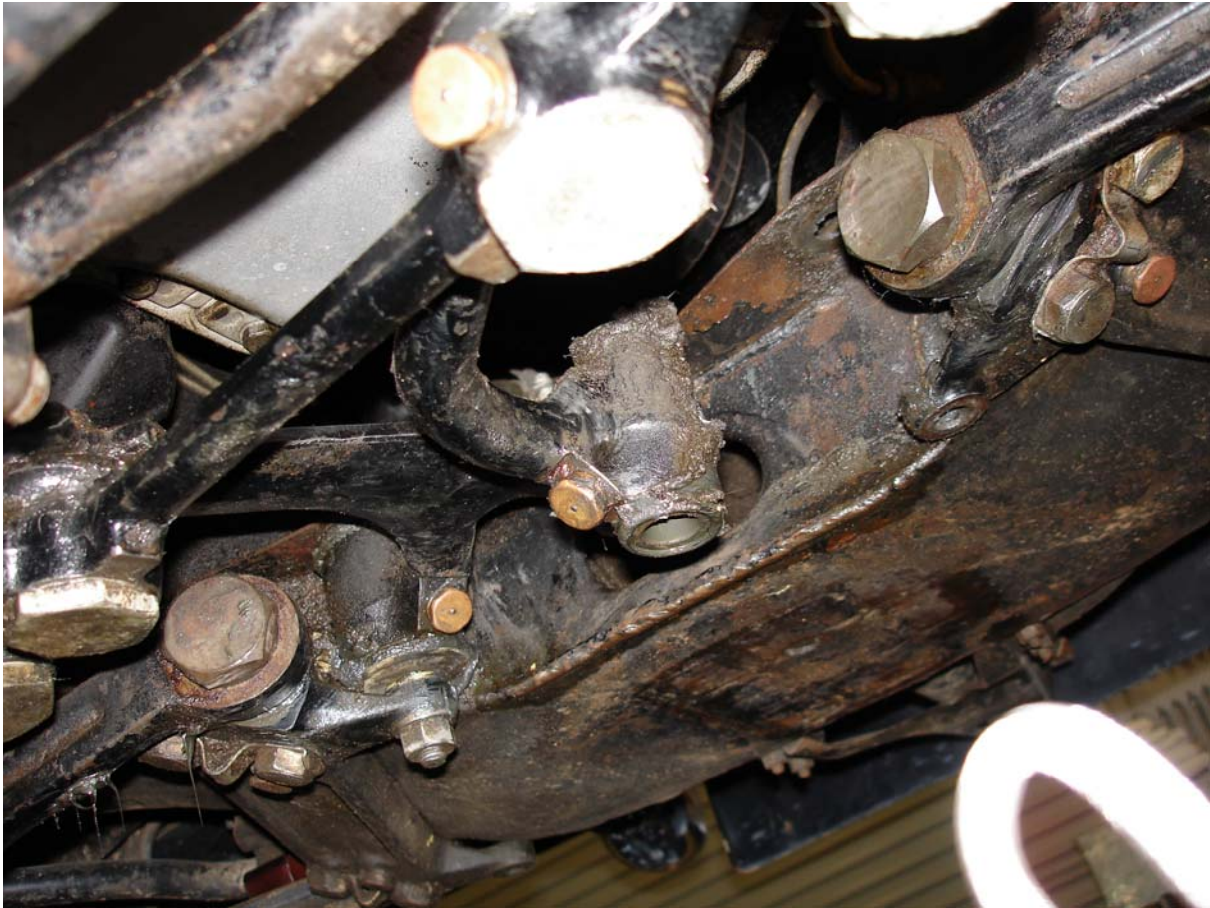
By contrast the right hand lever is much lighter, runs on relatively small bronze bushes and is prone to wear.. The repair is simple. Remove the pivot pin by removing the nut and washer and tapping the 'bolt' upwards with a long drift. The 'bolt' or pivot pin will fall to the ground when it clears the top mount and the entire pivot lever can be pulled free from the cross member. Note the washers that pack the lever top and bottom as it is important that they be replaced as they were on reassembly.

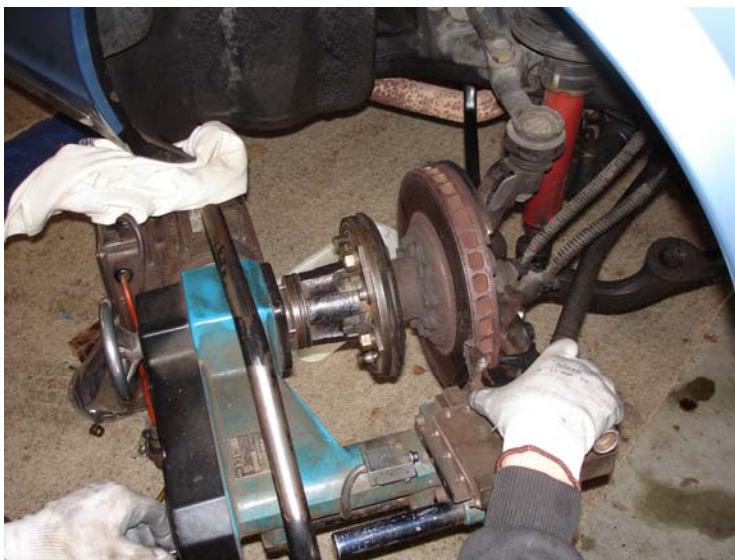
And here is the lever clear of the front axle. To disconnect it from the yoke usually requires a scissors type tie rod end splitter. There is sufficient room to work and once off, take all the bits to your friendly fitter and have him rebush the lever. The overall height of the bushes is important as the packing washers that were at the top and bottom were selected to give a tight fit. When fitting the lever it helps to cheat a little and lever the top flange on the cross member up a little to help line everything up. The bolt can then be dropped down from the top and tightening up the nut will provide the necessary nip.
