GETTING YOUR PEDAL UP!

EZYOUTS

SEALING THE SPHERES

PUMP SEALS

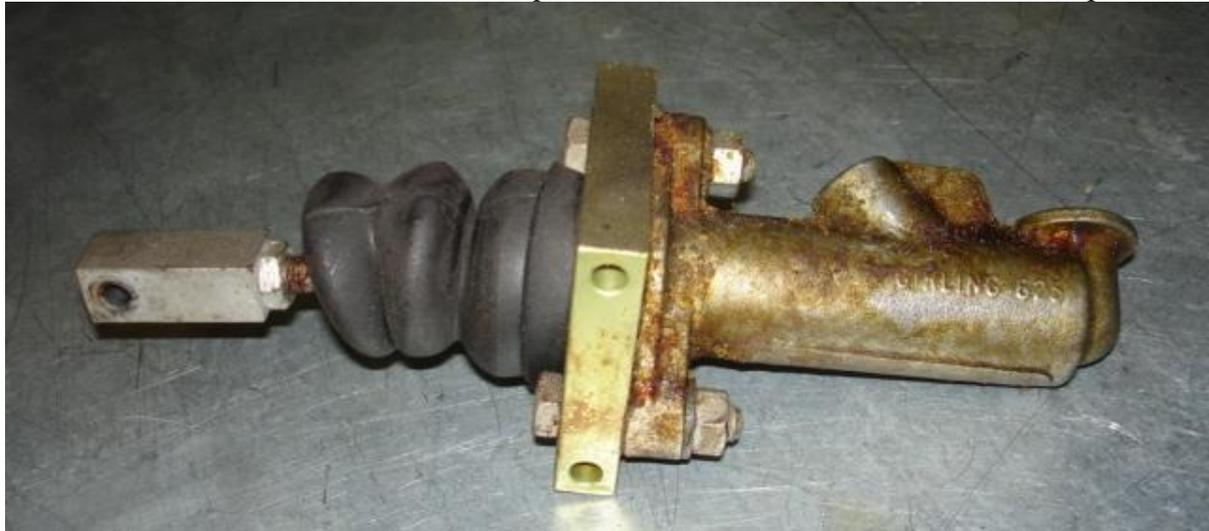
This is a forlorn master cylinder extracted from one of the iconic Corniches, well overdue for an overhaul or replacement. The external crud is from the continuous shower of brake fluid that drips from the brake actuation valves and blown back by the air stream. The master cylinder was fitted to all cars until mid '76 when they were replaced with a rubber cushion that pedal action forced into a suitable cup to give 'feel' to the pedal. The hydraulic line however was not wasted but incorporated into the high pressure system.

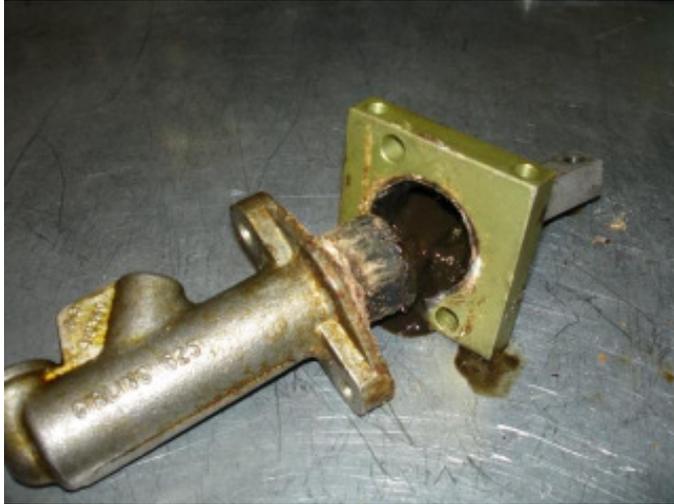
The crud seen here when the entry to the master cylinder is exposed comes from fluid leaking back through the piston seal when the pedal is not pressed. To check the veracity of similar seals in the wheels simply prise the rubber outer boots aside and inspect for fluid or viscous paste which is fluid 'condensed'.

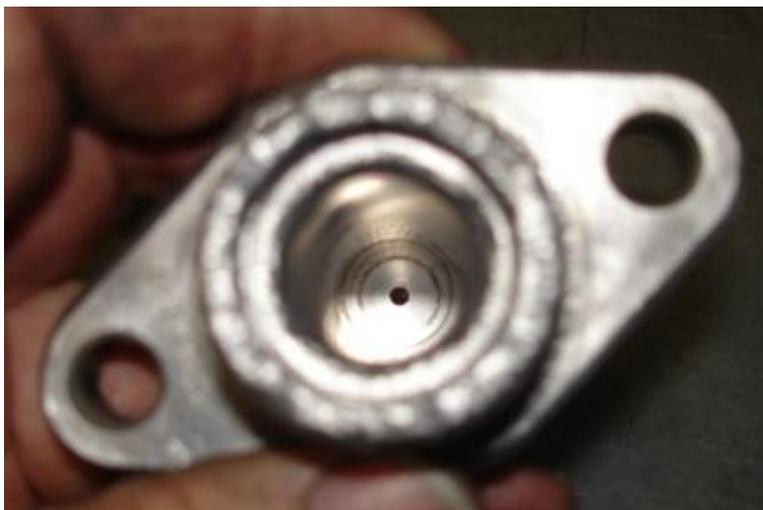
Here the push rod with its boot, the piston and the valving have been extracted. The hole at the end is the feed from the reservoir. This cylinder as always must be perfect. If it is not, have it sleeved in stainless steel and it should outlast you!

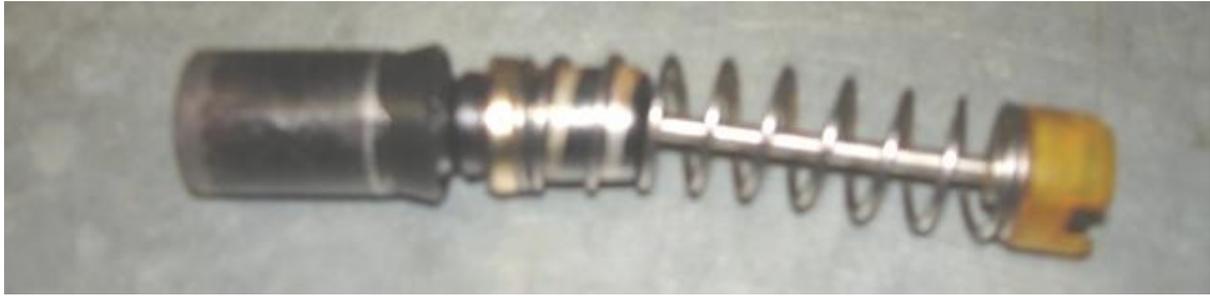
The piston and valving. The piston is the short dark coloured section on the left, the valve to shut off the feed from the reservoir is on the right. On the end of the piston can be seen the flared seal that retains the fluid in the cylinder the valve is necessary otherwise when the brakes were applied the piston would just push the fluid back to the reservoir and not along the brake lines to the wheels. When the brake pedal is released the spring seen above pushes the piston back to its stops and the rod through its centre releases the sealing valve in the coloured cap on the right. This allows the fluid in the lines to flow back into the master cylinder and back to the reservoir. If the push rod (not shown here) cannot come right back, the end valve partially keeps the fluid in the lines. Gradually there is a build up of fluid resulting in involuntary application of the rear brake pads.

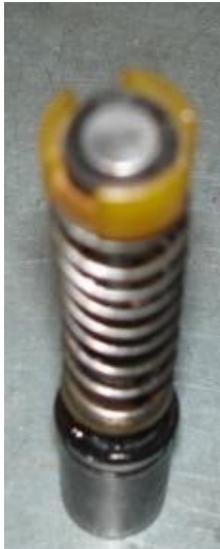
Here is a closer view of the business end of the piston with its valve. The orange plastic piece is actually a spacer in which the valve moves.

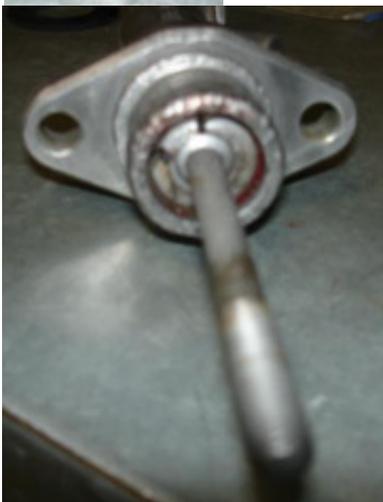
Take the car for a drive – some miles, using the brakes frequently whether needed or not. If you notice the pedal gets higher and higher the master cylinder rod is too long because the fluid cannot get back to the reservoir when the pedal is released since the inlet valve is still jammed up against the end of the master cylinder. If this is a chronic problem it can be instantly albeit temporarily corrected by opening one of the low pressure bleed valves. At left is the assembled master cylinder complete with threaded push rod and minus the protective rubber boot.

In summary having got the thing installed and bled give the car a good road test. When the whole system is well heated lengthen the rod in its clevis to get more pedal until you can feel the pedal building itself up with each application. At this point shorten the rod by say half a turn until frequent use does not create a 'rising' pedal. At that point lock the locknut and go and have a stiff drink!

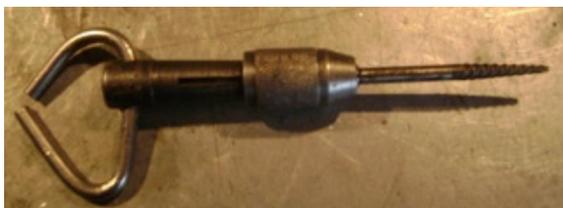
I mentioned this little tool in the last issue and here is one in a holder ready to extract the rivet from the bottom of the 'G' valve. They come in different sizes are as old as the hills and are principally designed to remove broken off screws and bolts. If you look closely you will notice the coarse 'thread' is 'left handed'. The idea is to drill a hole in the broken bolt that the ezyout can be screwed into until it jams. Continuous turning should unscrew the broken bit.

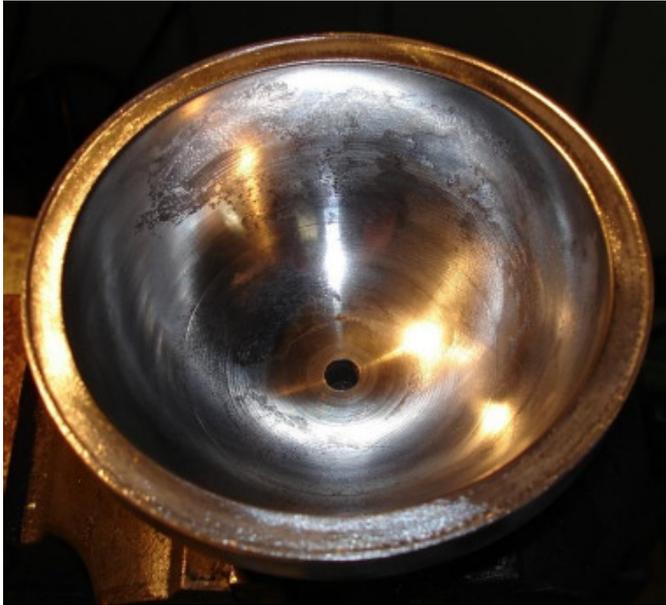
For those not familiar with their accumulators the picture is the inside of the bottom half of one of the hydraulic accumulators, having been cleaned and polished and ready to be reassembled. The hole in the bottom is the one through which nitrogen gas is forced until there is a pressure of 1000 psi. While few owners would bother to kit up to do this job it should be of interest to know some of the steps involved. In this case having reached the required pressure which has to be read with a high pressure regulator

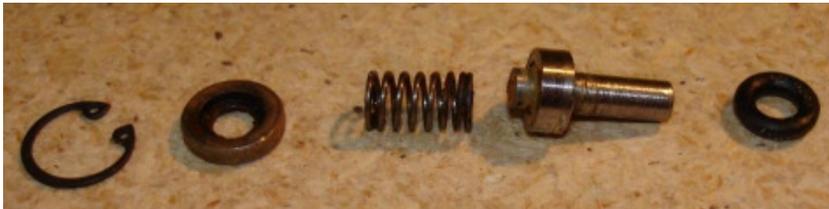
And here it is.

the circlip fits into a grooved hole in the accumulator about 1/4" in diameter. That is followed in the picture by the centring washer, then the spring then the plunger. The last bit, the plunger, has a small 'O' ring slipped over the shank and that is jammed tightly into the valve seat by the pressure of the gas.

When as with most owners you send your accumulators to have them overhauled and re-gassed, when you get them back do check them for leaks in a bucket of water!

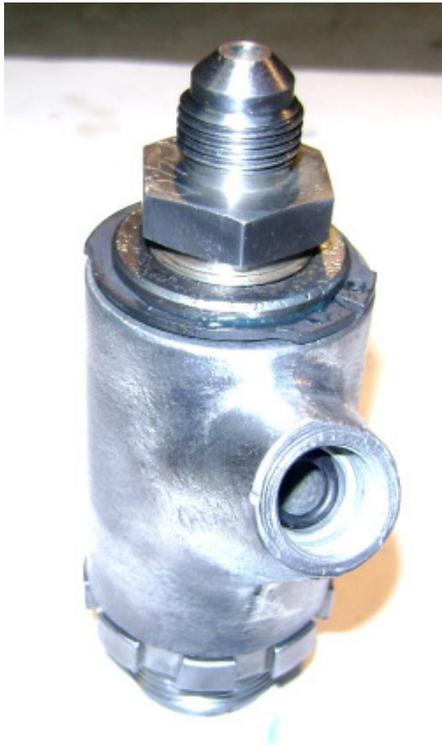
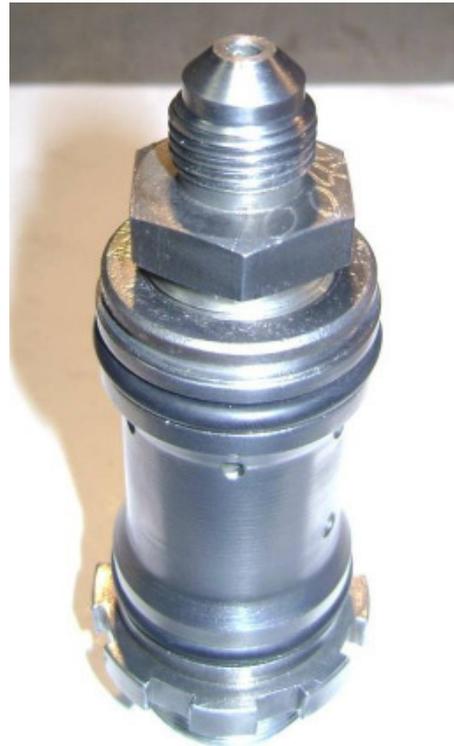
Many owners are quite incredulous when you point out that one or both of their hydraulic pumps are leaking. The usual cry is 'but I only had them fixed last year!' The pictures show a pump with its clothes on and the other naked! Note the outer casing on the left complete with its little 'O' ring. This is where the brake

fluid/mineral oil goes in fed by gravity. The casing simply slides over the pump and is secured by a large circlip which can be seen at the top of the casing. The only bits keeping the fluid in the casing are the two large 'O' rings seen in the stripped pump on the right. The fluid gets into the pump through the hole drilled around the inner body.

It is thought that every time the pump's plunger is pushed up by the cam shaft push rods et al, there is a monetary increase in pressure in the casing and of course against the large 'O' rings. The later are therefore continually flexing and rubbing on the inner surface of the outer casing. Eventually with the constant rubbing and the heat of the engine the 'O' rings shrink, the seal is broken and the pumps start to leak. Eventually especially with the very old cars it seems that the inner sealing surface machined into the outer sleeves in turn wears or distorts until no 'O' ring made will retain the fluid. The solution here is to have the casing sleeved – a process similar to sleeving brake cylinders.

Removal of the sleeve is quite simple. After releasing the pressure from the accumulators, the low pressure feed pipe is disconnected from the side of the pump after you have clamped off the rubber hose connecting the reservoir to the pump. The high pressure delivery pipe on the top of the pump is then disconnected. The circlip is removed and the outer casing carefully prised upwards and off. A dental pick is the best gadget to winkle the old 'O' ring out of its groove so than a small sharp knife can be forced down to cut it.

Having cleaned things up as best you can, lubricate the new rings and roll them down the pump. Fit the top one first and the lower one will roll over the upper one. Lube up the outer casing and carefully push it down over the 'O' rings which should have some lube also. It is usually a fairly tight fit. Circlip back on pipes back on and you are almost there. A tip on the low pressure feed pipe. Partially release the clamp on the feed hose while you are starting the nipple into the casing. This should ensure that fluid flowing into the casing will be free of air, otherwise it is not uncommon for there to be an airlock in the pipe and you find yourself

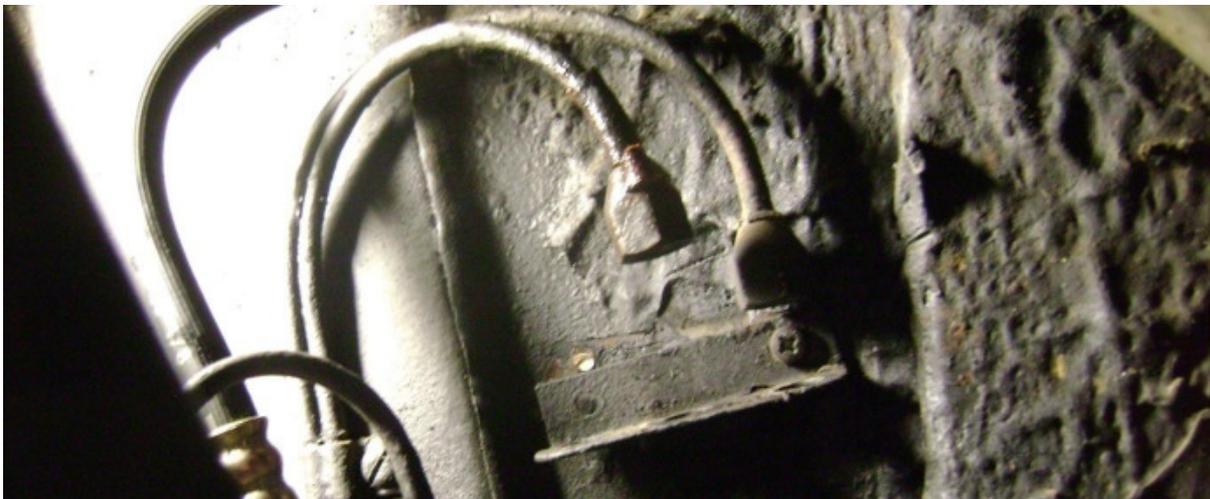
This is one of those sights that reduce conscientious amateurs to quivering incoherency! You are lying on your back looking at the underside of the Corniche. This it appears has been serviced by those Denison of various caves and who operate apparently by feel. Their task here was to disconnect a flexible hose from one of the nipples. The hoses as you know are held in place by a large half nut which holds the hose end to a bracket also seen here. The bracket is perfectly capable of carrying out its functions but is NOT equipped to handle the force of a large spanner swinging on a frozen half nut. The result is as you see one of the hardened self tapping screws simply snapping off. The troglodyte operator solved the resulting problem by ignoring the break and the pipe. The latter then at some stage burst depositing the entire contents of the rear section of the main reservoir on the ground!

The solution is relatively simple albeit somewhat awkward. The latter because the area in this case is somewhat cluttered with sundry items of suspension etc. Not possessing a foot long drill to remove the broken stub of the self tapper I was able to use a small socket on a long extension, in turn chucked in a variable speed drill.

In the socket I placed one of the wonders of this age – a self drilling screw, in the little socket managed to get a direct poke at the broken one and simultaneously drilled out the stub and screwed in the new screw. I thought I was very clever to do that but some swine will come along and say they have been doing that since JC played full

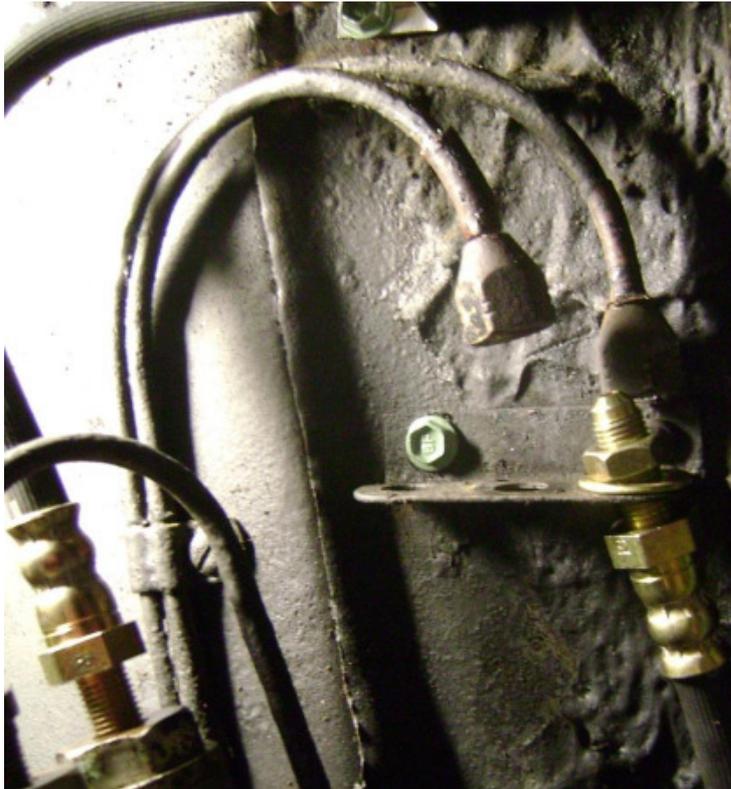
Next to exhaust work brakes would have to be one of the dirtier areas to work on for any car. Rolls-Royces are no exception. When these cars were made the body was immersed in a swimming pool filled with metal primer in the vain hope that it would fend off rust. Then there was the belief that if they sprayed on a bucketful of 'thixotropic' (their word) paint – we call it Proofcoat which has been around for at least 50 years again in the hope that stray rocks and sundry pedestrians would not damage the under-bits. This stuff is soluble in kerosene and very much more soluble in the higher complexity hydrocarbons. Perchlorethylene available in pressure packs as brake cleaner simply relishes the thixotropic paint. The results is half the staff dissolves the paint which is then deposited on you your tools and anybody else standing nearby! The more observant will notice that I fit not only new brake pipes but new half nuts as well. These are cheap, spin onto the pipe terminals with a flick of the finger and speed the whole job up. That they are anodised might give the purists dyspepsia being devotees of cadmium but then the same people I have noticed having delivered crushing observation on such detail drive off in their Crewe whatsis complete with rotten brake lines seals and often seriously worn brake pads!

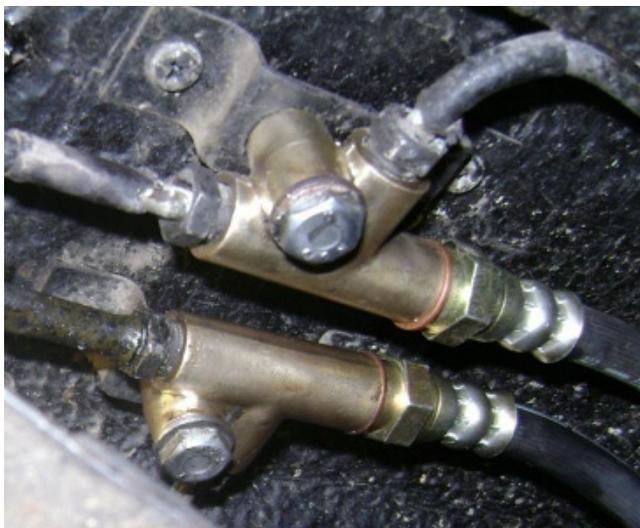
These little darlings at left also demand the utmost in respect. After some 40 years the nipples screwed into these brass junction blocks are pretty well cemented in. Note that they are again mounted on a spacing bracket held by two screws. After liberal doses of WD40 some hours earlier the main bolt securing the junction piece to the bracket should unscrew. You will then be able to hold the former securely while you undo the nipples one by one.

Note also that the junction between the flat face of the hose and the junction block requires a soft copper washer to seal the joint.

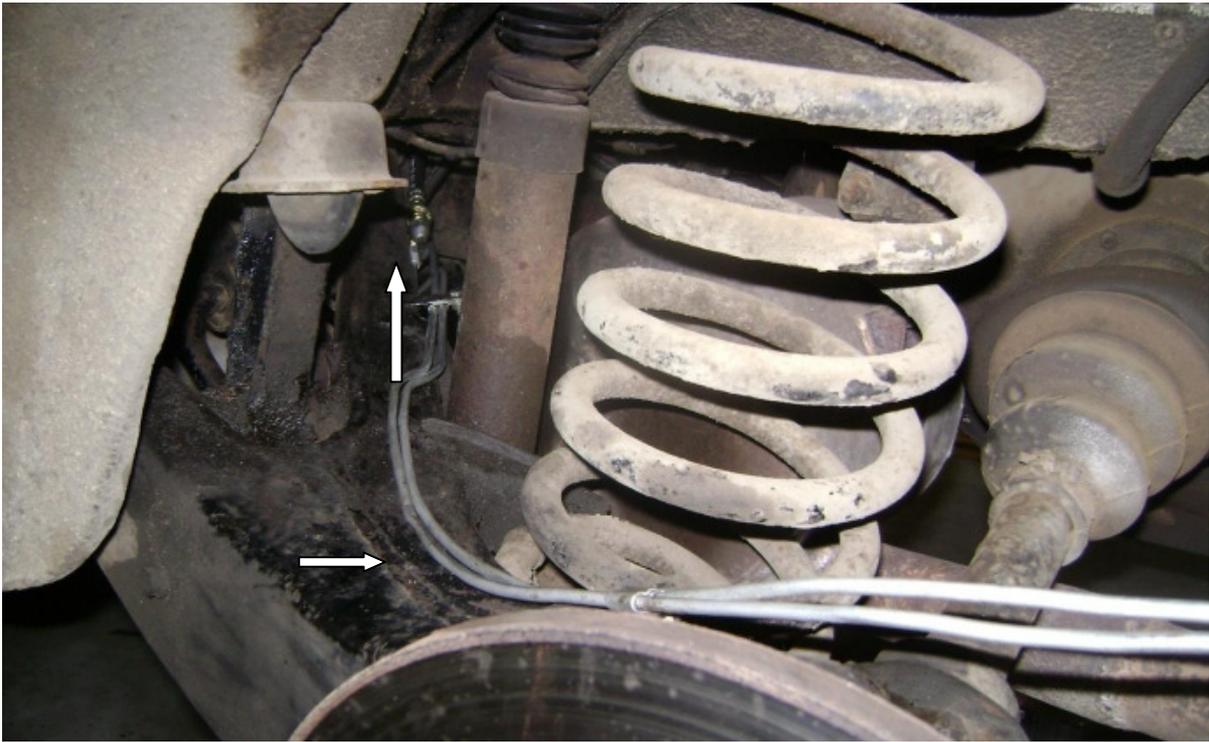
For those mere mortals they have not be allowed to view the private parts of a Corniche here is some detail of the rear suspension that is peculiar to the model. First up you will have noticed that there is no shock absorber nestling in the centre of the rear spring. Instead it is placed forward and more centrally. Its job is the same and the results are similar. This is necessary because there is simply not enough room for folded down roofs and associated mechanisms to accommodate the standard suspension rams and shock absorbers.

But my concern involves the pair of brake pipes snaking along the rear suspension arm. These pipes connect to flexible brake pipes well forward and which can be seen at the top of the picture. They then snake back to the rear calliper, one carrying high pressure fluid to the larger piston in the calliper and the other the low pressure fluid to the small piston. The latter providing the 'feel' to the brake pedal. The pipes are bracketed to the suspension arm in two places which again can be seen in the picture and above the calliper there should be another bracket that simply ties one pipe to the other for stability.

Somebody had for reasons unknown moved these pipes so that rather than lying close to the inner edge of the arm they were position almost centrally on the arm. As a result when the rear suspension was crushed up as far as it would go which involves the conical rubber buffer being jammed totally into the holding cup, the lip of the latter in this case just clipped the edge of the outer brake pipe. A little bit further in for the pipe and it would have been punctured. The pipes are all shipshape by the way because the low pressure line nipples on both sides had frozen solid in the callipers. Rather than smash a few more components, the calliper was dismantled in situ, the pipes unbracketted and the assembly pulled out of the chasm!

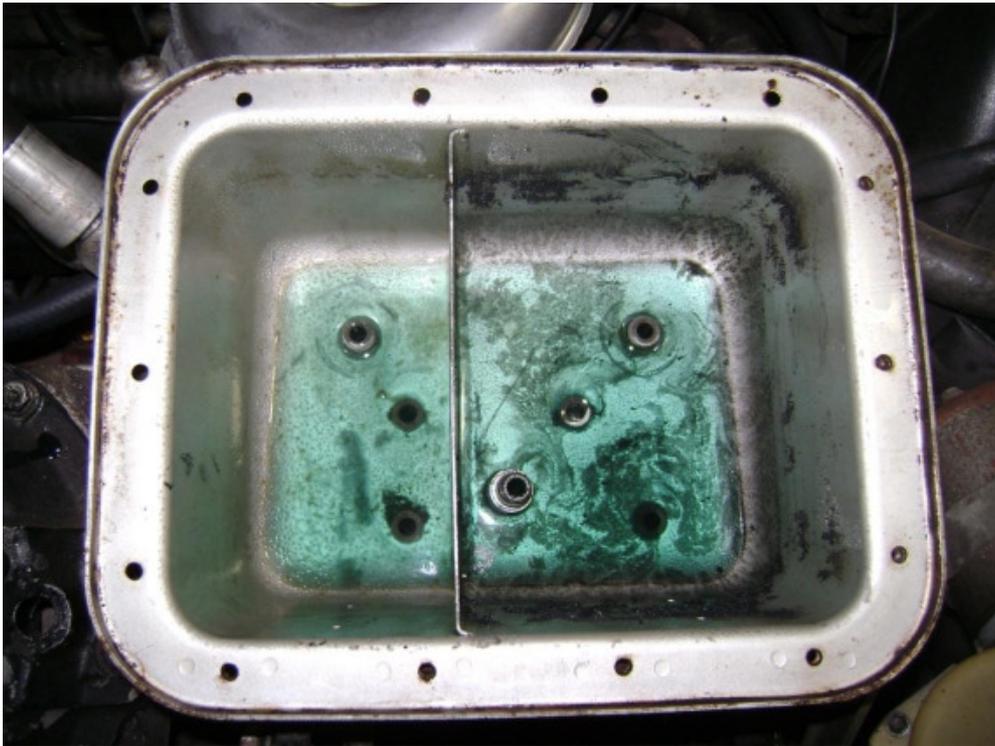
Eventually all the callipers 'G' valve were removed cleaned and re-kitted. The system was again filled with standard DOT 4 fluid and bled this time very successfully. A few hundred miles later the reservoir was opened and the fluid siphoned out. What you see in the bottom of the picture is the rubber residue from the decaying pipes which was still circulating in the system. A good clean out and more flushing (some 15 litres) and the system is like brand new.

There is simply no excuse for not changing brake hoses at least every 8 years!

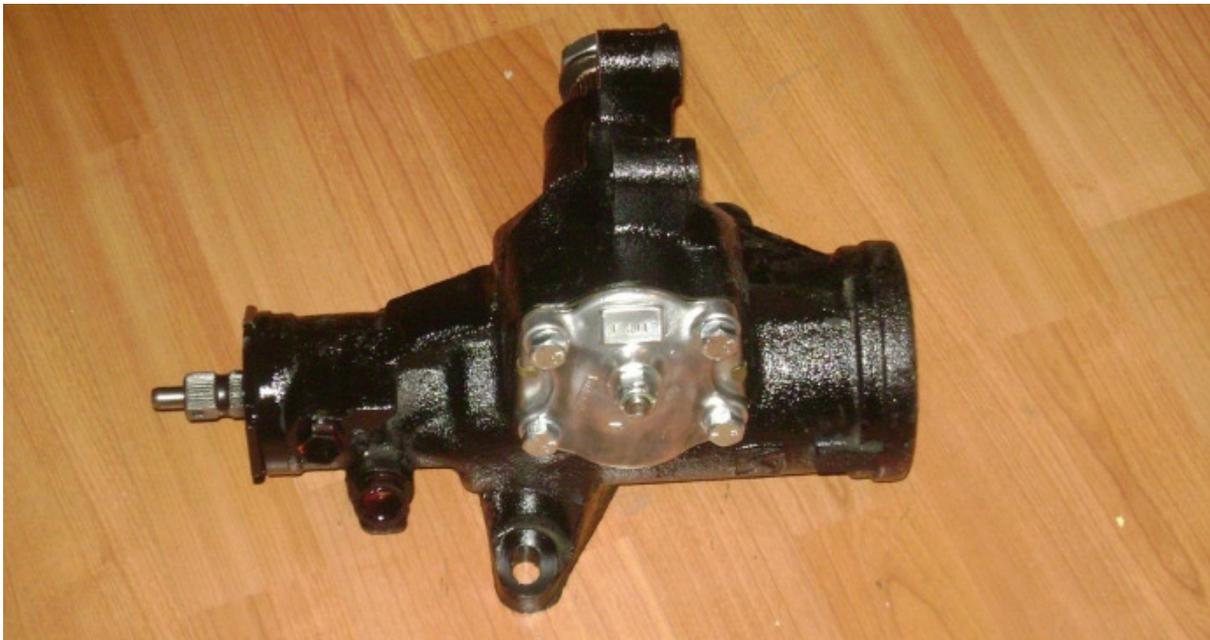
The Saginaw box of American design and manufacture fitted to the Shadow I's is remarkably resilient and reliable. Unavoidably it is at the bottom of the system so that any sludge, including metal fragments, settle in the main piston housing shown here protruding on the right of the casting.

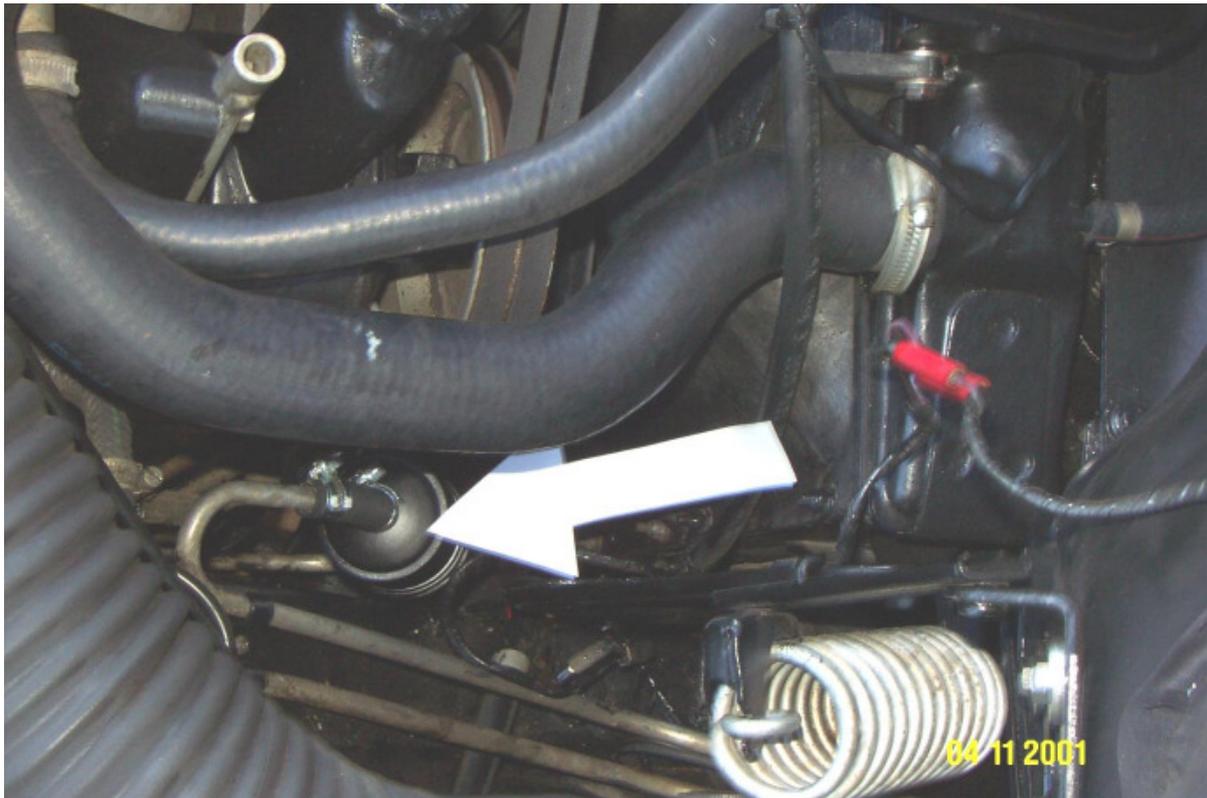
One prophylactic measure is to provide a filter in the return line. These are standard accessories for transmissions and incorporate a magnet. The filter should be changed every year to avoid back pressure on the return. Interestingly filters were always provided in the systems used on the Cloud series of cars. Apparently there are a lot of owners who are unaware of these little items and they are left to eventually clog up!

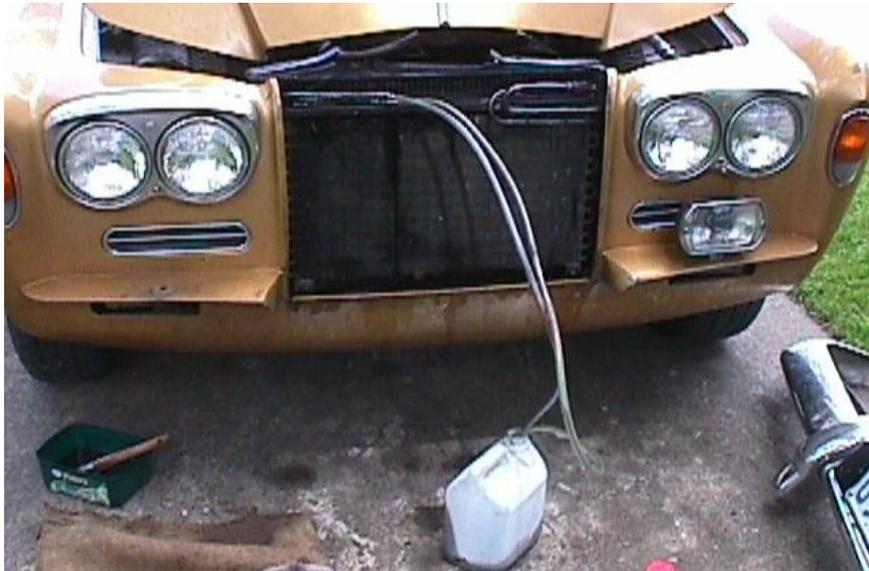
If you decide to flush the system this is a convenient method. Both lines behind the grille which normally feed the oil cooler were connected by plastic hose to a suitable container. The engine was started and while a steady stream of oil was poured into the reservoir the steering wheel was turned slowly from one side to the other. The oil will eventually run clean.

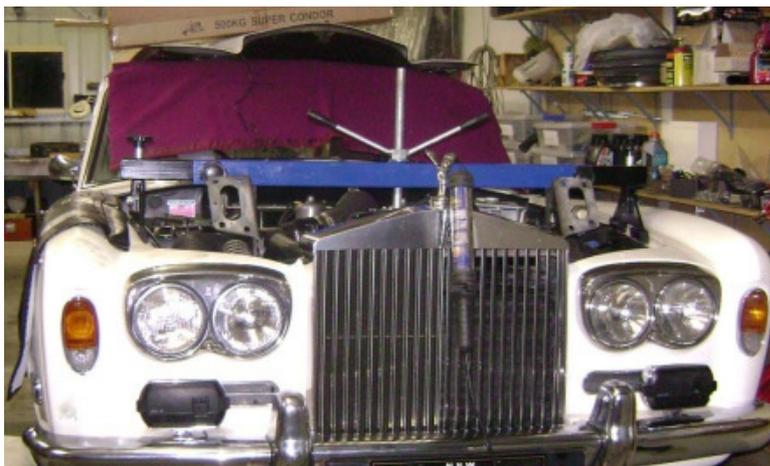
Here is a propriety stand that is readily available to the handyman. Legs on either side of the engine compartment fit into the water channels at the edge of the mudguards. The beam sits on these supports and the centre screw assembly which has a hook on it can be attached to a bracket on the front of the engine. The turn buckle is quite strong enough to lift the engine until the aircon compressor pulley is level with the header tank!
