REPLACING AND MODIFYING REAR WHEEL BEARINGS ON ALL BENTLEY MKVI/R TYPES

N.W.Geeson

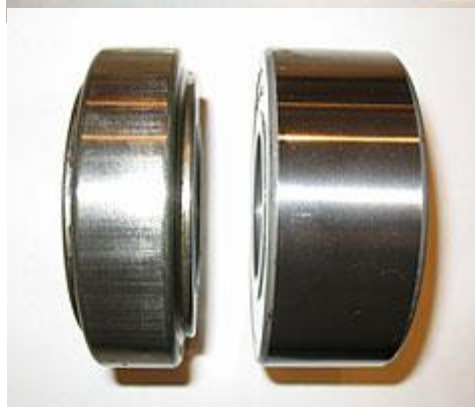
Comparison of original and modified bearing, end view, the old bearing is on the left hand side

The 3309 bearing is nominally 100 mm x 45mm x 40 mm wide and unlike the original; it is a massive double row thrust ball bearing, the inner and outer tracks being of the same width. The conversion described is based on this 3309 neoprene sealed type bearing. This particular heavy bearing was chosen because it has far greater load carrying capacity than the original bearing and the wider outer track enables the wheel loading to be evenly spread along the wheel bearing housing. In addition the width of the bearing is usually the same as the housing depth and enables machining to be kept to a minimum to provide a pre-fit of 0.001 inch. Replacement using the original bearing or any single row type will at least require re-machining of the outer bearing spacer and if this is already undersized then a new spacer must be machined out of 4 inch (100mm) steel stock.

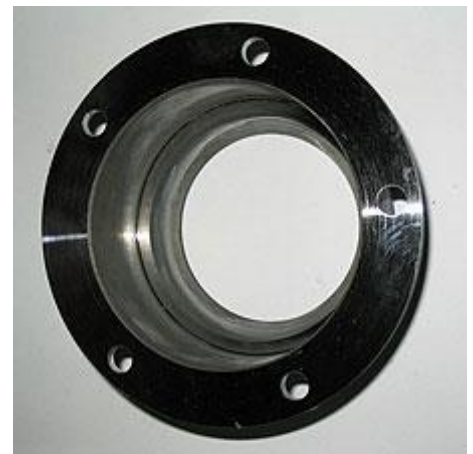
A wheel bearing housing after machining and the flange has been ground

Initially check the flange of the bearing housing to ensure it is flat and

not distorted, if any out of truth is present it **MUST** be faced off, keeping any metal removal to within approximately 0.005 inch.

Measure the thickness of the bearing and the actual depth of the bearing housing to the internal step where the bearing locates. These measurements will be approximately 1.5615 inch (39.66mm) if the bearing housing flange has not been faced off. The measurements finally will require adjusting by machining either the flange face or housing internal step to ensure that the bearing is thicker than the housing depth by 0.001 inch. In other words when the bearing is fitted to the housing it should protrude by 0.001 inch. This protrusion allows for a thin film of sealer to be applied to the bearing housing flange, and also ensures that when the bearing housing is re-bolted to the spigot plate the plate will actually contact the bearing and stop any bearing end float or looseness. In simple terms the bearing will be trapped hard between the spigot plate and bearing housing. Normally even making allowances for truing up the housing flange no more than 0.0010 inch needs removing from either the flange or the housing step.

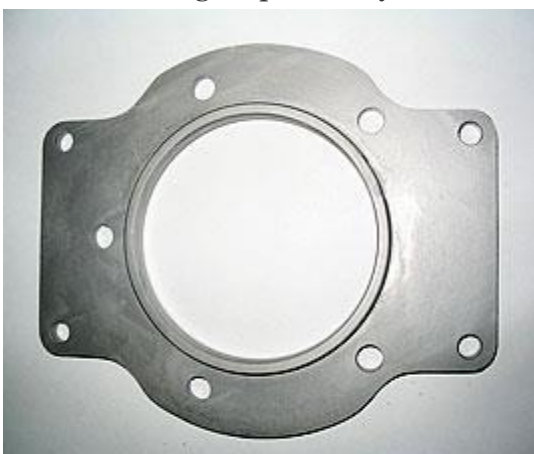
Original bearing spigot plate, showing spigot lip

Next, examination of the bearing spigot plate will show a location protrusion or spigot, which needs machining off the plate and the plate face grinding to finish. This protrusion originally contacted the original bearing spacer ring, which has now been discarded, it should also be said that the protrusion did provide a spigot to assist in centralising the assembly. However the bearing housing attachment bolts and their holes are very accurate in size and circular pitch dimension, and therefore centralisation and the retention under load appears well catered for, even when the assistance of the spigot is lost. Note that it is necessary to dismantle the rear brake assembly to extract the bearing spigot plate!!

This spigot plate is shown in most parts lists on plate K1 and is the item shown nearest the half shaft splines, it is not individually numbered, and the illustration does not show the spigot section on this plate. The bearing spacer ring, to be discarded, is also shown on plate K1 and is the second item inwards from the half shaft splines. The plate spring (Belleville washer) also to be discarded is shown as the fourth item from the splined end of the shaft.

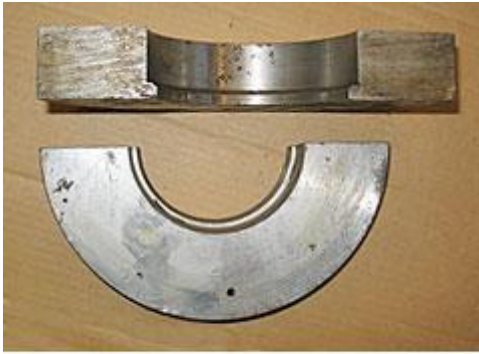
Supporting blocks showing shape to support the bearing housing

At this point it is necessary to mount the shaft in a hollow hydraulic press bed and provide a suitable support for the bearing housing whilst the shaft is pressed through and therefore off the bearing. My own supports are made of a steel circular section some 9 inches in diameter and 1.250 inch thick. This circular section was then machined to fit around the bearing housing with an integral step, this step was lathe turned to fit the step in the bearing housing and then finally the circular section was sawn across the centre. This tool then forms two "U" shaped sections, which completely surround and support the bearing housing whilst the pressing operation is in progress.

It is very important that the flange of the bearing housing, which is about 0.125 inch thick, is not used to support the housing during pressing operations. The bearing housing STEP must take the load and if any load is applied to the flange, distortion and subsequent water entry will result. There is also a very serious possibility of the flange breaking away at some time in the future.

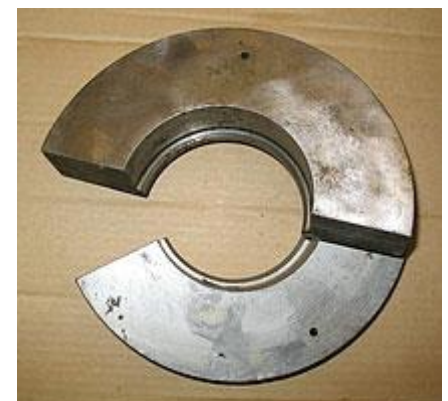
Supporting blocks to hold the bearing housing during pressing operations

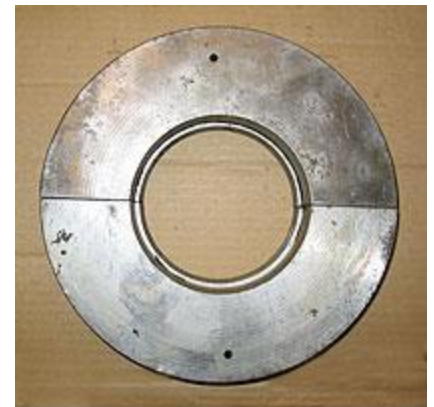
Supporting blocks showing how they surround the bearing housing

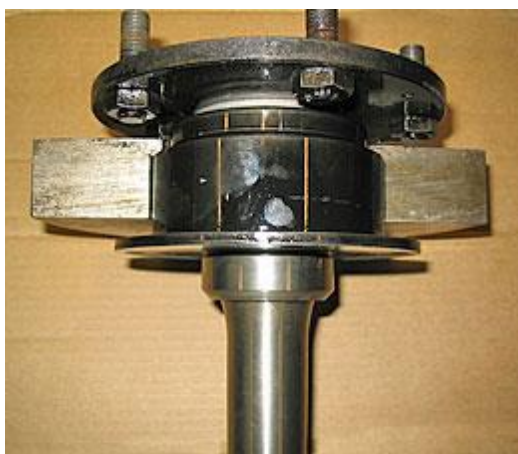
Supporting block showing how the block lip embraces the bearing housing

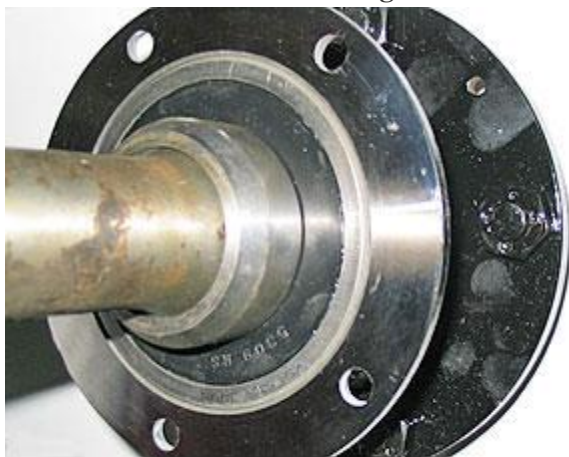
Showing a finished assembly note how the new bearing fully fills the bearing housing

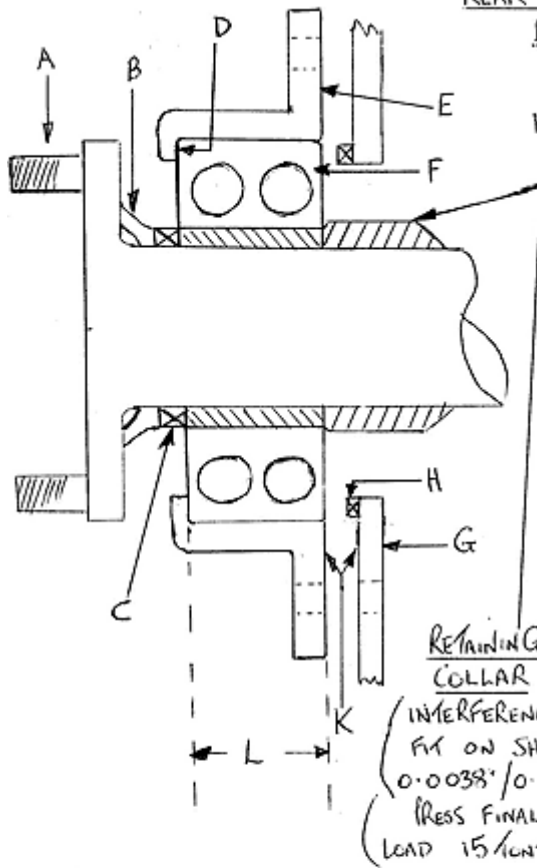
REAR WHEEL BEARING CONVERSION
 BENTLEY MKVI (LATE) R. TYPE
 SILVER DAWN / WRAITH

- KEY:-
- A - WHEEL STUD
 - B - EXISTING SPACER
 - C - EXTRA SPACER
(1.775" ID X 2.30" O.D
X 0.205" THICK)
 - D - INNER FACE OF BEARING HOUSING
 - E - FLANGE FACE OF BEARING HOUSING
 - F - BEARING TYPE
3309 WITH NEOPRENE SEALS.
 - G - BEARING RETAINING PLATE AND BRAKE CARRIER.
 - H - CENTRALISING LUG TO BE REMOVED.
 - K - FACES TO BE SEALED ON ASSEMBLY
- RETAINING COLLAR
 INTERFERENCE FIT ON SHAFT
 (0.0038" / 0.0046")
 (PRESS FINAL LOAD 15 LBS)

NOTE :- WHEN THE ORIGINAL BEARING TYPE WAS FITTED A LARGE CIRCULAR DEPTH PRE-LOAD SPACER WAS FITTED WHICH CONTACTED POINT "H". THIS SPACER AND THE WASHER BETWEEN THE RETAINING COLLAR AND BEARING ARE SURPLUS.

Sketch showing cross section of a modified bearing and associated parts
