Rear Brakes (All Types) Rebuilding, Modified Parts, Objective and Background

R-R Silver Dawn, Silver Wraith. Bentley MkVI, R Type.

N.W Geeson 2014

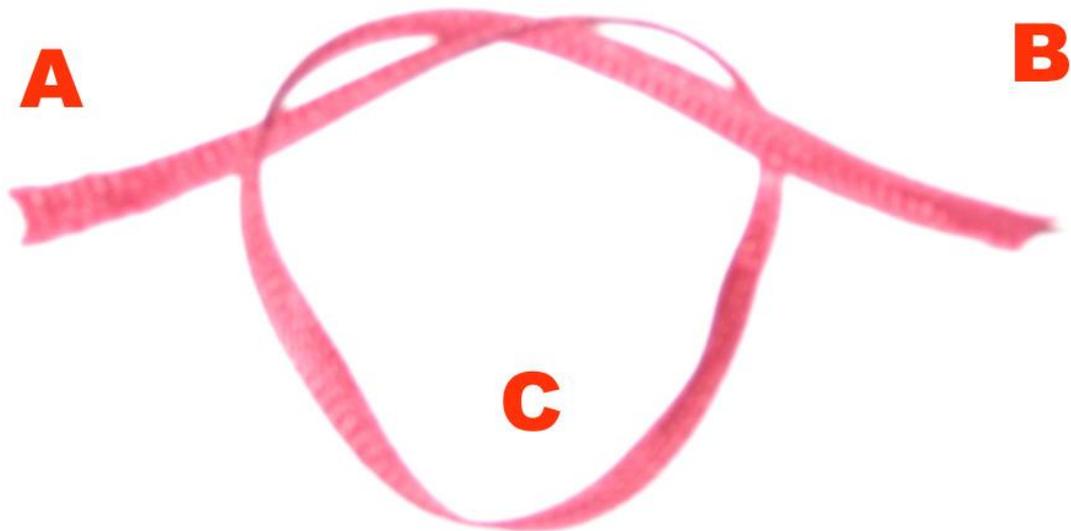
Fig 1. An action will cause an equal and opposite reaction.

Fig 1 shows an half knot and readers will immediately recognise that if the ends 'A' and 'B' are pulled simultaneously then there will also be a reaction at the loop 'C'. They will also realise that if either of the ends 'A' or 'B' are pulled but the opposite end is not held, then there will be no reaction of the loop at 'C'. The reason is that we need an opposite and equal force to be applied at the opposite end to the one that we are pulling. In practice we would apply that opposite and equal force by pulling both ends at 'A' and 'B',

however if we could just hold one end “firmly” at either ‘A’ or ‘B and pull the other end we would also have a reaction at the loop.

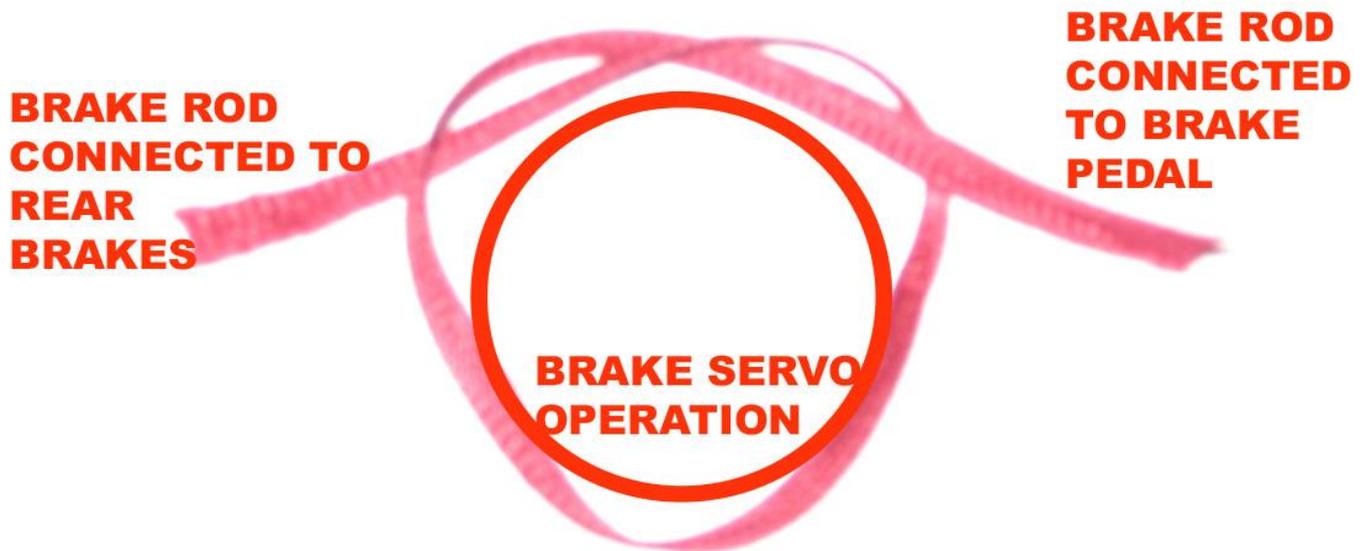
Fig 2. How the example loosely fits our brake operation.

Now if we replace the notations with those as shown in Fig 2 and add a circle to represent the brake servo, the forces and requirements may be better understood. Note that the former end ‘A’ is now connected to the rear brakes, the action here being to hold the end “firmly” once the rear brake linings contact the brake drum. From that point onwards any pull force at the former point ‘B’, that force now being applied by the brake pedal, will result in the operation of the brake servo at former point ‘C’ and an ever greater effort being applied to the rear brakes. In this analogy the loop at ‘C’ is shown tightening up onto a circle that represents the brake servo, this is a schematic illustration and the actual action is axially, which means a side force operates the cams of the servo.

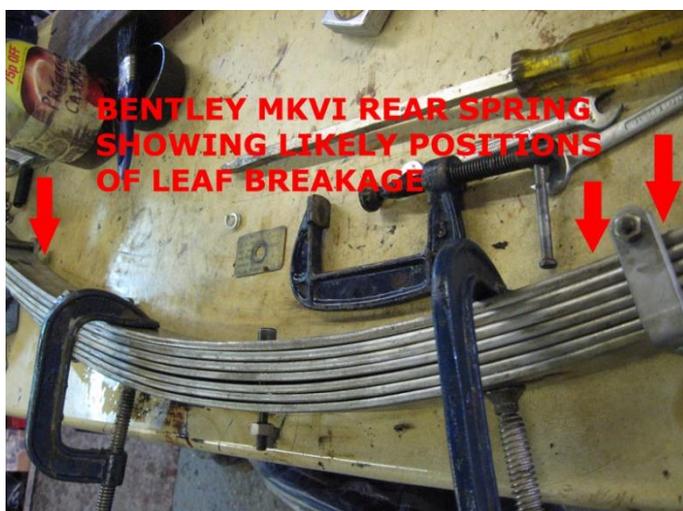
Fig 3. A Bentley MkVI rear spring showing the likely points of breakage.

Rear road springs need checking to ensure that their main leaves have not broken, as this will allow the complete rear axle on one side to move fore and aft as brakes are applied and released. A similar movement will occur if there is excessive wear in the rear spring front shackle pin. Fig 3 illustrates the most likely point of leaf breakage, which can also occur right adjacent to the main leaf front spring eye just under the black coloured leather spring gaiter shown in Fig 4. If wear is present in the front threaded shackle pin it will usually show up as a wear or rust witness mark around the shackle pin washer as shown also in Fig 4. The spring gaiter will need at least partial removing if it is suspected that a spring leaf is broken so that a thorough inspection can be made of the leaves. Leaf breakage normally occurs when the shackle pins have seized at some time due to lack of lubrication. Fig 5 shows a close view of a threaded front shackle pin.

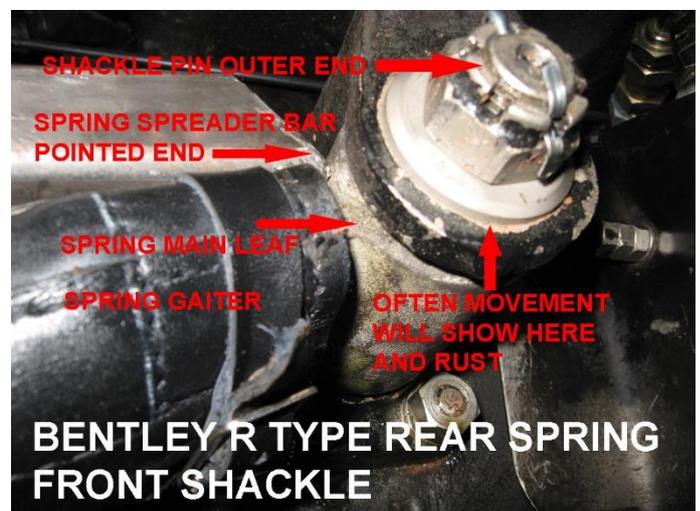
Fig 4. Bentley R type front shackle, a prise bar needs inserting between the bracket and spring eye to highlight shackle wear.

Some idea of the wear in the shackle pin will be gained if a tapered bar or tyre lever is inserted between the spring eye and shackle bracket and moved up and down.

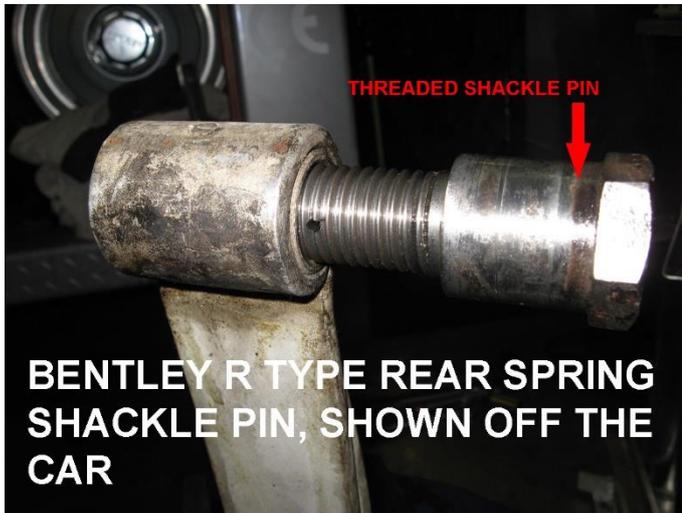
Fig 5. Wear on the threaded part of this shackle pin will add to the brake pedal movement.

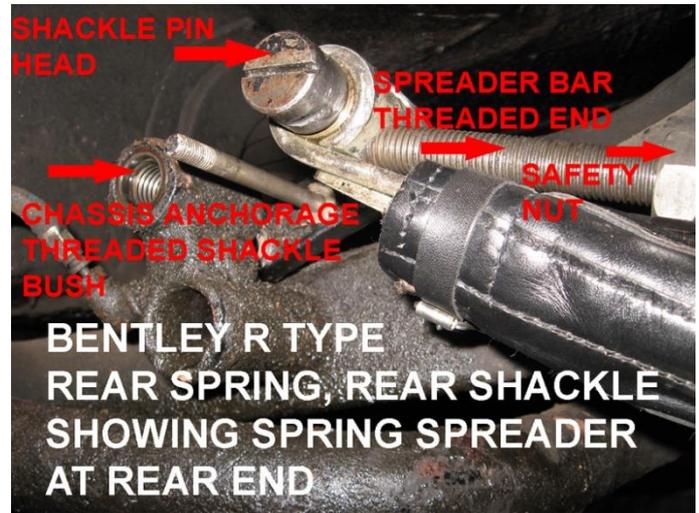
Fig 6. Just for the inquisitive ones, showing just where the spreader bar sits at the rear end, if you need to spread a spring.

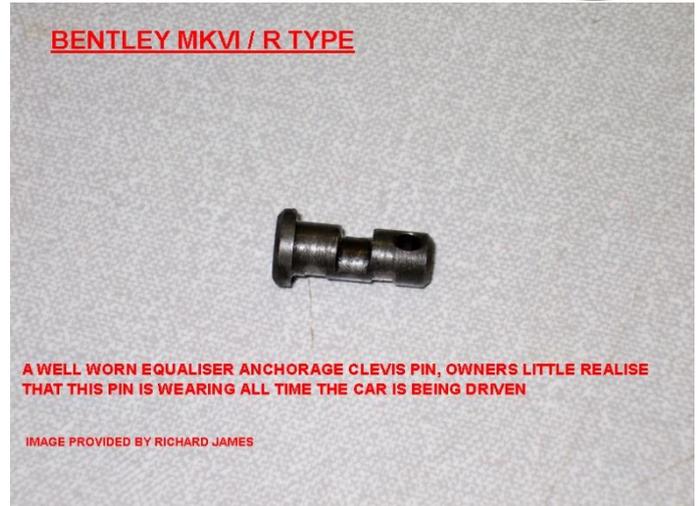
Fig 8. This equaliser bar clevis pin is in dire shape, at this point you are close to full brake failure.

A typical well-worn pin is shown in Fig 8 and regular lubrication with an oil can using EP80 / EP90 will help prevent this horrendous, and potentially dangerous wear. A clevis pin in this condition will allow the brake linkage to move back and forth in the same way as a broken spring leaf. It is a very wise precaution on any of these cars to inspect the condition of this equaliser pin during servicing as breakage will cause brake failure.

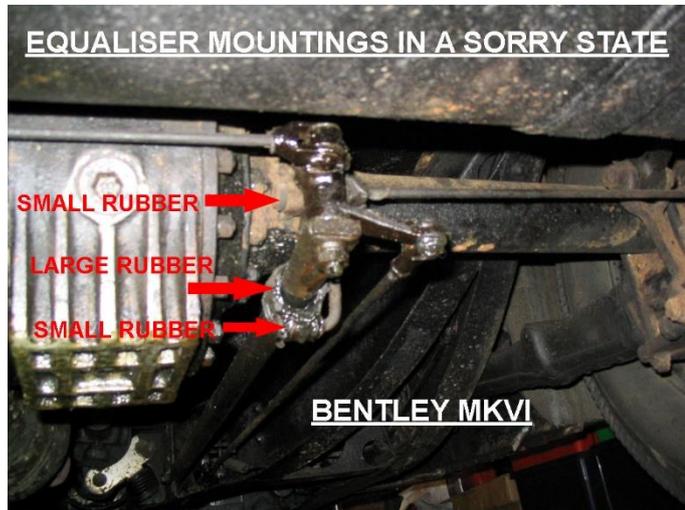
Fig 9. An equaliser with severe rubber rot!

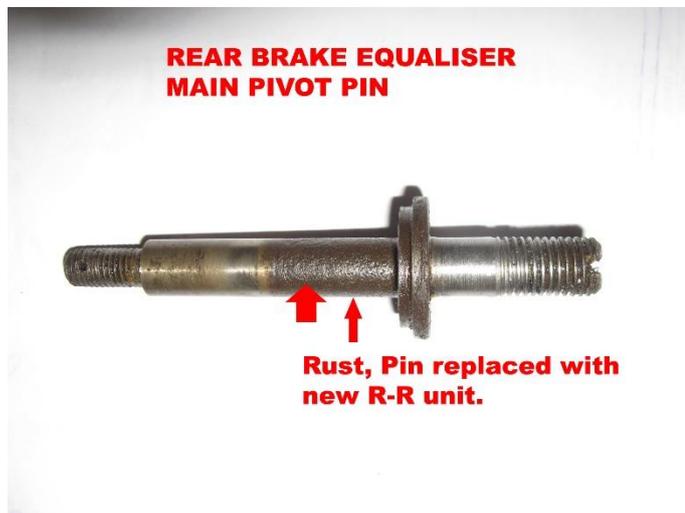
Fig 12. Equaliser pin showing how they suffer from water ingress, at least remove and grease yours!

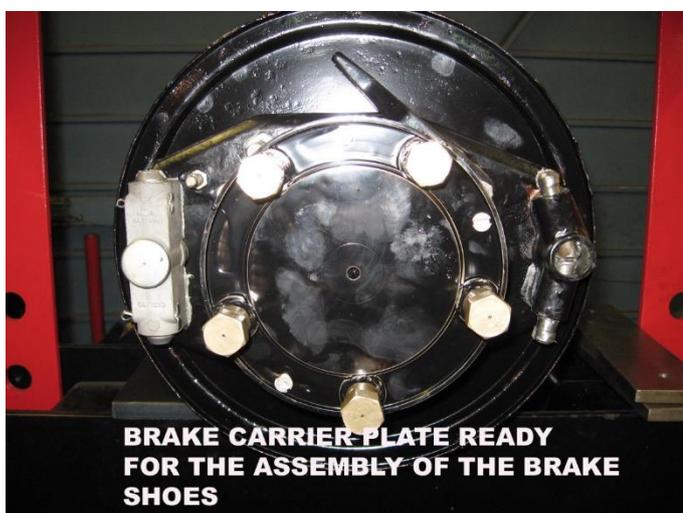
Fig 14. Rear Brake back plate unit ready to accept the shoes.

Fig 14 shows the view of the brake that has no doubt faced many owners, in this case the right hand side. The assembly of the actuator and adjuster shown fitted to the back plate in this view, is discussed in detail later, but note how the heads of the split pins in the actuator are on the outside. This positioning makes removal easier at some later date.

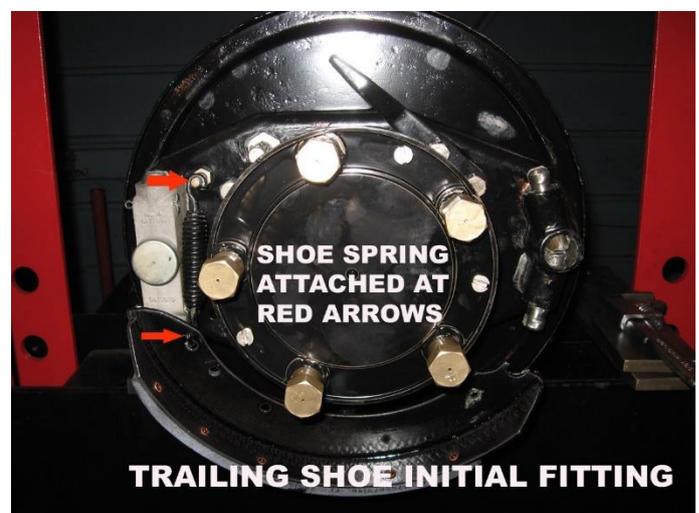
Fig 15. Trailing shoe hung off brake return spring.

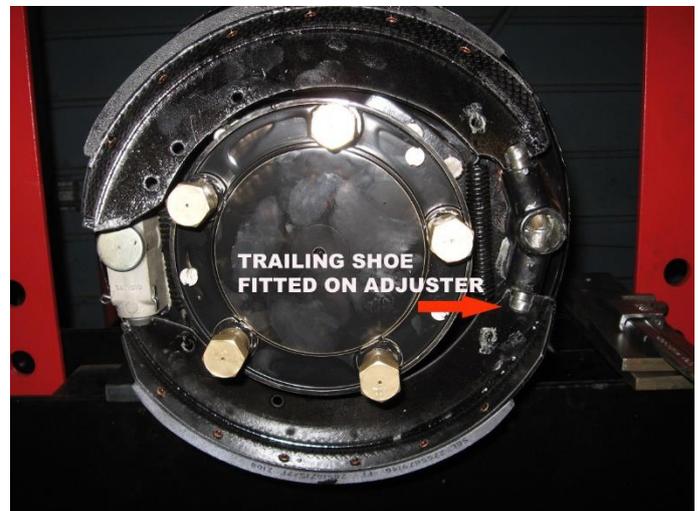
Fig 19. Trailing shoe engaged on the adjuster

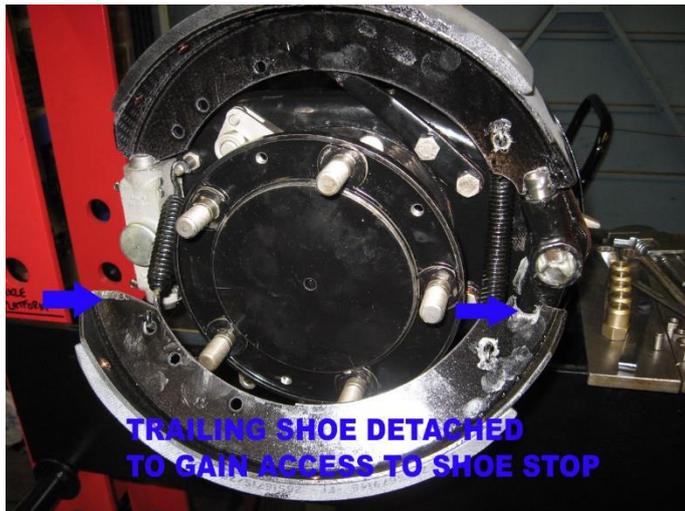
Fig 24. Detaching a brake shoe to gain access to a shoe stop.

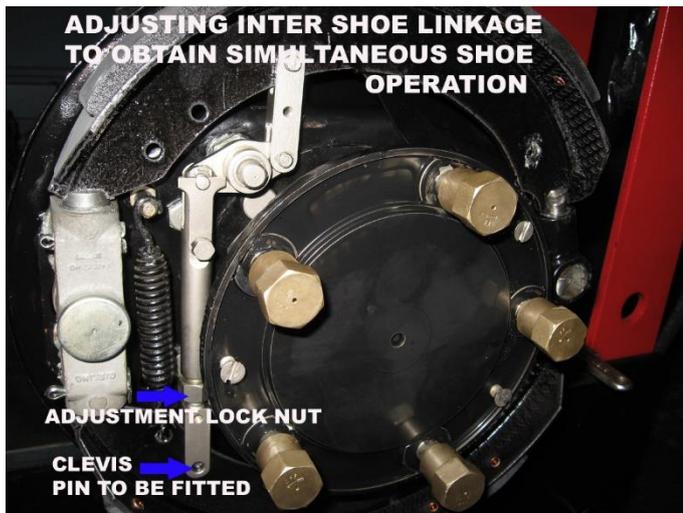
Fig 28. Inter shoe linkage fitted but lower clevis pin left out...

The inter shoe linkage should be assembled as shown in Fig 28 with the short link attached to the leading shoe. Assembly of this linkage can be carried out before the shoe stops are set providing the bottom clevis pin is not in position as shown, and this is also to be the condition up to the point of setting the inter shoe linkage.

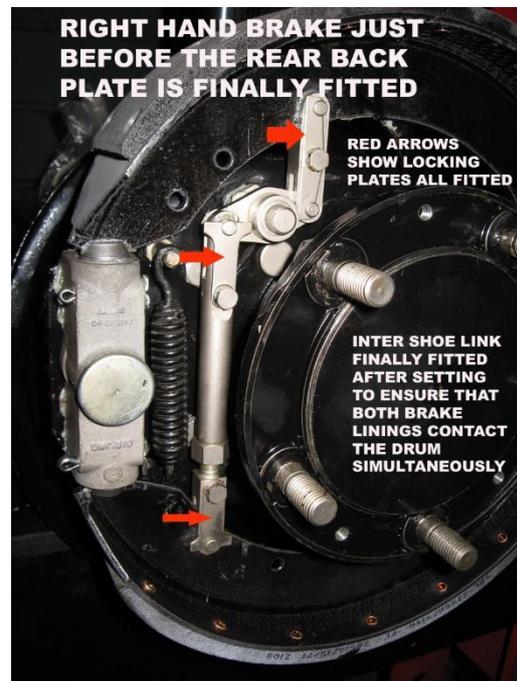
Fig 31. All locking plates in position and secured almost ready for fitting the brake drum.

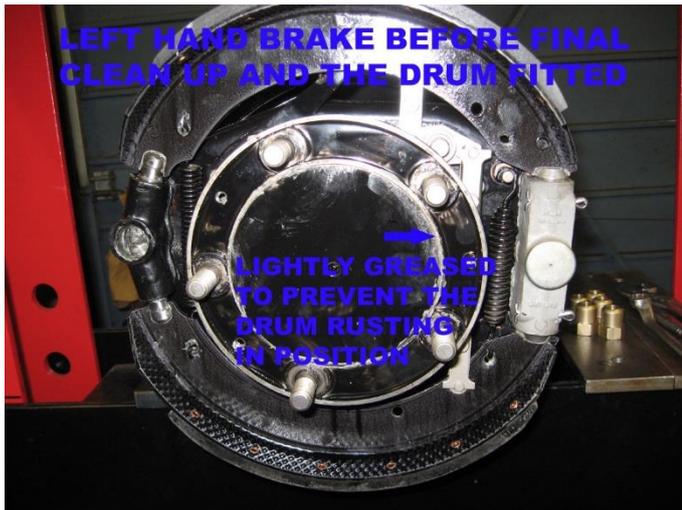
Fig 32. Applying a little grease around the locating spigot for the drum will prove dividends later.

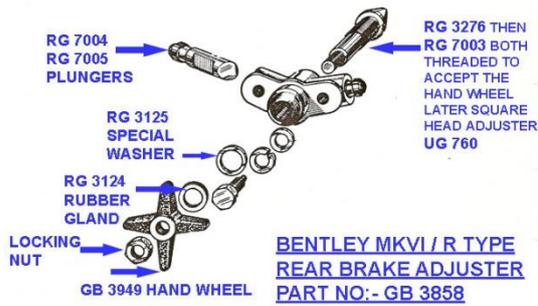
Fig 39. Rear brake adjuster

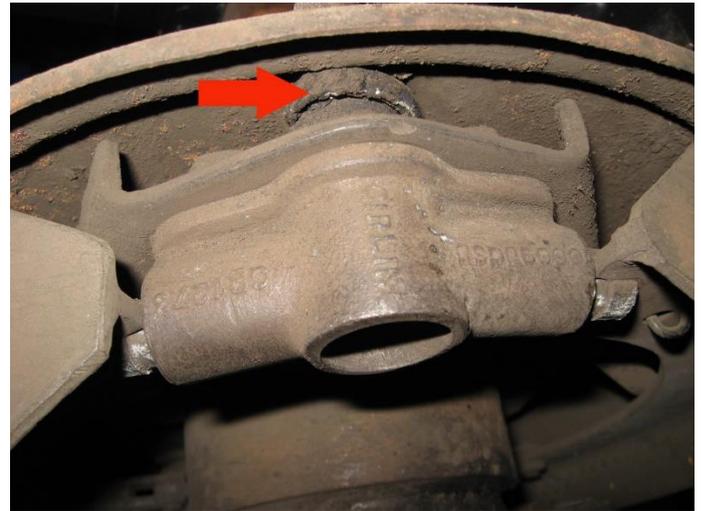
Fig 40. Rear brake adjuster rubber sealing washer needing renewal

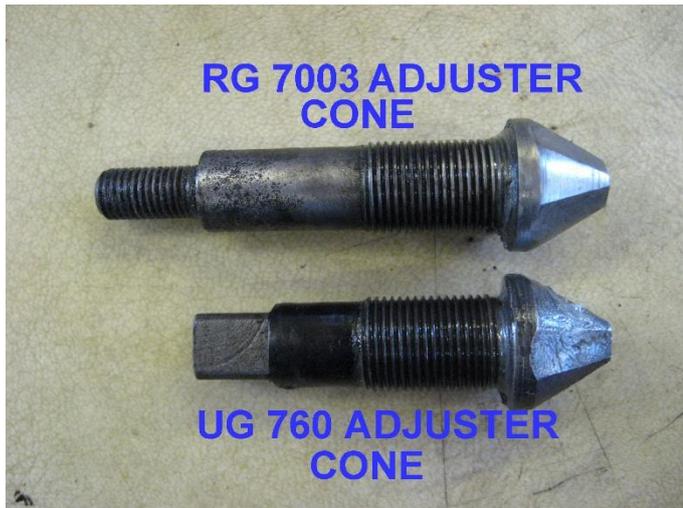
Fig 43. Early and very late type threaded adjuster cones.

Near the end of R type production the adjuster cone was modified by the simple expedient of cutting off the threaded section and forming a square 0.500 inch across the flats, see Fig 43. It is feasible and in fact preferable to carry out this modification on any threaded adjuster. Forming a square on the adjuster overcomes the need to fit a locking nut and riveting the end of the adjuster after first having replaced the adjuster hand wheel. These hand wheels are malleable cast iron and do not take kindly to any rough treatment and they have an annoying habit of screwing off the adjuster when the brakes are adjusted. The

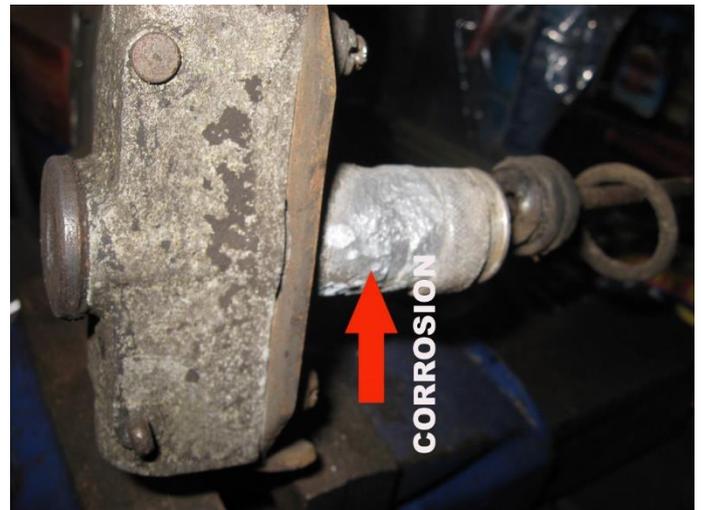
Fig 46. Typical corrosion that can be repaired.

Most owners will want to achieve a finished product as shown in Fig 45. The majority will probably initially start with an actuator with extensive corrosion as in Fig 46 and be worried about achieving a working unit.

A few points are worth consideration. In most instances the corrosion occurs on an exposed surface that is not under an operating load and therefore can be easily repaired as shown later. The second point to remember is never to try to twist the two holding studs or they will break out of the casting as they are cast in during manufacturer. Thirdly do not try to turn solidly seized plungers by holding the housing and using a blunt instrument in the slot of the plunger. If this is tried, the plunger top will break usually before the housing, but both will sustain damage, as shown by the arrows in Fig 47 and Fig 48. Soak the actuator in

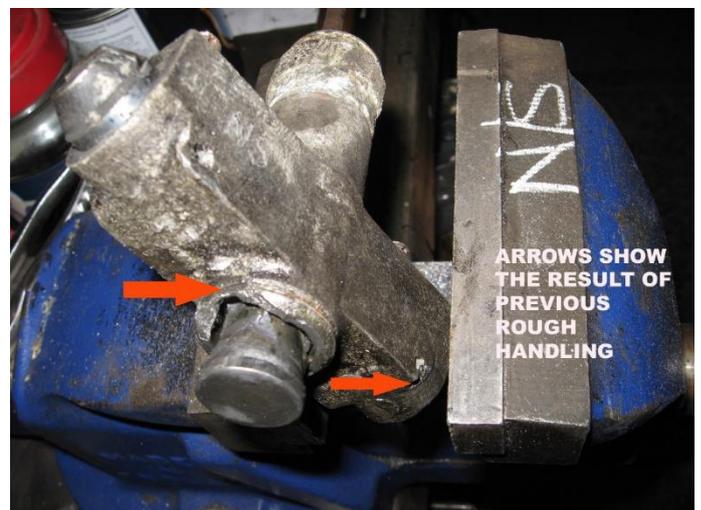
Fig 48 Actuator damage by forcing off the end cap.

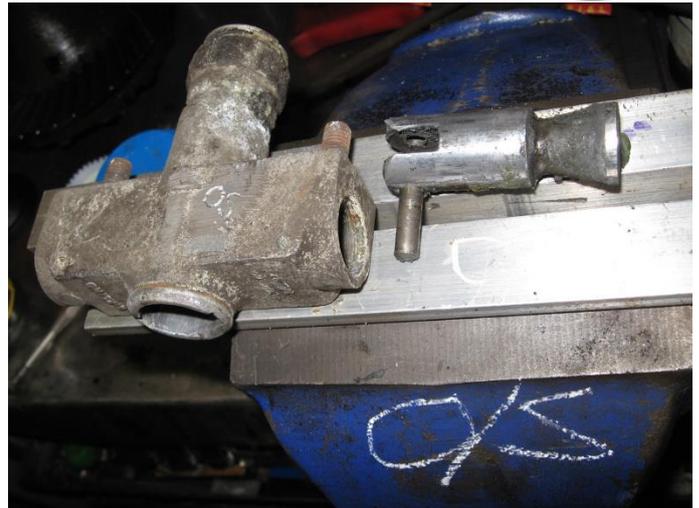
Fig 50 Actuator cone to rod retaining pin

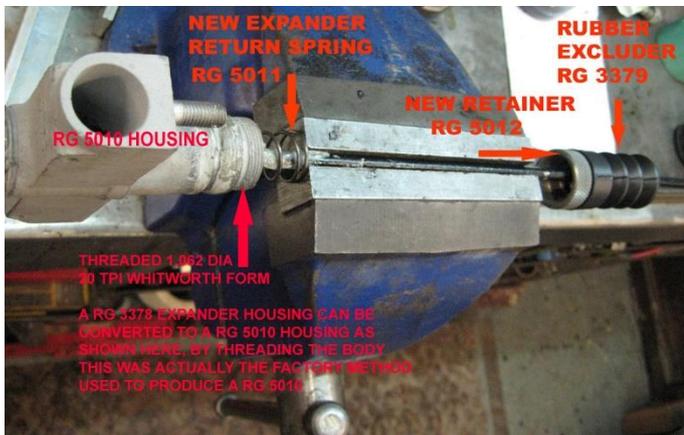
Fig 51 Actuator main parts

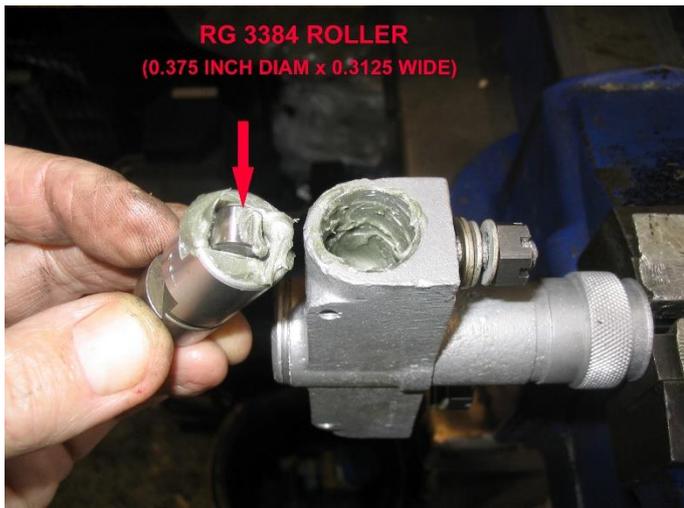
Fig 53 Roller RG 3384

Fully engage the expander by pulling on the rod and then holding the rod in a vice to keep the expander cone withdrawn against the spring as in Fig 53. Grease each plunger and position a roller using grease for its retention then engage each plunger in the body, shown in Fig 53. Replace the retaining pins, or correct sized split pins into the body to capture the plungers. Replace the pins with their tails inboard so that in service they can be withdrawn without having to remove the actuator from the brake carrier plate, Fig 54. Firmly hold the plungers into the body as spring action can still eject the expander, previously shown in Fig 49. Lightly grip the assembly across the plunger tops in a vice, or obtain the help of a second person to keep the assembly intact during the time the end cap is being replaced.

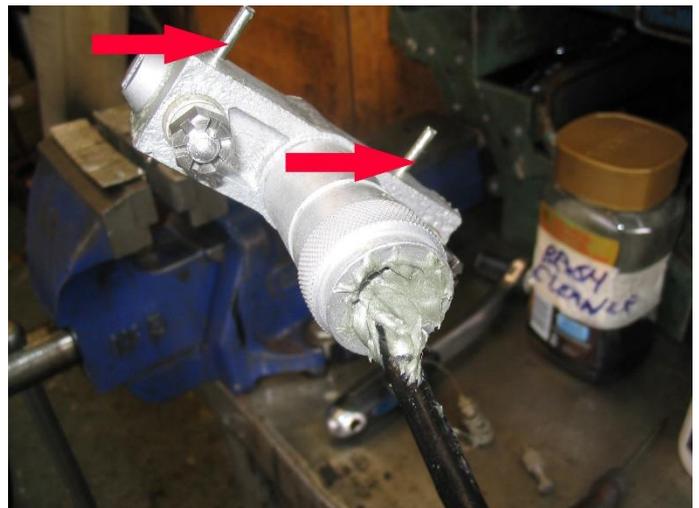
Fig 54 Pin replacement

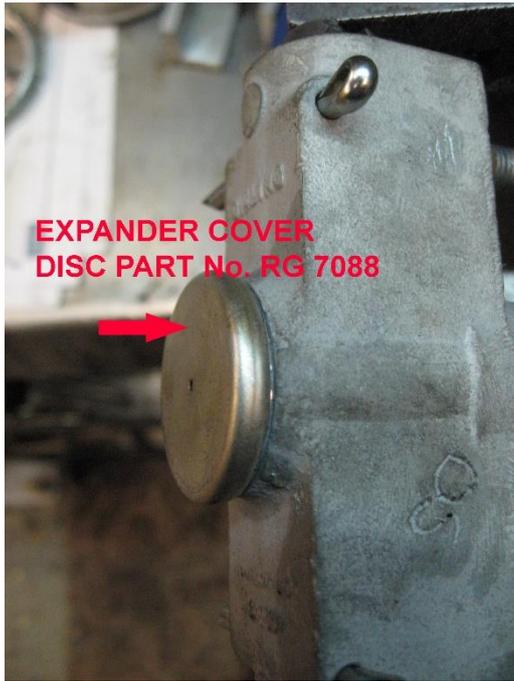
Fig 55 Actuator cover RG 7088

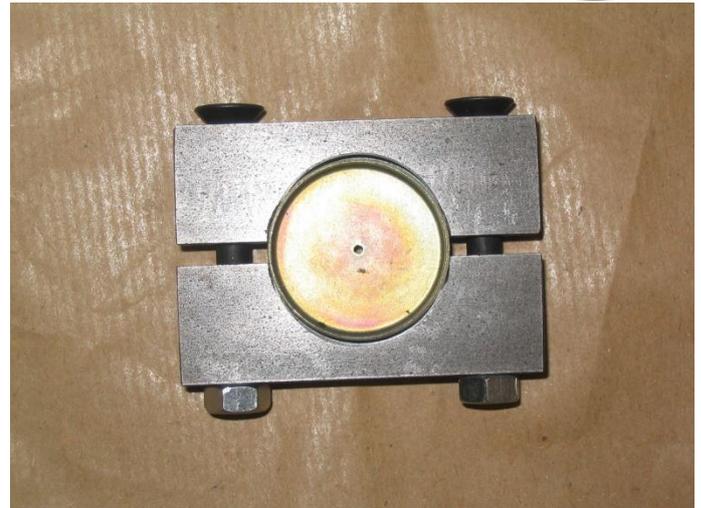
Fig 56 Tool to replace RG 7088

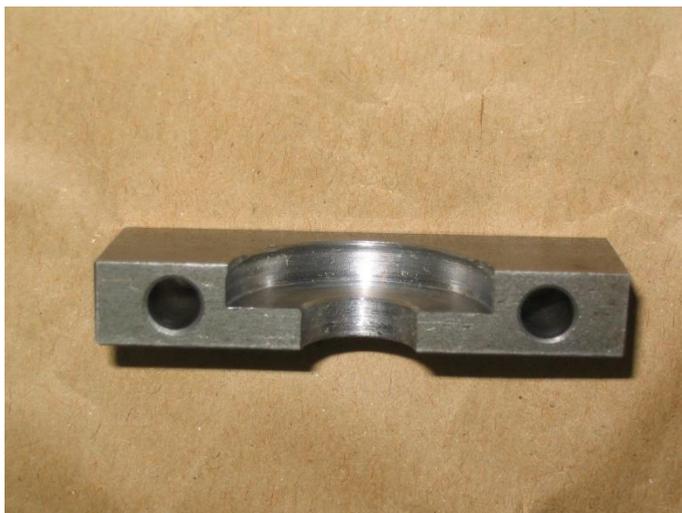
Fig 57 Tool cross section

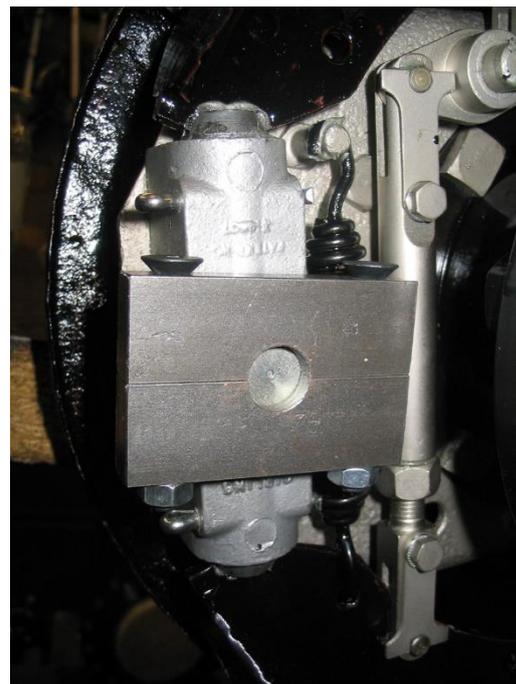
Fig 58 Tool for RG 7088 in use on a car

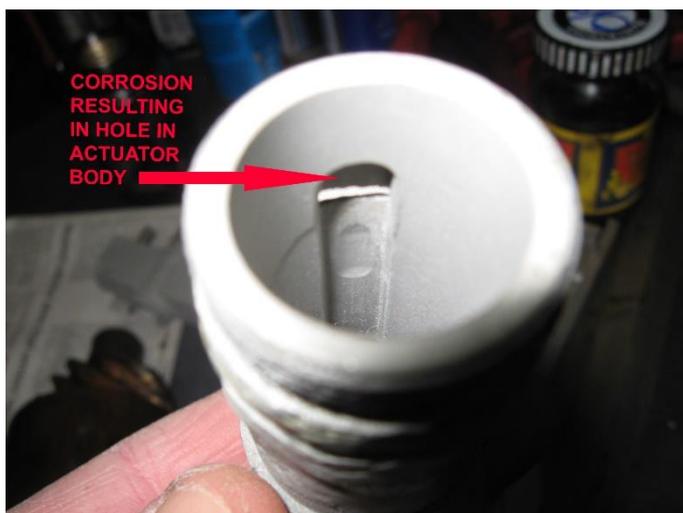
Fig 60a Hole in actuator body that can be repaired

Fig 59 shows a reconditioned actuator in the condition we all desire but Fig 60 shows the frequently found condition of these actuators discussed above. As discussed elsewhere it is possible to clean up the damage by turning but if the corrosion is severe often the worst can be ground out and replaced with metal filler or epoxy as shown in Fig 60a and Fig 60 b.

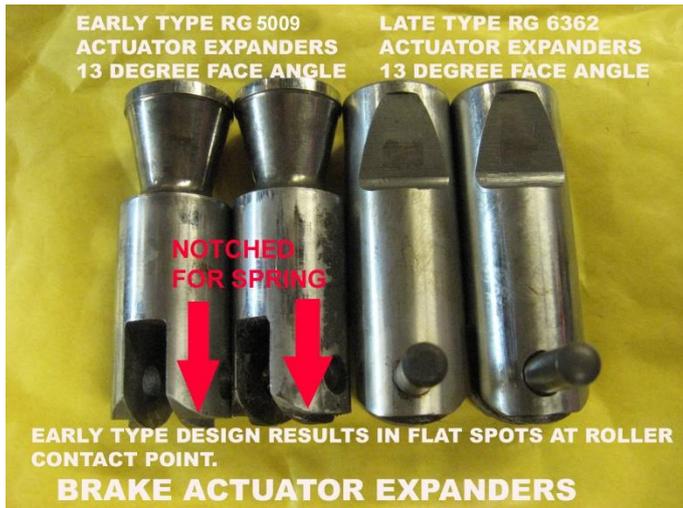
Fig 64 Actuator cone types

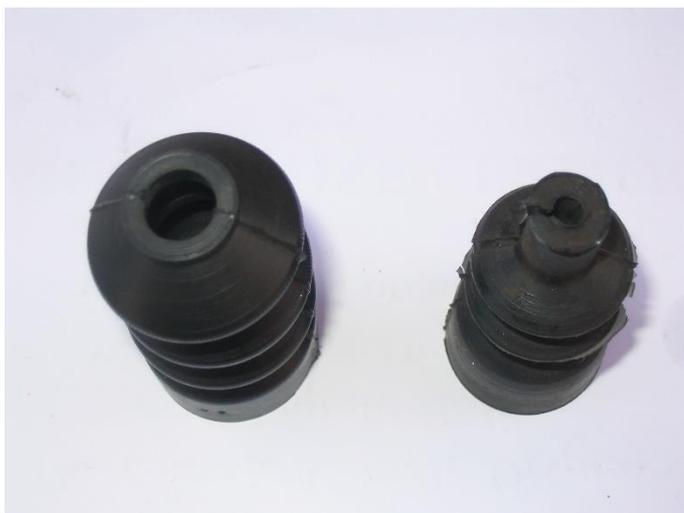
Fig 66 Rubber dust covers RG 3379 plan view

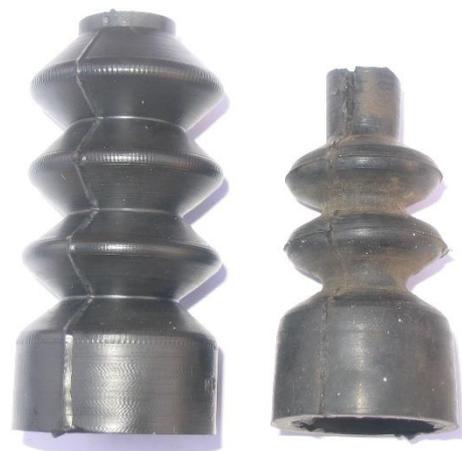
Fig 67 Rubber dust covers RG 3379 side view.

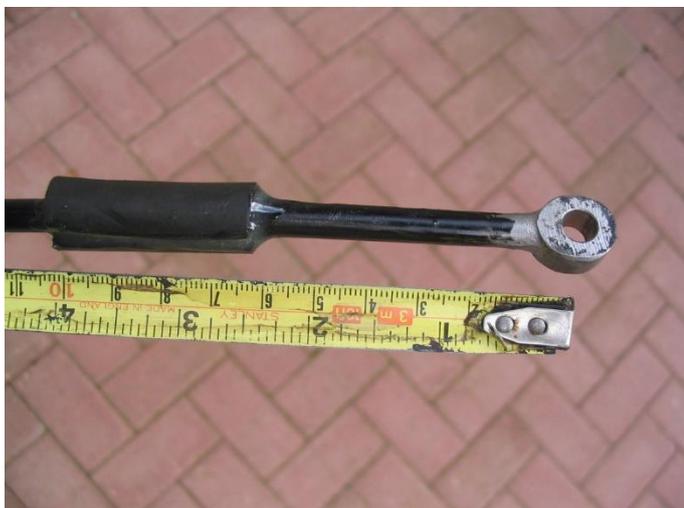
Fig 68 Rod with bonded fuel hose

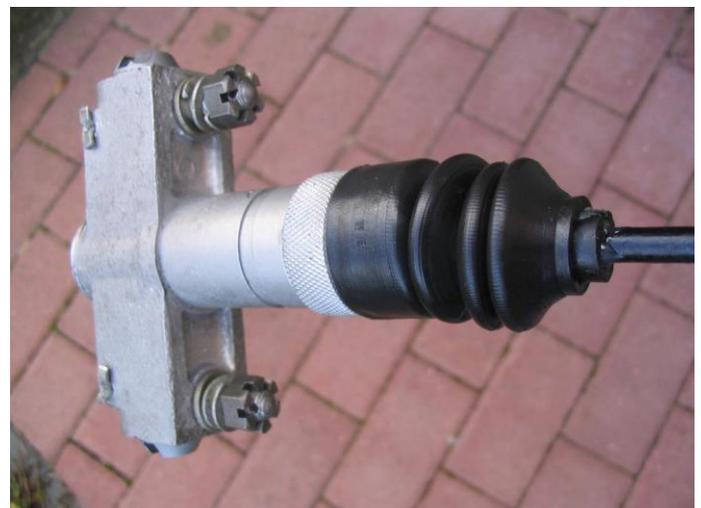
Fig 69 Rubber dust cover and rod modified.

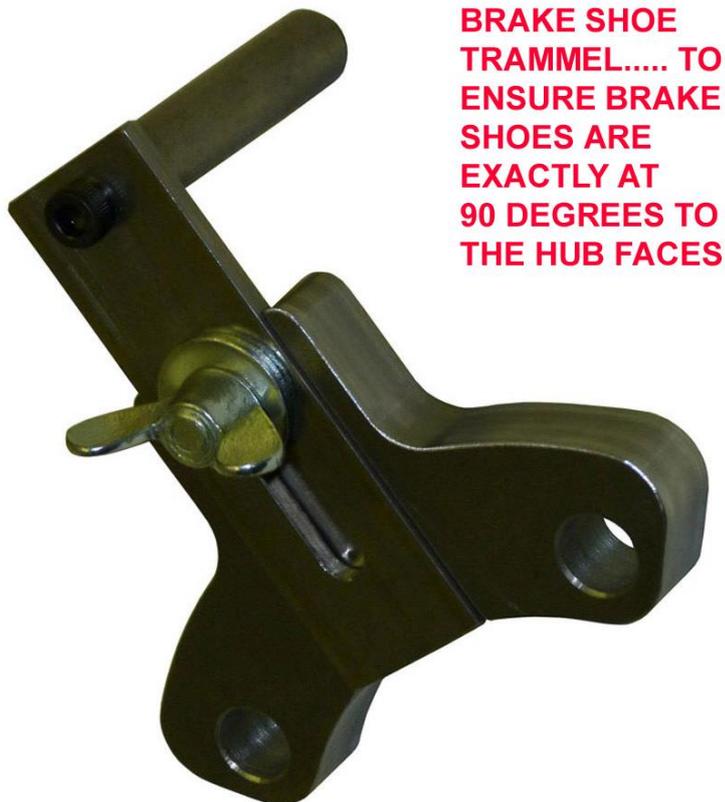
Fig 70 Brake shoe trammel tool

The trammel shown in Fig 70 is nicely designed and easy to use as it is adaptable to a number of cars in the R-R / Bentley range. It is not always easy for the home mechanic to find an old brake drum and this tool will fit the bill in those circumstances.
