Rear Axles...What Fails and Why (PART 1)

R-R Silver Dawn, Silver Wraith. BENTLEY MKVI, R type.

N.W.Geeson ver 1. 2006

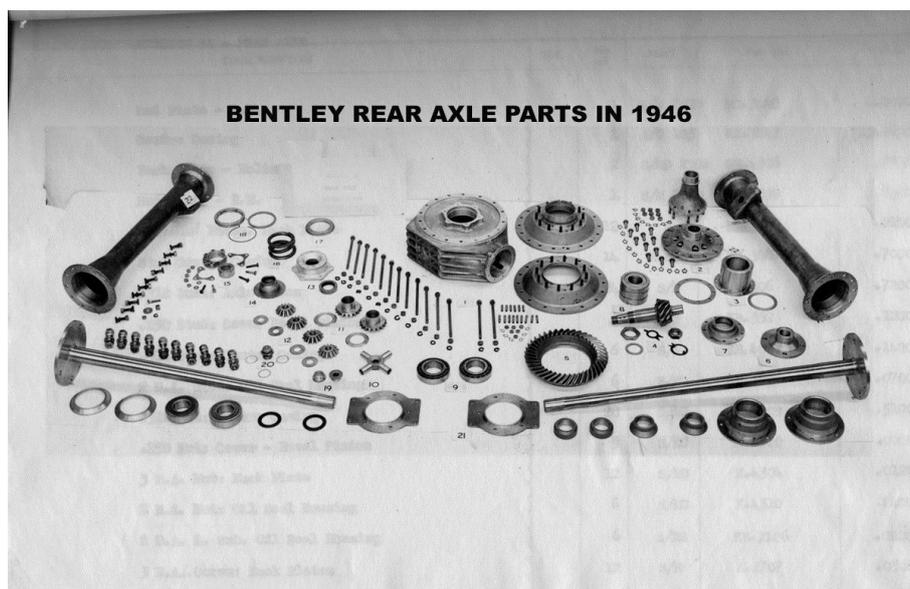
Fig 1. All the parts necessary to assemble a complete Bentley axle in December 1946. Many of the parts were modified for later axles.

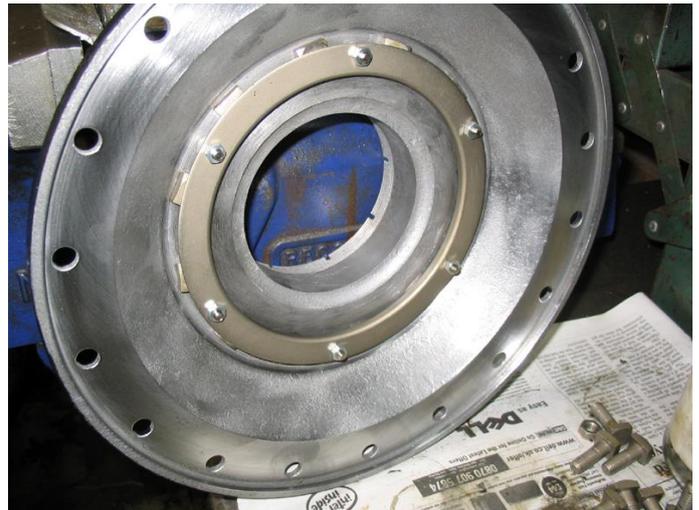
Fig 13. The side plate previously shown in Fig 12, now cleaned and assembled with nickel plated bolts and retaining ring. Looking much better!

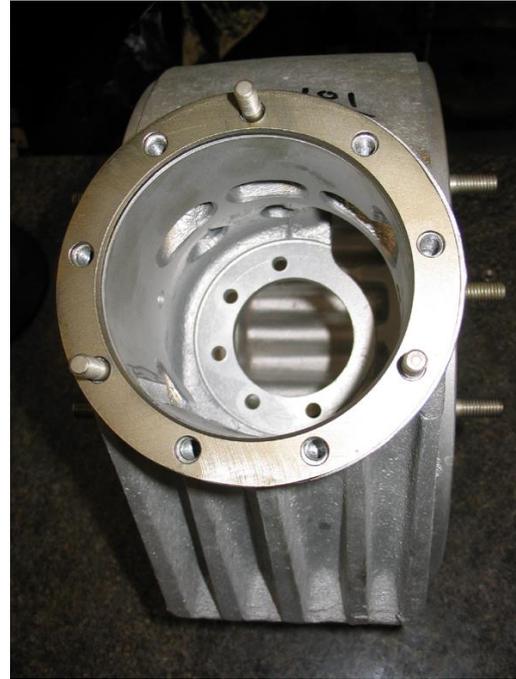
Fig 15. A similar view to the previous image, of the front of an axle case, now cleaned ready for rebuilding.

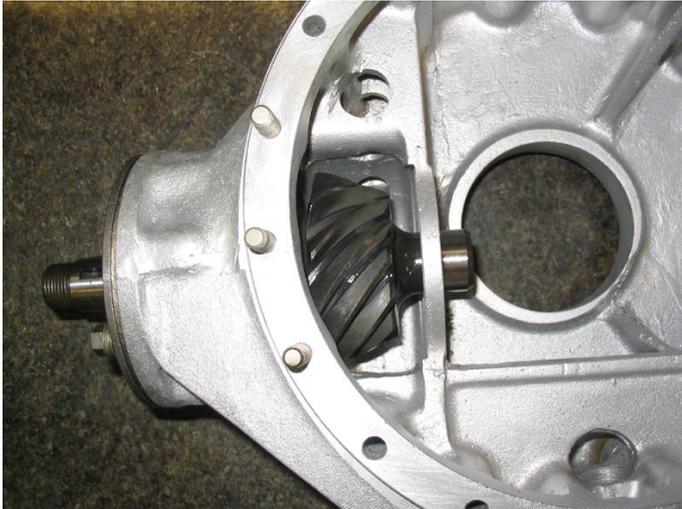
Fig 22. Ah, an R type axle case and actually clean.

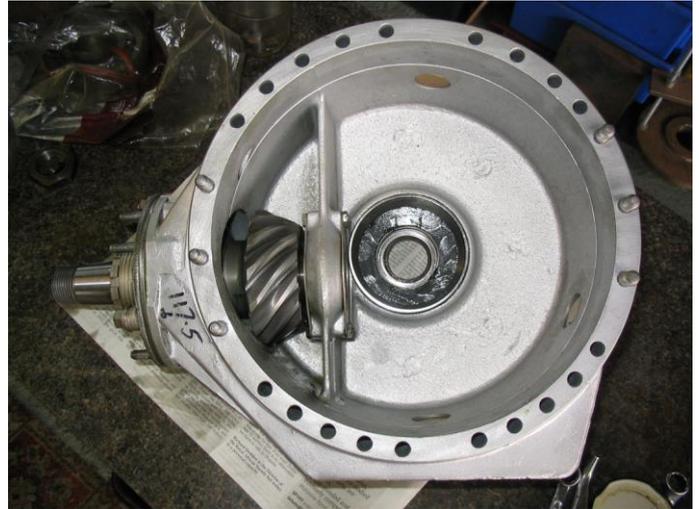
Fig 23 Oh, and a Bentley SI Continental axle, also clean. Seen here with the nineteen bolt case from the intermediate axle. Count the holes and you will see how the nineteen arises. Very early cases had eleven bolts.

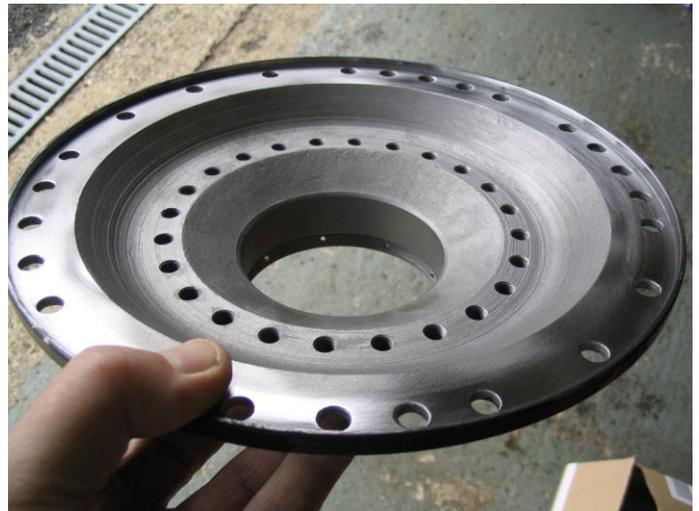
Fig 25. Just to prove the left hand side plates are cleaned before they are replaced. Bentley S3 again.

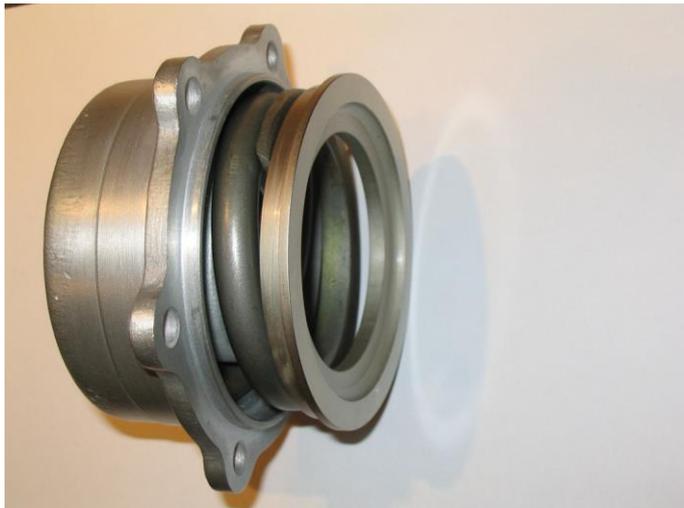
Fig 37. This is the side spring mentioned in the note to fig 35, and when it is tight with 1000 lbs of pressure, it disappears into this little housing. In this instance the spring thrust washer is shown on the end of the spring.

Ignoring for one moment any residue thrust loads the main reason that these bearings are inclined to move sideways and either bore into the inner case or spacer, is that they are heavily sprung loaded. In the immediate post war axles this takes the form of a coil spring, fig 37, some 1.650 inch long, whilst in the later axles up to Phantom VI the thrust is imparted by three belleville washers or spring disks. These spring disks, shaped like a dinner plate, are shown in fig 38 fitted to a R-R Phantom V axle case. Whatever the method used some 1000 lbs is imparted directly to the bearings at all times in addition to any working load. This sprung method has distinct advantages as it allows a constant bearing load regardless of the different expansion rates of the alloy main case and steel attachments. It is however a blessing in disguise, for it also allows the axle centre components to 'float' and is one of the main reasons that the axle is intolerant of rear wheel bearing wear.

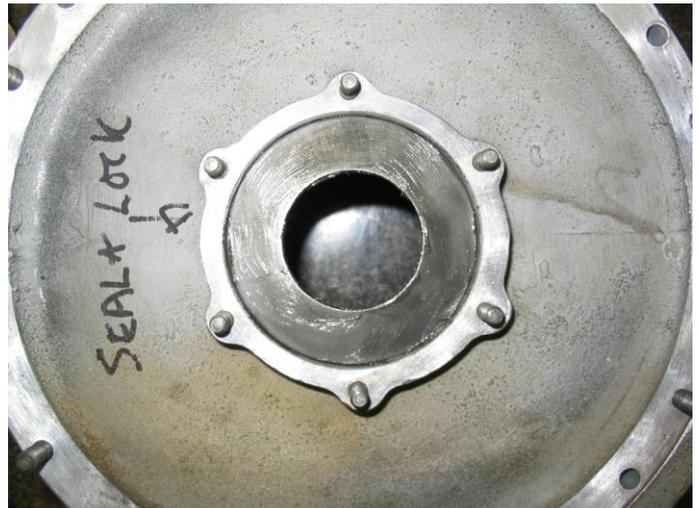
Fig 38. Belleville spring disks or washers replace the side spring on Bentley SI onward; they are seen here in position on a Phantom axle case.

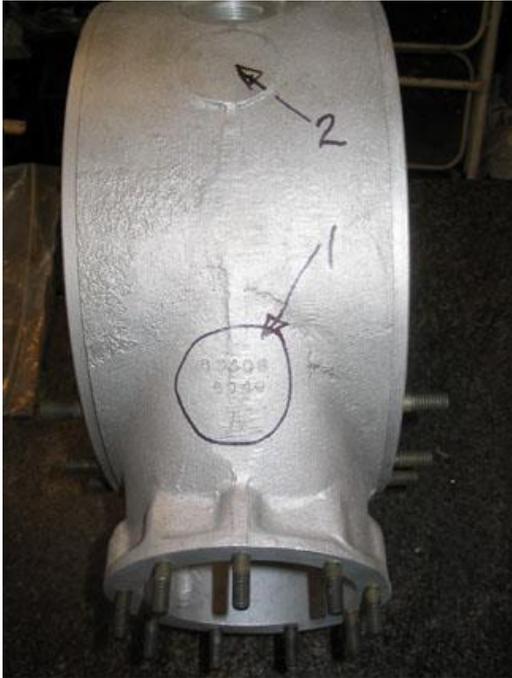
Fig 47. Showing position of serial numbers of the axle and gear set together with alternative 12/ 41 ratio.

Fig 47 shows a very late Bentley MKVI axle casing from a 'P' series chassis. At the position shown in (1) are two rows of letters and numbers. The top row of numbers identifies the actual axle serial number, in this case prefixed with a letter 'B' for Bentley. In the instance of R-R models the prefix is sometimes eliminated at this point on the earlier axles. The axle serial number is suffixed with the letters 'TB' when taper bearings are fitted to the pinion assembly on R type axles. The lower row of numbers show the serial number of the gear set originally fitted to that axle case.

The arrow showing point (2) indicates the position of the casting lug. Stamped onto this lug will be the numbers 12 / 41 if the axle has the higher 3.42:1 ratio. In other instances of early axles when only the 3.72:1 axle were fitted it was usual to find the letter 'W' for Silver Wraith or 'D' for Silver Dawn stamped on this lug. Later R-R axles had the code letter prefix the axle serial number.

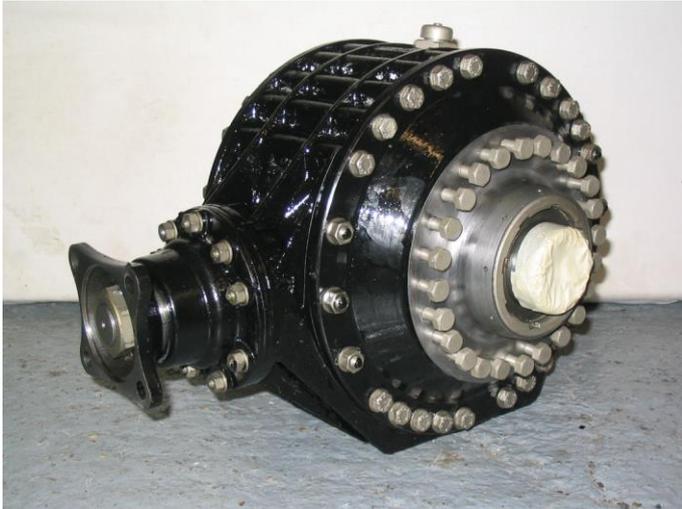
Fig 48. Intermediate type SI axle awaiting delivery.

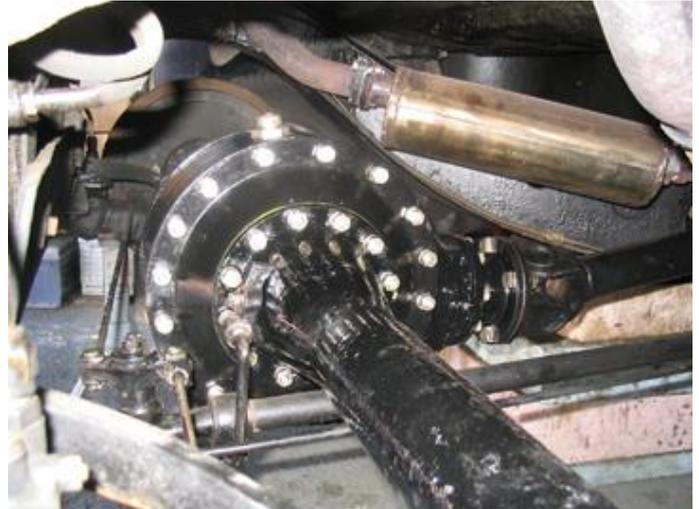
Fig 49. Axle installed in an R type, in this instance a 3.08:1 Continental unit

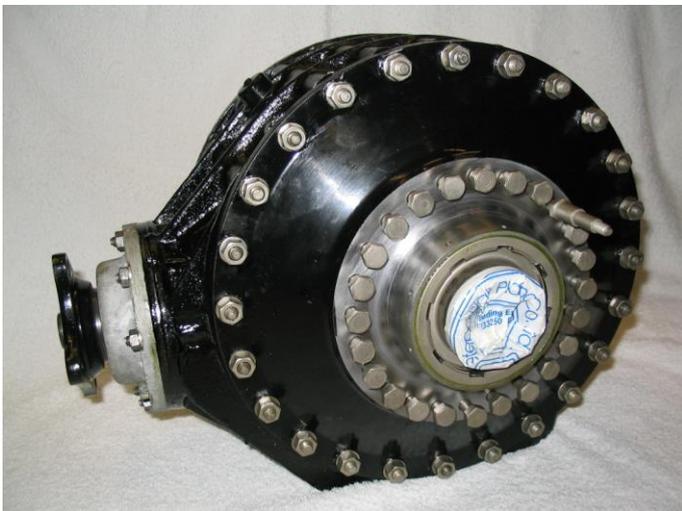
Fig 50. Phantom V / VI axle awaits the re-anodised alloy pinion housing painting before delivery. The short front nose on the axle main case ensures that this could only be a Phantom axle, as does the forward location of the breather.

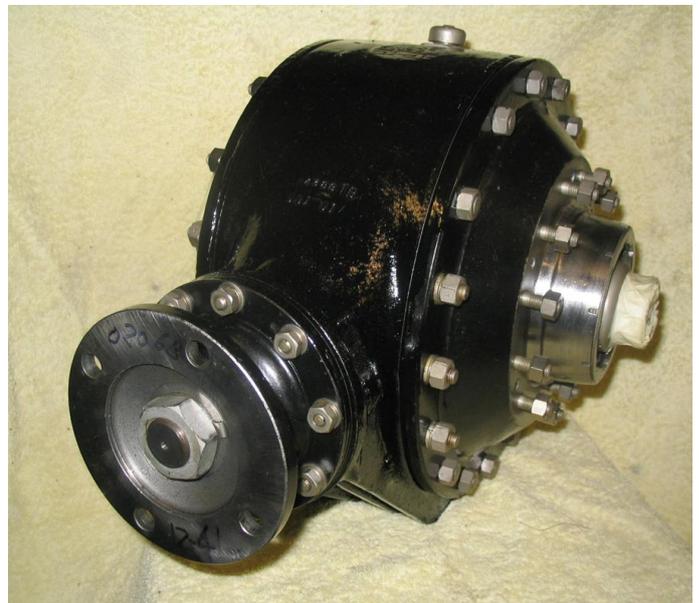
Fig 51. A standard 3.42:1 for a customer's late Silver Dawn axle or more correctly an early axle converted to that specification. A number of clues point to this having originally been a very early axle case with a triple pinion bearing. Note the authors newly stamped letters 'TB' suffixing the axle serial number and indicating taper pinion bearing fitment.
