FRONT AND REAR ENGINE AND GEARBOX MOUNTINGS RENEWING

R-R Silver Dawn, Silver Wraith, Bentley Mark VI, R type

N. W. Geeson

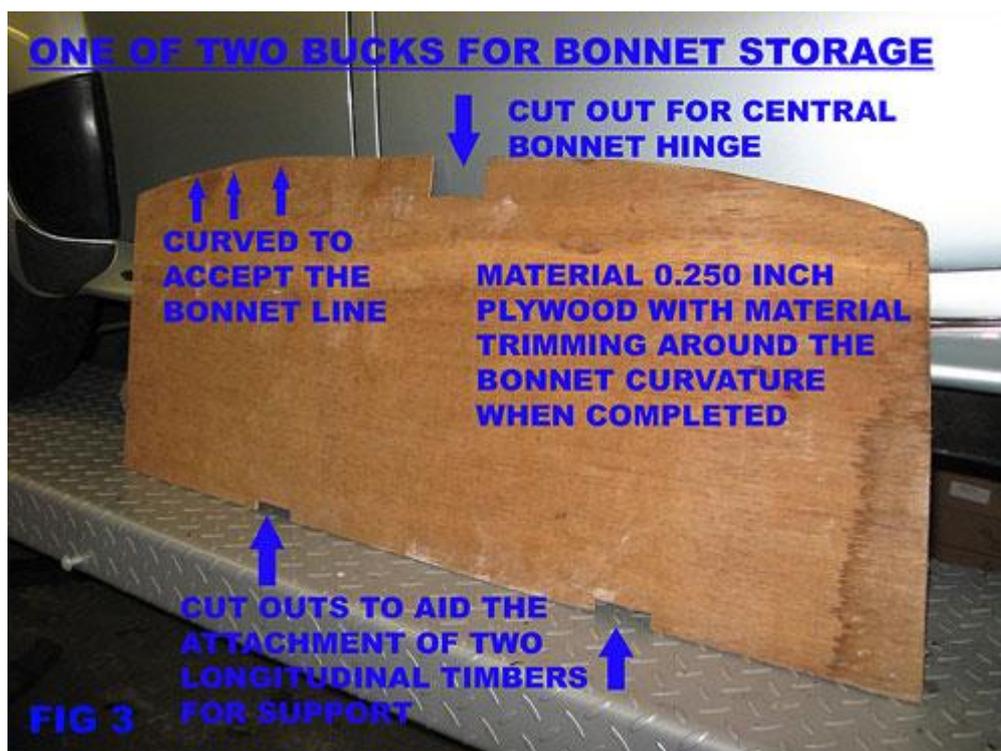
Fig 3 Bonnet Buck to aid storage of the bonnet (hood) without damage

plywood bucks, which are each cut in a half moon shape, see Fig 3. One panel with a large radius to suit the rear of the bonnet radius and one small radius to suit the front end radius. These two panels are flat on their base to represent a line rough below the bonnet line and they are joined together by two length of timber.

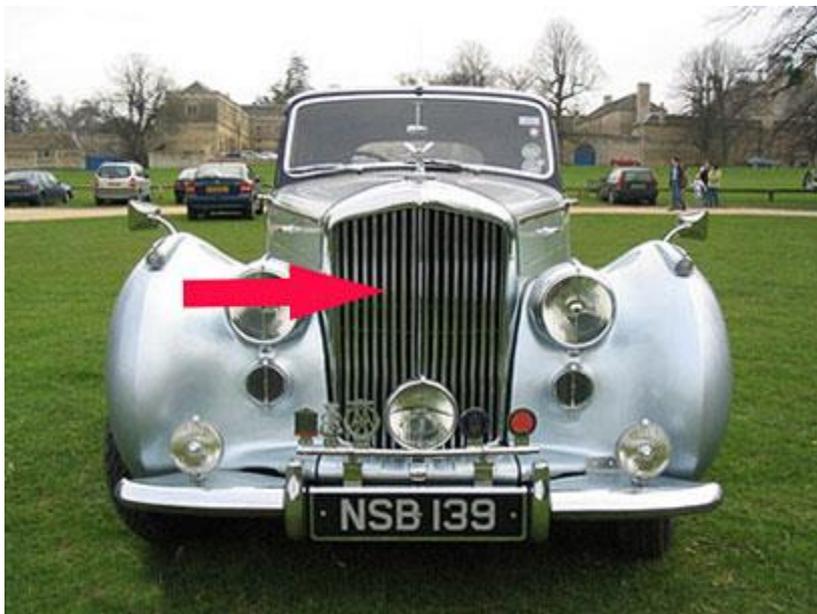
Fig 4. Front shutters opened out on an R Type

Fig 4 shows the shell and shutter appearance on a late R type when the shutters have been opened out to maximum. Close up, the radiator matrix can just be seen from a direct head on view, but in 20 years even specialists have admitted they have never noticed the modification. An examination of other cars will usually show that the radiator matrix cannot be seen, and even the company admitted that on the earlier cars the centre 8 inch of the matrix is starved of cooling air.

All these changes were not completed for the styling exercise but to improve cooling. Further to these changes a system of modifying the earlier and intermediate shutters took place to assist cooling. These changes need applying to all shutters whenever the shell unit has been removed from a car.

The modification on each shutter set comprises of drilling out one of the two rivets at each end of individual shutter rails. The vertical rail is then turned or pivoted on the existing rivet, towards the open position as far as is feasible to admit more cooling air commensurate with a

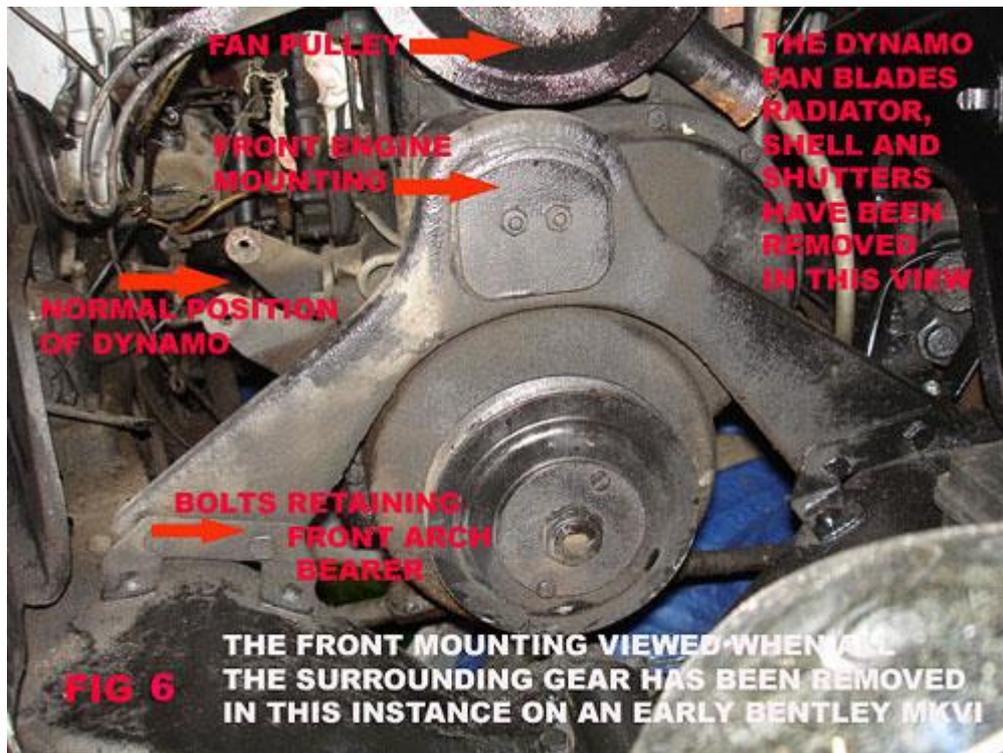
Fig 6. The view, once the front end is stripped off the car

The production parts that originally made up the front mounting are shown at Fig 5. Once the radiator assembly has been removed, the fan and belt, and preferably the dynamo can be removed to improve access. At that point the front of the engine will look similar to Fig 6. Note in this view the arch bearer to chassis bracket four retaining bolts have previously been fitted back to front; their nuts should face to the front of the car.

Extract the four split pins from the front cross bearer arch to chassis attachment bolts, remove the castel nuts from the bolts, but leave the bolts in place. Take note that the bolts are a very close fit and packing pieces, Fig 5, are inserted between the arch bearer and chassis brackets.

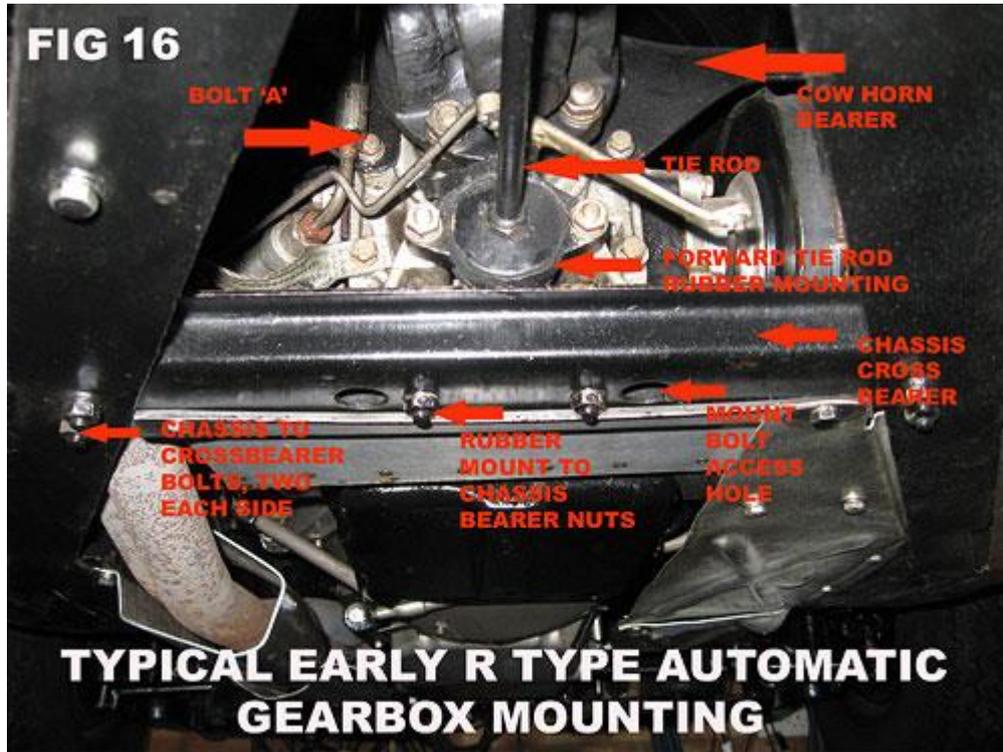
Fig 15. Gearbox Rear left hand side

If reference is made to Fig 13, Fig 15 and Fig 16 the orientation of the position of parts can be judged by locating the position of "Bolt A" on each image.
