# REAR AXLE PINION OIL SEAL RENEWAL AND MODIFICATION

Applicable to all early post war cars up to and including Silver Cloud III / Bentley S3, but excluding all Phantom axles

N. W. Geeson

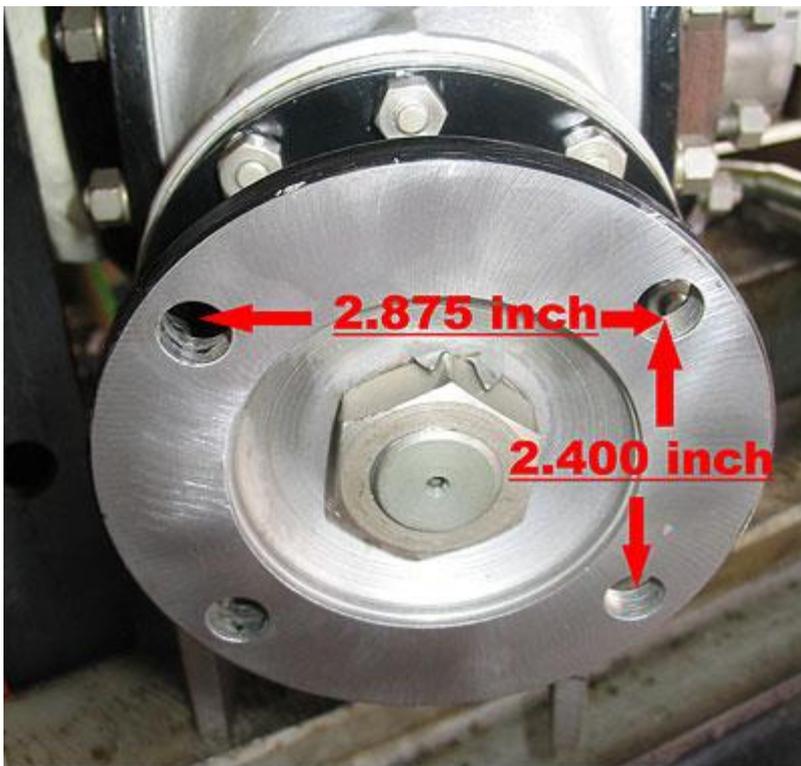
Fig 8. Drive flange hole spacing

The drive flange design changed when the Silver Cloud / Bentley S type were introduced but the same pitch centres were used as were roughly the shank diameters of the four bolts. Referring to Fig 8 will show the holes are staggered in pairs with holes of 0.4375 inch at 2.875 inch and 2.400 inch centres. This allows us to use the same flange puller, described later. In the same Fig 8 image the lock tab and flange retaining nut can be seen.

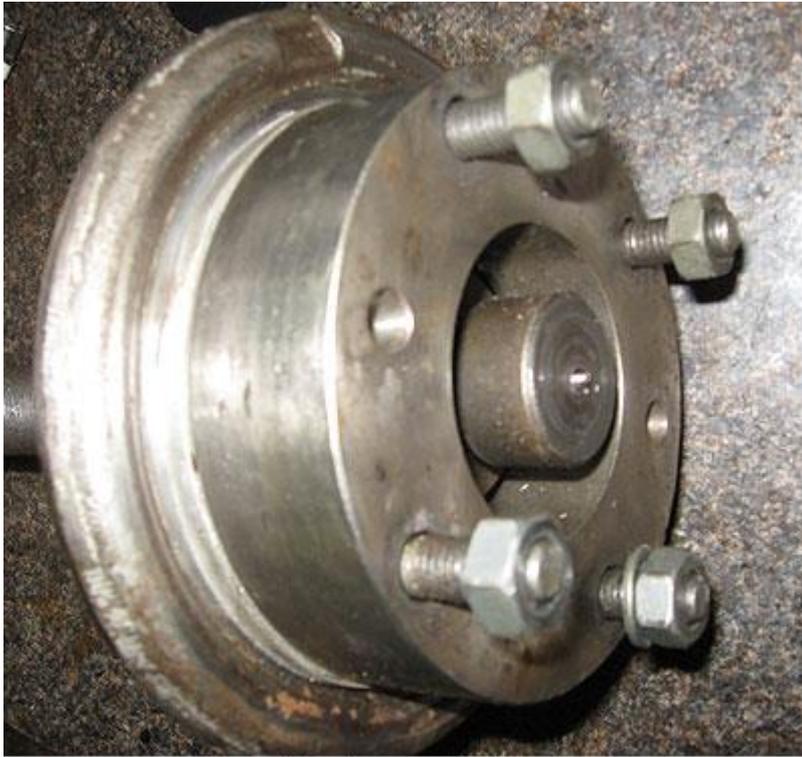
Fig 9. Drive flange puller bolted end

Previously the problem of removing the drive flange without distorting it any more than it may have already been damaged was mentioned. You don't want to bend it anymore because you definitely do not want to know the new price! The way to overcome the problem is to make a thick block puller similar to that shown in Fig 9 and fitted to the drive flange in Fig 10. A block of metal is used circa 1.25 inch thick. Notice in Fig 9 that there is quite a large diameter central relief around the puller screw. This relief is required to accept the slight protrusion above the flange face of the axle pinion shaft end and the flange retaining nut that stands proud of the flange face, when the tool is coupled as in Fig 10. This particular puller has been
