# ROLLS-ROYCE BUILT “HYDRAMATIC” AUTOMATIC TRANSMISSION

David Chaundy

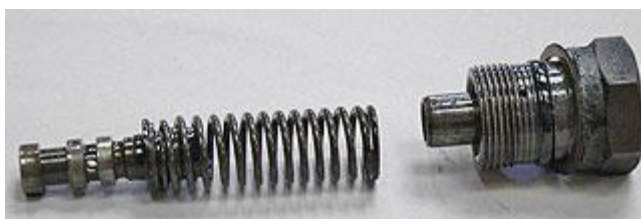
The main pressure regulation valve. This valve screws in to the top of the transmission near to the band adjusters near the bell housing. It controls the main operating pressure of the transmission. **IT IS VERY IMPORTANT 6 CYLINDER VALVES ARE NOT INTERCHANGED WITH V8 VALVES.** they run at different pressures, the V8 being the higher pressure.

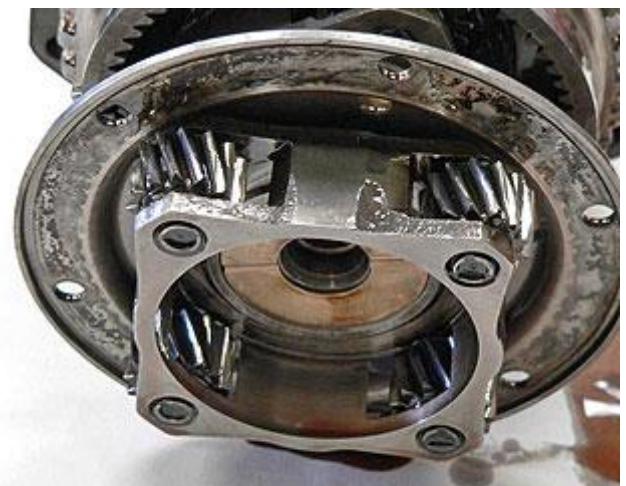
The rear forward drive epicyclic gear train with one of the bronze adjusting washer in the centre. The reverse epicyclic gears and the locking annulus can be just seen behind.

the problem was solved.” You assembled this to the drawing” Graham said. “Yes of course” I replied. “The drawing is misleading, I made the same mistake myself when I first started working on these” Graham said. You have put the adjusting washer on the wrong side of the spring ring on the rear planet gear output shaft. That puts the whole rear assembly 1/8” out and makes it

tight.”

With the adjusting washers in the right order we soon had the rear housing back in place. I left the transmission with Graham to be rig tested the following day. I had purposely left the final adjustment of the brake bands to Graham. I did not possess the special gauges necessary to effect the adjustment, and as the bands may have needed further adjustment during testing I thought it pointless to worry about the settings.

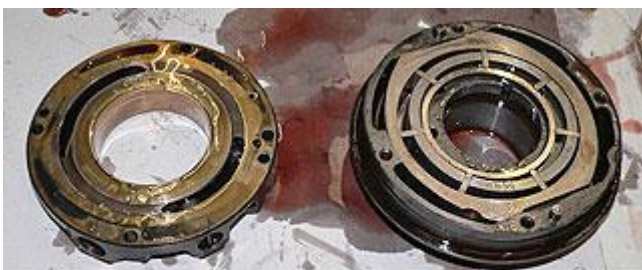
The main pump. To the left is shown the main pump body complete with rotors and vanes. To the right is shown the cover.

One problem that springs to mind is the main fluid pump located just behind the bell housing. These pumps are an engineering nightmare to manufacture and require very fine tolerances to work effectively. If unsuspecting “specialists” fit a G.M. made pump to a Rolls-Royce built transmission they must first carefully fettle to pump internally to ensure it is dimensionally correct. Failure to do this can result in the pump seizing. If at all possible, to avoid problems, only fit genuine numbered Rolls-Royce parts.

and will burst the main torus neck seal. It is therefore very important careful attention is paid when building the main pump.

Never try to prise the main pump out of the transmission casing when dismantling. The outer retaining lip is very delicate and is very easily broken. Be very careful and follow the instructions given for removal of the pump in the workshop manual. These pumps are becoming very hard to find these days.

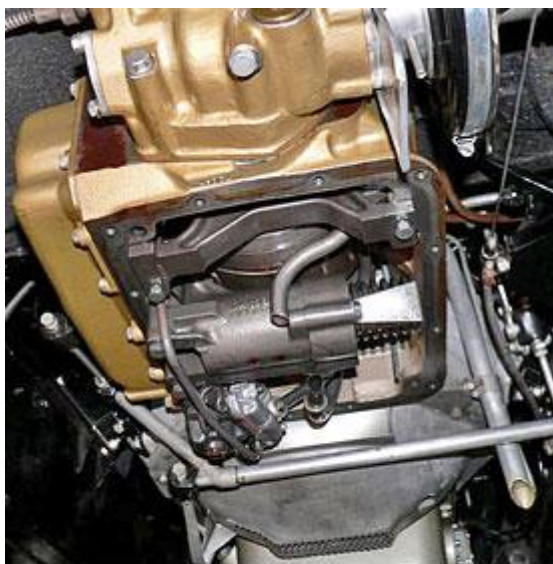
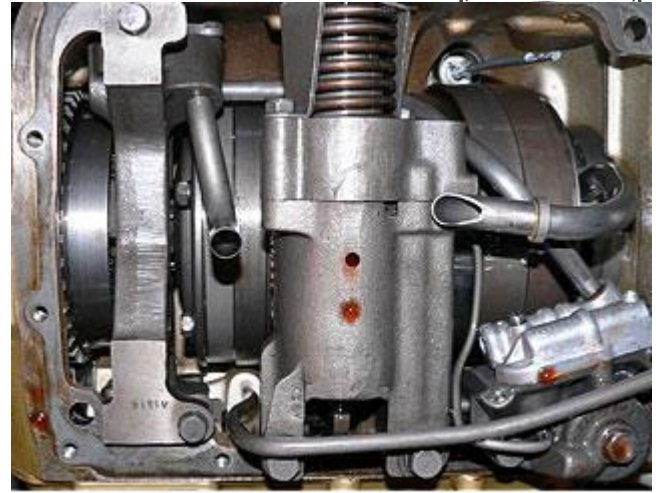
With my transmission re-installed in the chassis I was keen to see how it performed on the road. A drive around the block showed a problem with the 2nd to 3rd gear change. Instead of changing smoothly the transmission made a loud bang and jolted as it changed gear. All the other gear changes were smooth and very satisfactory. My initial thought was the throttle valve setting was incorrect. The throttle valve linkage had been carefully set as per the instructions in the workshop manual. I had been warned by Graham to expect the setting of the throttle valve to take some time. It really is trial and error until the correct setting is arrived at. Later transmissions have an adjustable link on the gearbox. This saves a great deal of fiddling

The finished and installed gearbox with the sump off.

around, lengthening or shortening the throttle valve link rod by screwing the end fork in or out. I spent a whole afternoon trying every possible setting of the throttle valve with little improvement in the 2nd to 3rd gear change. I rang Graham to ask his opinion. He told me he felt the band adjustment was probably out, despite the bands being carefully adjusted with the correct factory gauges. Sometimes the desired synchronisation of the brake bands is not achieved. I decided my transmission needed Graham's expertise, to affect a cure.

Graham drove the car with his assistant in the passenger seat. I sat in the back observing closely. Graham was surprised how violent the 2nd to 3rd gear change was. Graham explained in order to obtain a smooth 2nd to 3rd change it is essential that the application of the front epicyclic brake band is synchronised with the release of the front epicyclic clutch and the release of the rear brake band and application of the rear epicyclic clutch. Any lag or advance in band operation causes the violent gear change I had experienced. To be able to adjust the bands without the correct gauges requires some trial and error and an intimate knowledge of the transmission to get it right. Graham made it look easy, but not so easy I would try it myself.

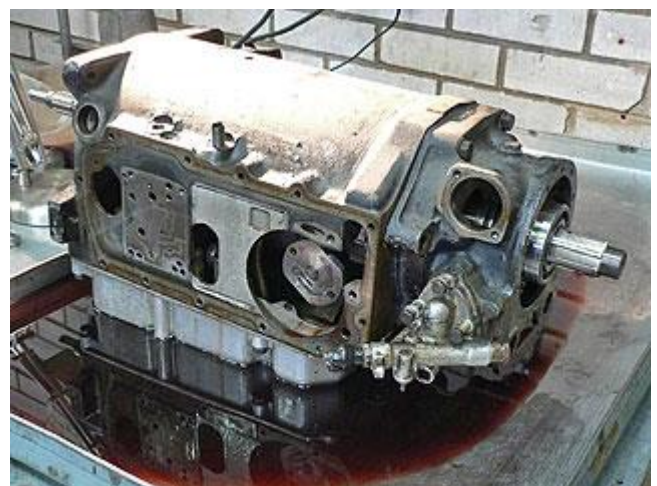
This is a view of a partially dismantled Bentley R type transmission. The different tailshaft housing and ride control pump can be seen.
